## **NATIONAL TRANSPORTATION SAFETY BOARD**

### **Group Chairman's Factual Report**

# **OPERATIONAL FACTORS**

DCA17LA145

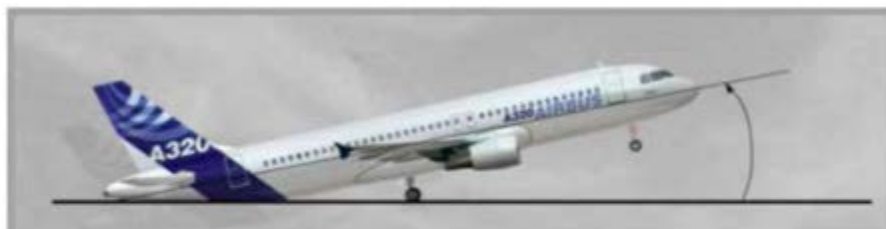
| Aircraft | Tail Strike Pitch Attitude (x) | Typical Pitch Attitude at Touchdown (y) | Difference [i.e., available “slop”] (x – y) |
| A320 | 13.5° | 7.6° | 5.9° |

The above chart depicts tail strike pitch attitudes for the A320 and A321. It also displays the typical landing attitude at touchdown. Note that the A321’s landing pitch attitude is one degree lower than the A320’s. This is due to the A321’s double slotted flap system, which reduces the pitch attitude on final by about a degree. Other carriers that operate the A321 say a simple landing flare of around 2 degrees results in a smooth landing, well within the runway’s touchdown zone...”
