## **NATIONAL TRANSPORTATION SAFETY BOARD**

### **Group Chairman's Factual Report**

# **OPERATIONAL FACTORS/HUMAN PERFORMANCE**

DCA18IA081

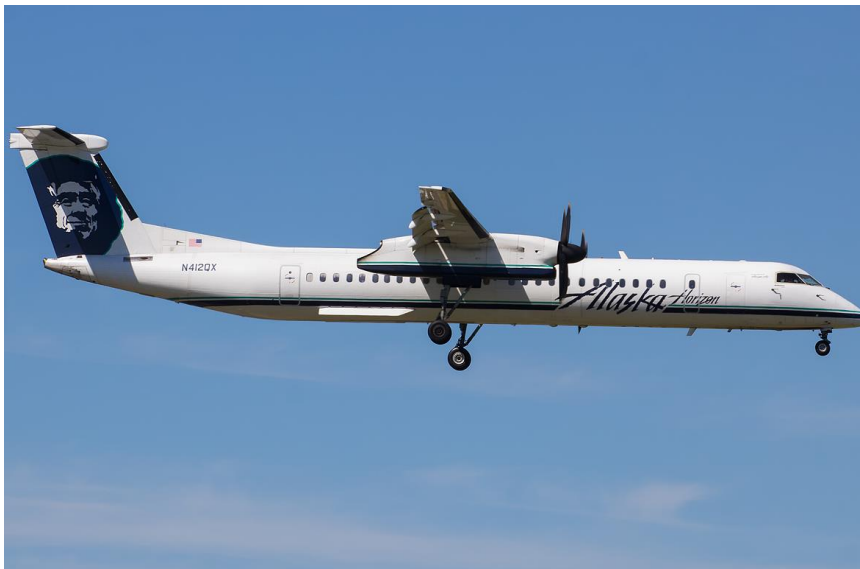
**Photo 1: Photo of incident airplane N412QX.**<sup>27</sup>

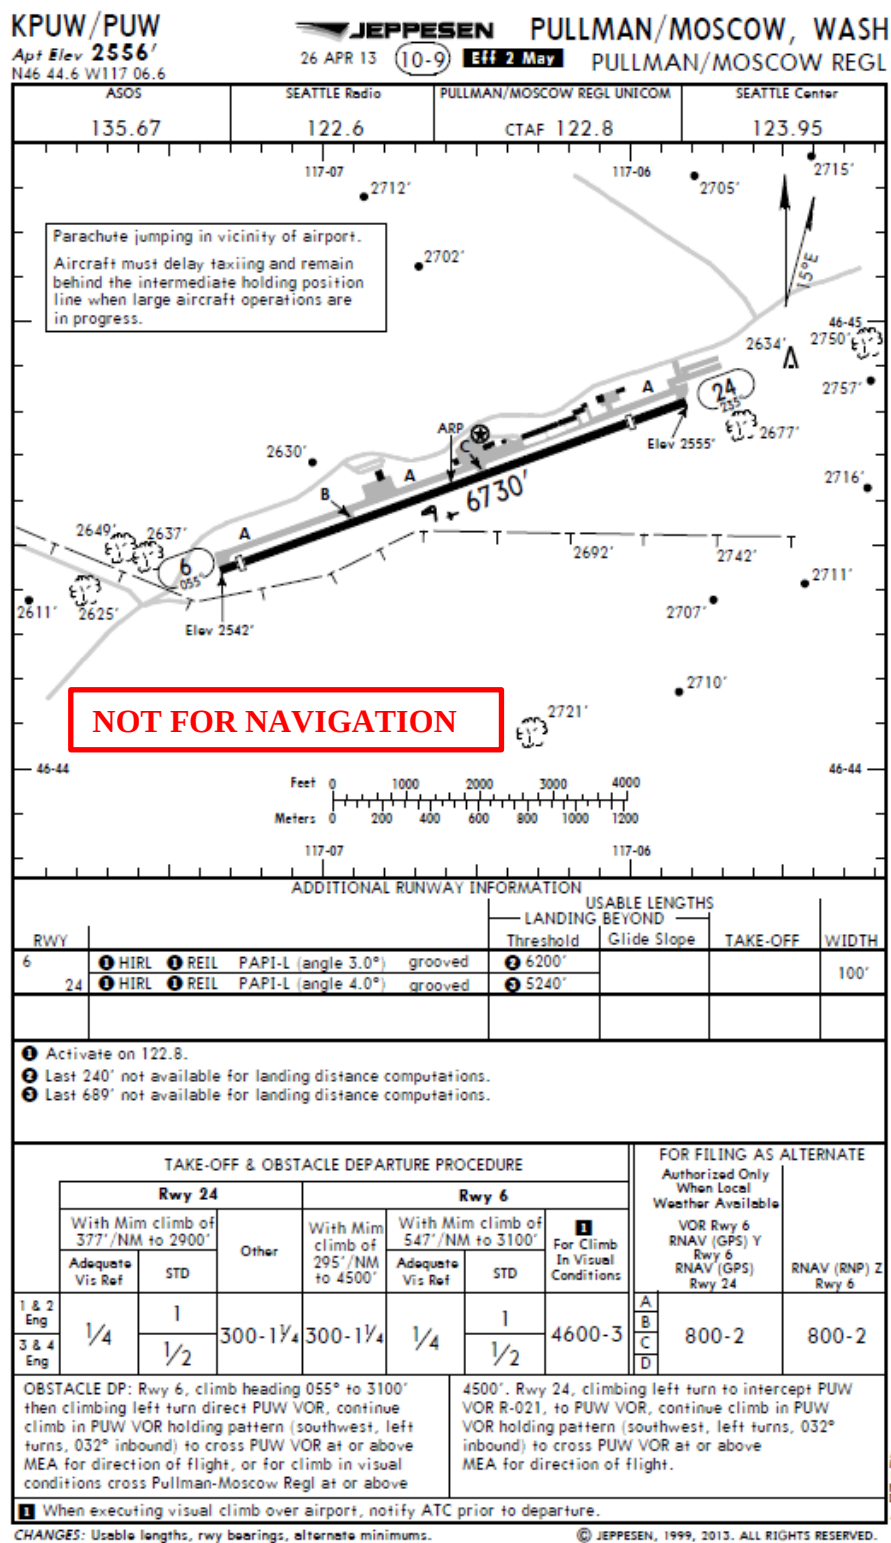
Figure 1: PUW Jeppesen 10-9 Airport Chart.<sup>40</sup>

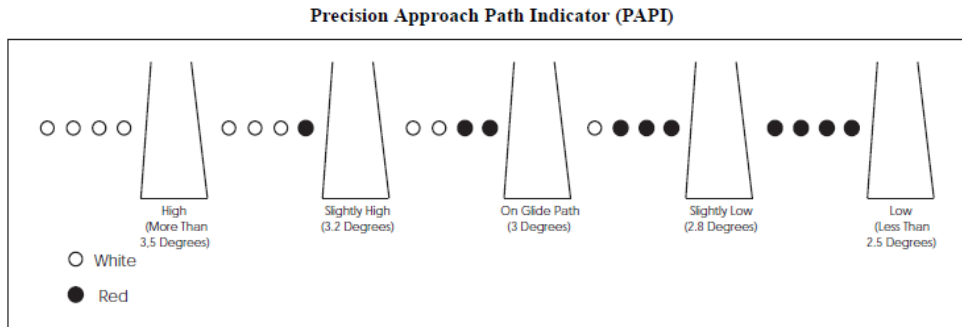
**Figure 3: Precision Approach Path Indicator (PAPI).** Source: AIM, Figure 2-1-5.

<sup>54</sup> The PUW PAPI was a 2-bar PAPI with a 3.00 degree glide path. Source: <https://www.airnav.com/airport/KPUW>.

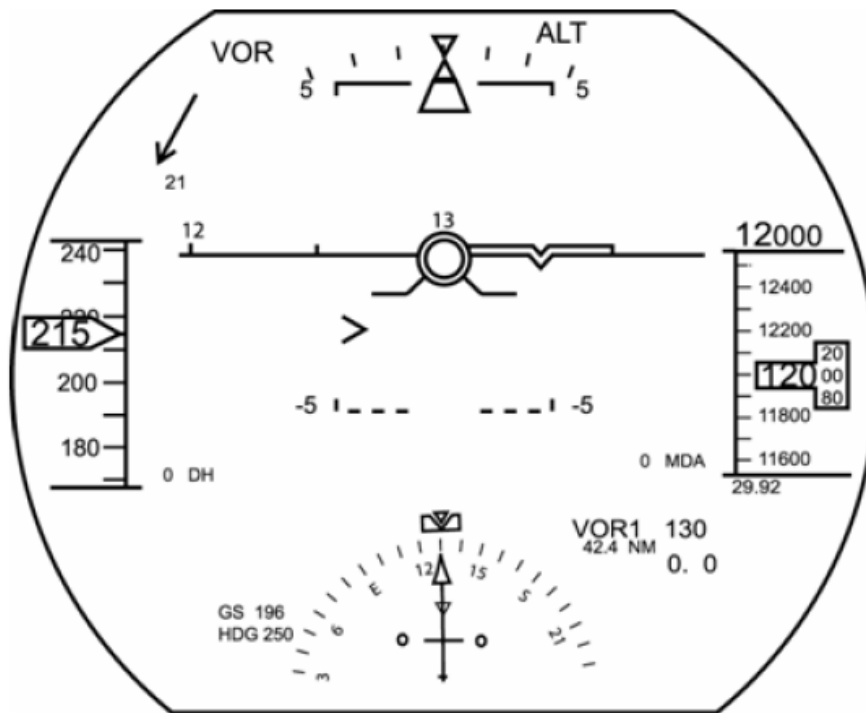
**Figure 4: Primary Mode Symbolry (typical).** Source: Horizon Air Q-400 System Description Manual, Chapter 20.

The PRI mode may be used during any conventional Flight Director Approach (including an RNAV approach), but no lower than for a CATI approach, for lateral and vertical navigation to the runway.

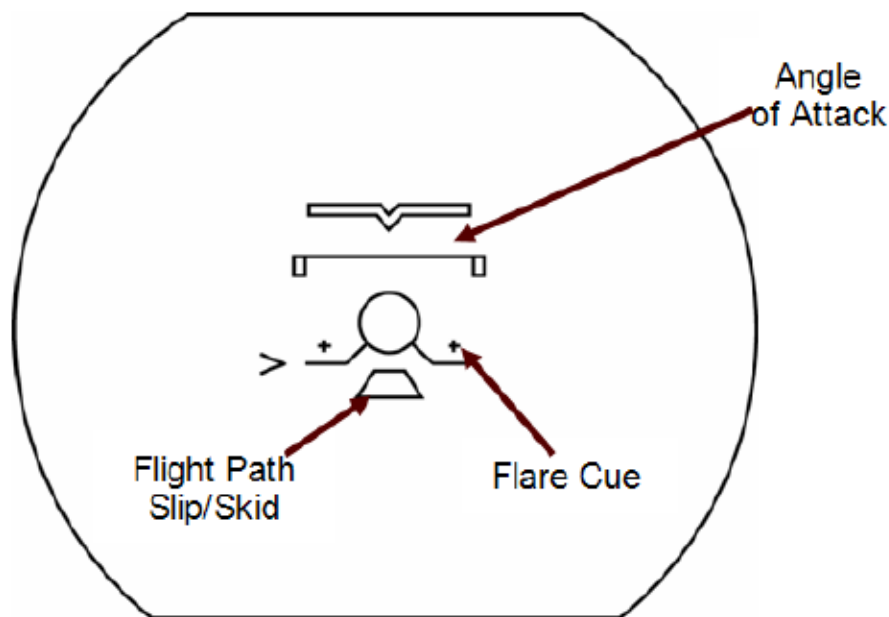
All Horizon Air Q-400 HGS had been upgraded with optional Autonomous Flare guidance. HGS Autonomous Flare guidance was available in PRI, VMC and IMC modes as supplemental information to aid the pilot in completing the visual segment of the approach. Autonomous Flare symbology appeared in the combiner during the flare segment of every landing, including visual approaches. Autonomous Flare symbology was based on RA (radio altitude), energy state, and inertial reference. If a failure occurred that inhibited Autonomous Flare, a NO FLARE message was displayed. To avoid two types of vertical information, the Flight Director Guidance Cue was removed from view below 80 feet AGL.

**Figure 5: HUD Flight Path Symbolology. Source: Horizon Air Q-400 System Description Manual, Chapter 20.**

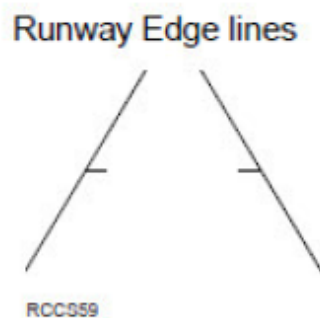
Runway edge lines were also displayed between 300 feet AGL and 60 feet AGL. The aircraft's orientation to the runway was shown with the runway symbols in perspective to the real-world runway. The lateral position of the runway edge lines was set using the Course Select knob on the Flight Control Panel (FCP).

**Figure 6: Runway Edge Line Symbolology. Source: Horizon Air Q-400 System Description Manual, Chapter 20.**
