**NATIONAL TRANSPORTATION SAFETY BOARD**

**Group Chairman's Factual Report**

**OPERATIONAL FACTORS**

DCA19CA081

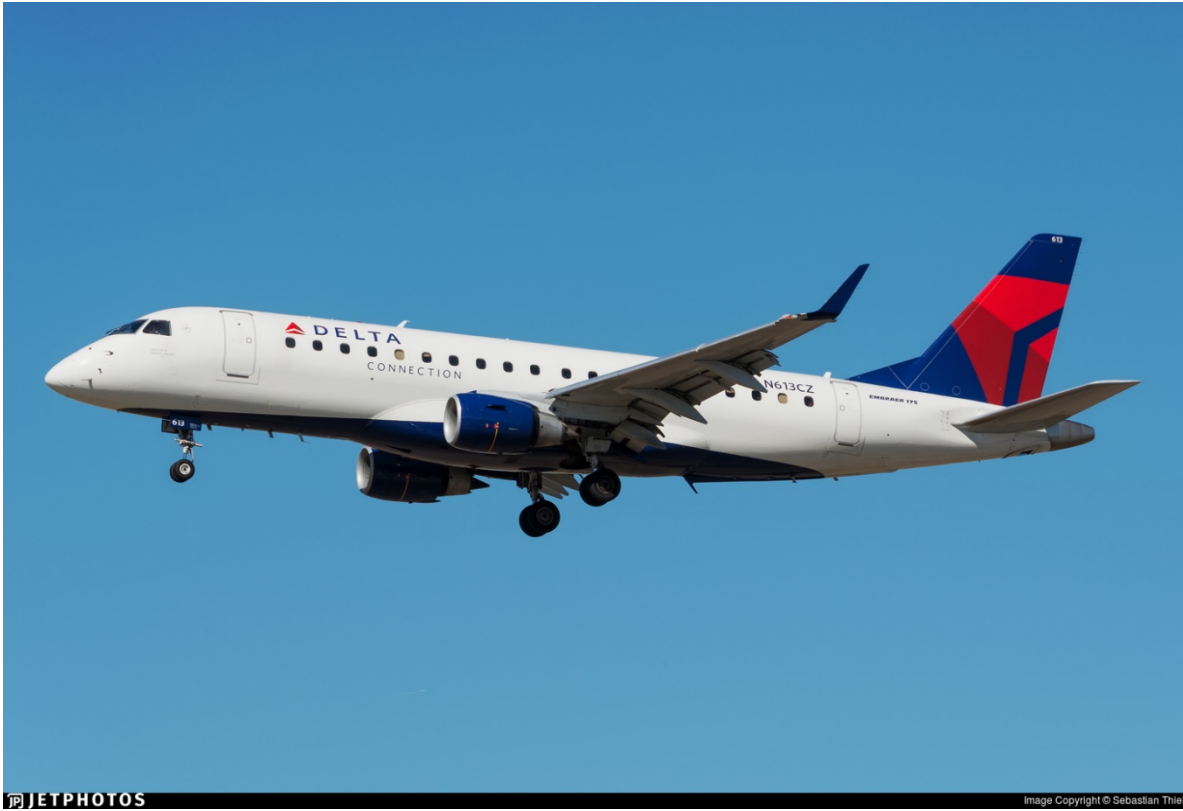
**Photo 1: Accident Airplane, N613CZ (Courtesy of JetPhotos.net)**

The accident airplane (Registration N613CZ, Serial No. 17000203) was an Embraer-Empresa Brasileira De ERJ 170-200LR. The airplane was built in 2008, registered to Delta Air Lines, Inc, operated by Compass Airlines LLC as a Delta Connection flight, and held a transport category airworthiness certificate dated January 23, 2008. The airplane was powered by 2 General Electric CF34-8E5 engines, each were rated at 14,510 pounds of thrust. The airplane was configured with 2 pilot seats, 1 cockpit observer seat, 4 flight attendant seats, and 76 passenger seats.

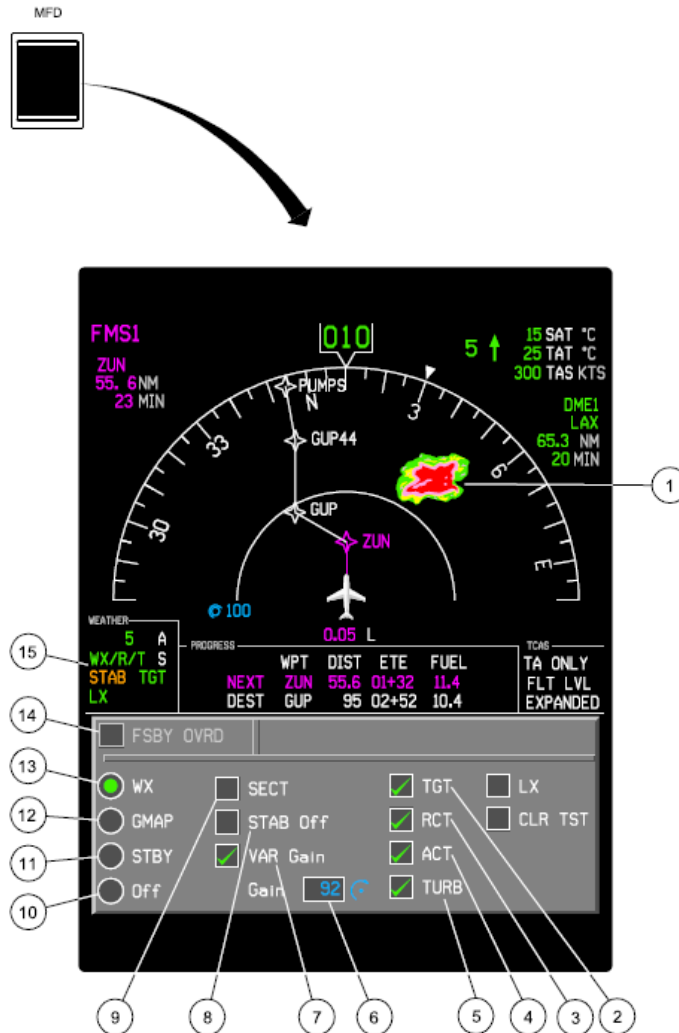
Compass Airlines, Airplane Operations Manual – Volume 2, Section “Systems Description – Flight instruments/Comm/Nav/FSM” provided the following pictorial and textual information about the weather radar indications on the MFD:

**Figure 2: Weather Radar indications on the MFD (Source: Aircraft Operating Manual, Vol. 2)**

#### 1 - WEATHER RADAR RETURNS

- Displays target in colors.
- WX mode: the color indicates rain intensity. In increasing order of intensity: green, yellow, red and magenta.
- RCT mode: attenuation is too high, hiding possible severe weather areas (cyan).
- GMAP mode: color indicates surface information: black, cyan, yellow and magenta.
- TURB mode: areas of potentially hazardous turbulence (white).

GREEN (WX/R/T): normal WX with RCT and TURB.  
 GREEN (GMAP): GMAP mode.  
 GREEN (FSBY): forced standby.  
 GREEN (TEST): test mode and no faults.  
 AMBER (WX CTRL): invalid WX control bus.  
 AMBER (FAIL): failure is detected.  
 AMBER (OVRNG): MAP range greater than 300 NM.  
 WHITE (WX OFF): WX is OFF.  
 WHITE (WAIT): power up.  
 WHITE (STAB): STAB OFF function selected.  
 WHITE (STBY): normal standby.  
 WHITE (S): slave mode is active.

- Stabilization annunciation: radar stabilization is inhibited.
- Target and gain mode annunciation.
  - GREEN (TGT): TGT selected.
  - FLASHING AMBER (TGT): TGT selected and alert condition.
  - AMBER (VAR): variable gain selected.

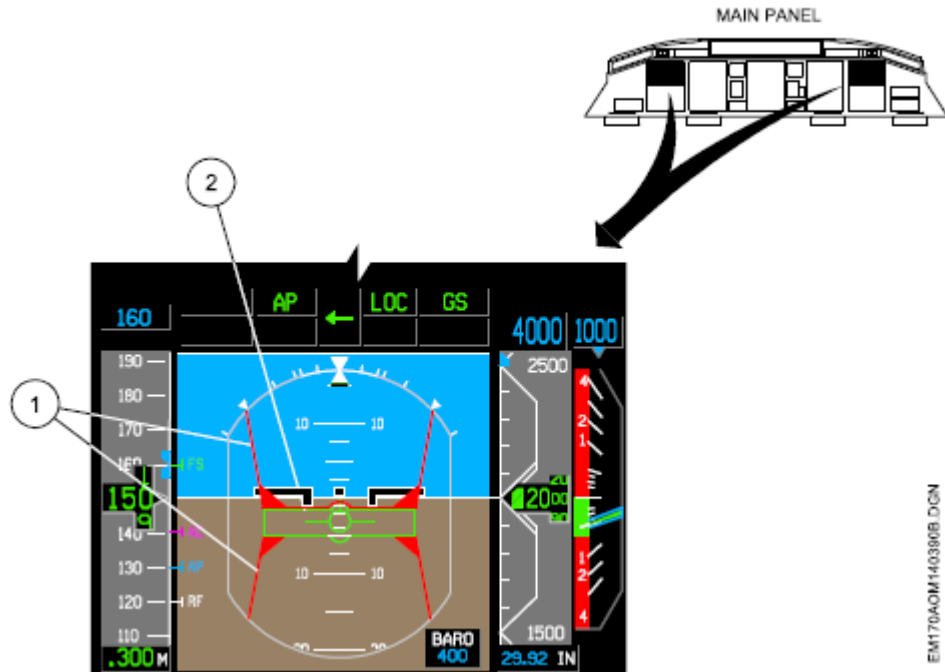
Compass Airlines, Airplane Operations Manual, Volume 2, Chapter 14 “Systems Description Warning System” pg. 15, provided the following picture and textual guidance on the TCAS indications on the primary flight display (PFD):

**Figure 4: TCAS Indications on the PFD (Source: Compass Airlines AOM Vol. 2 Section 14-15-05 pg. 10)**

*The commands provide pitch guidance information to the flight crew to recommend or prohibit a maneuver and prevent hazardous encounters with other [sic] airplane.*

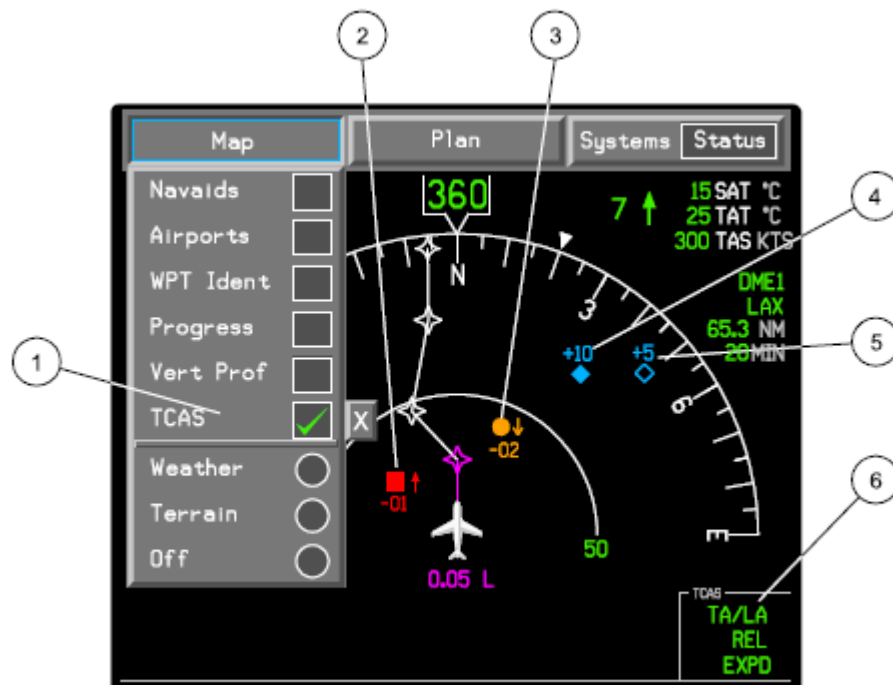
Compass Airlines, Airplane Operations Manual, Volume 2, Chapter 14 “Systems Description Warning System” pg. 11, provided the following picture and textual guidance on the TCAP Map indications on the PFD:

Figure 5: TCAS Map Indications with Symbols (Source: Aircraft Operations Manual Vol. 2)

**1 - TCAS SELECTION IN MAP MENU**
