## **NATIONAL TRANSPORTATION SAFETY BOARD**

### **Specialist's Report**

# **OPERATIONAL FACTORS**

DCA19CA091

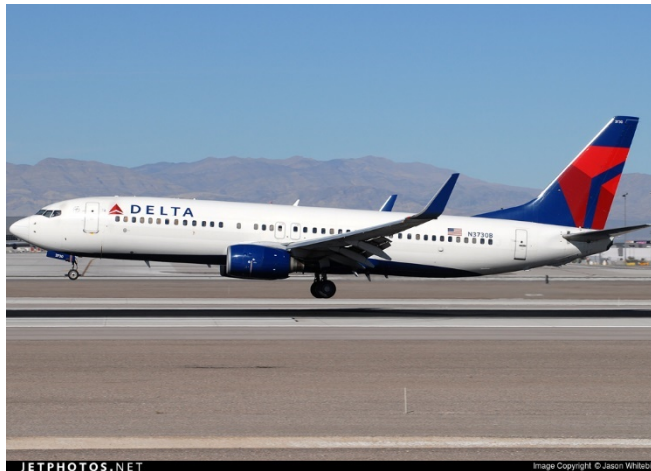
**Photo 1: Accident Airplane, N3730B (Courtesy of JetPhotos.net)**

The accident airplane (Registration N3730B, Serial No. 30538, Ship No. 3730) was a Boeing 737-832. The airplane was manufactured in 2000, registered to and operated by Delta Air Lines, and had a transport category airworthiness certificate dated September 25, 2000. The
