## **NATIONAL TRANSPORTATION SAFETY BOARD**

### **Group Co-Chairmen's Factual Report**

# **OPERATIONAL FACTORS/HUMAN PERFORMANCE**

**DCA19IA036**

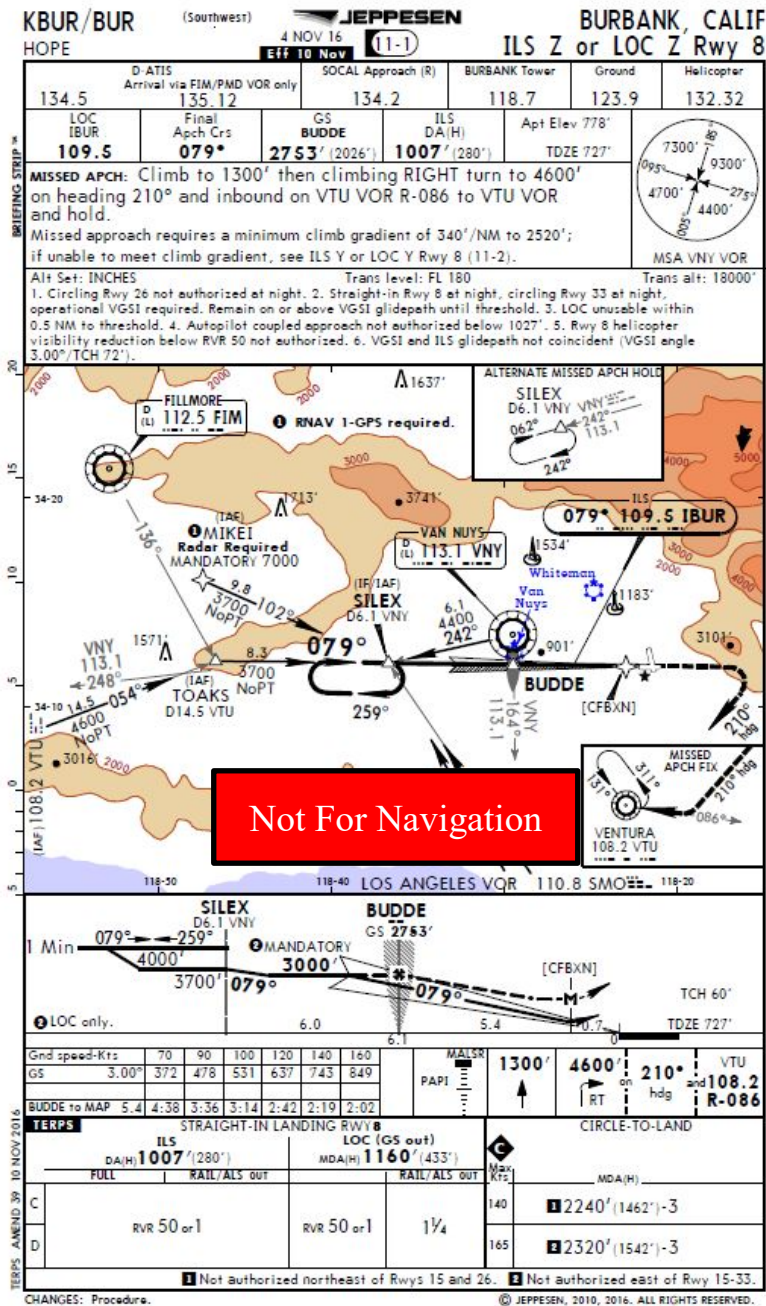
Figure 1: KBUR ILS Z RWY 8 approach procedure. Source: Southwest Airlines

According to the ATC Specialist Report for this incident, at 0848 an ATC controller advised the flight that there was moderate to extreme precipitation around the airport. At 0851 the flight was directed to descend to 8000 feet, and to expect the ILS Z RWY 08 approach at KBUR, shown in Figure 1.

<sup>12</sup> The ILS Z Runway 08 approach procedure at KBUR (Figure 1) notes a threshold crossing height (TCH) of 60 feet if following the 3-degree glideslope.

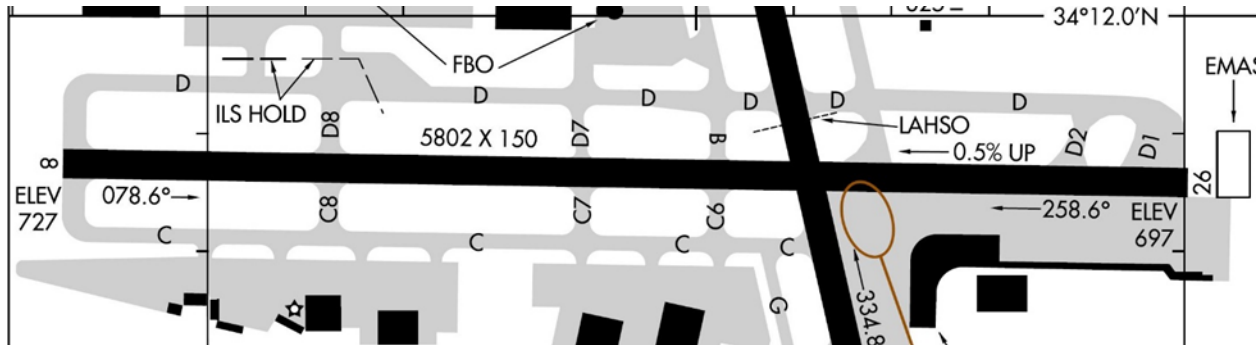
Figure 2: KBUR Airport Diagram excerpt. Source: FAA

and 50-foot calls of the EGPWS<sup>11</sup>. The NTSB Performance Study for this incident states that the airplane crossed the threshold at an altitude of 54 feet and a speed of 137 KIAS.<sup>12</sup> In the landing flare, at about 5 ft. agl, the captain noted that rain intensity “picked up and visibility decreased a little bit.” He reported he touched down between 1300 and 1500 feet from the runway threshold. The FO stated they touched down in the touchdown zone, which he defined as 1000-1500 feet from the threshold. The Performance Study indicated the airplane touched down about 2504 feet from the threshold at a speed of 126 KIAS. The ATC Specialist Report stated that a controller in the tower observed the touchdown near where taxiway D7 intersected the runway, about 2600 feet from the threshold. See Figures 2 and 3 for the location of the taxiway and the 1000-foot markers on runway 08.

The KBUR airport was located in Burbank, California. The airport had two runways, 08/26 and 15/33. Runway 08/26 was 5802 ft. in length and had an EMAS installed at the departure end of runway 08. Runway 08 was the only runway at the airport served by a precision instrument approach. About the first 490 feet of runway 08 is concrete and is distinctly lighter in appearance than the remaining runway, which is asphalt. This difference can be seen in Figure 3. The runway was grooved.

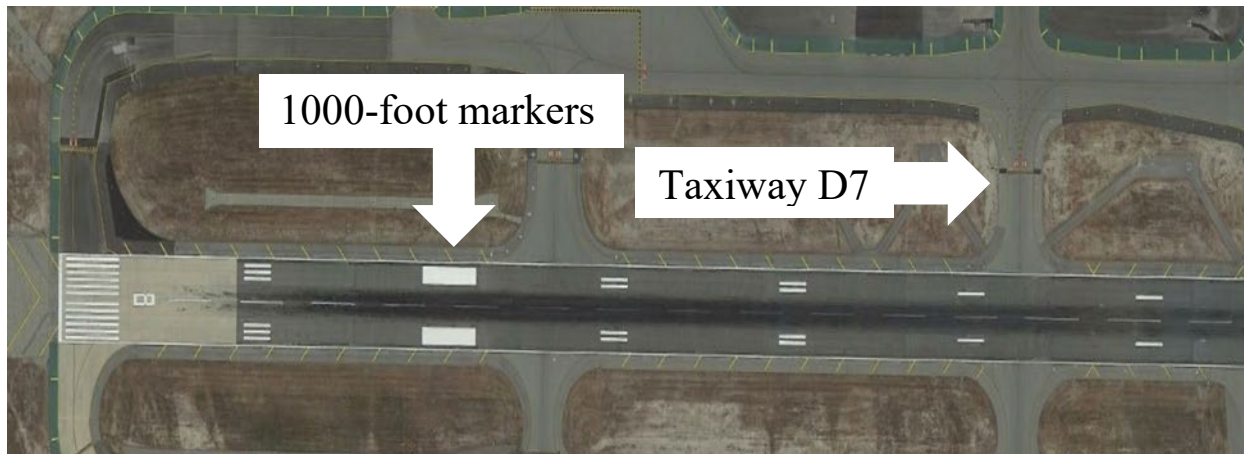
Figure 3: KBUR Runway 08 segment. Source: Google Earth

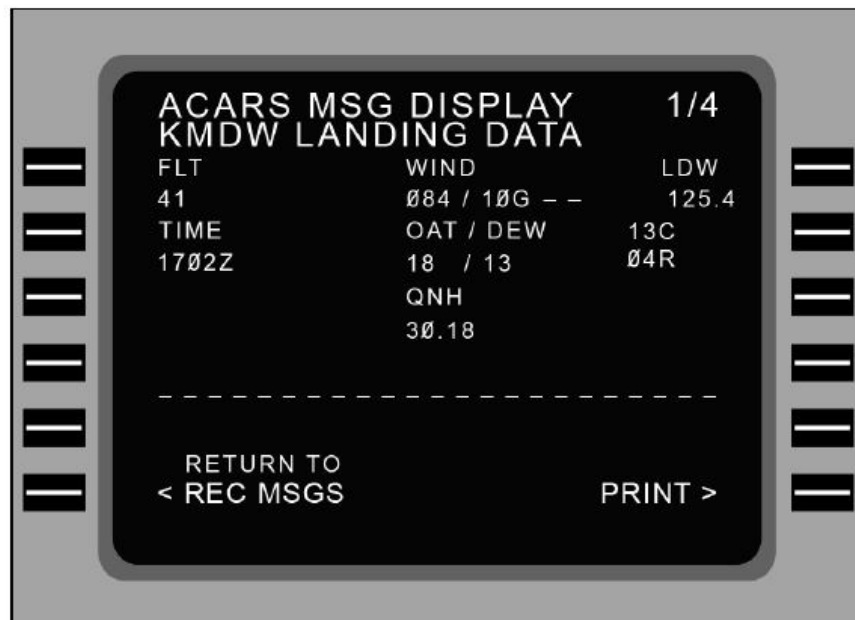
Figure 4: PWB System Landing Data page 1. Source: SWA

Page one of the Landing Data (Figure 4) shows the data was computed for a runway at Midway Airport (KMDW), the flight number, the time the data was generated, the wind and other weather information used in the data calculations, and the landing weight.

Example pages of the Landing Data report returned to a flight by the PWB System and displayed on the MCDU are shown below. Note: These examples are taken from the SWA AOM. The data they display is not that of the actual event.

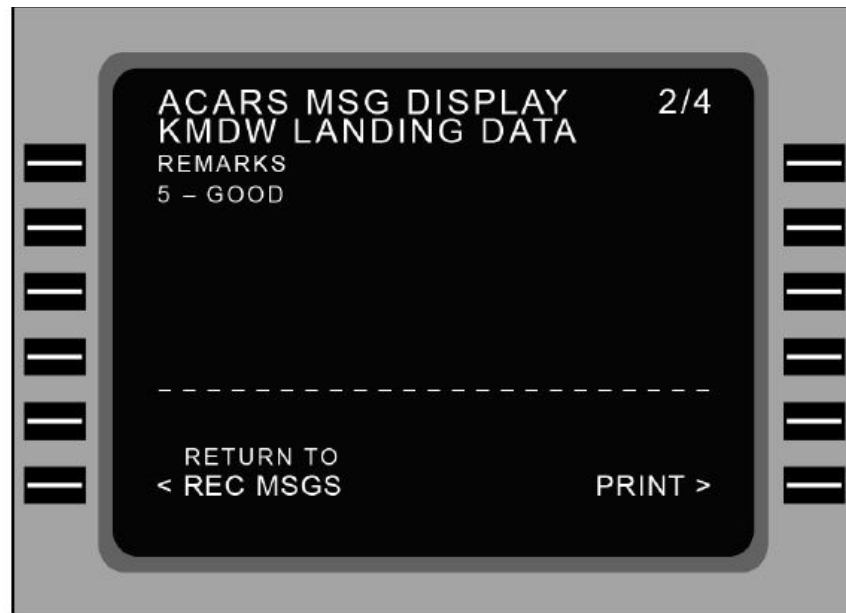
**Figure 5: PWB System Landing Data page 2. Source: SWA**

Page two of the Landing Data (Figure 5) shows the runway condition used in the data calculations (5—GOOD indicates a runway condition code<sup>30</sup> of 5 with good braking action.) Other items that could be included under the “Remarks” heading, but not shown in this example, are conditions which may have been selected by the crew such as anti-ice options. Other remarks may be included here, such as the requirement for use of autobrakes.

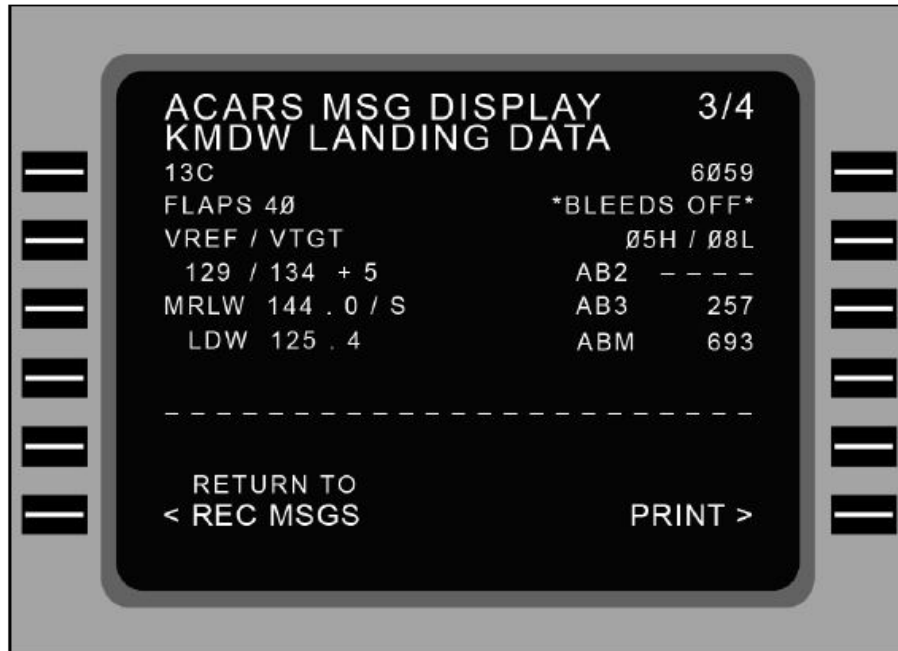
Figure 6: PWB System Landing Data page 3. Source: SWA

Page three of the Landing Data (Figure 6) shows the runway the calculations were performed for (13C), the flap setting the crew planned, the computed  $V_{REF}$  and  $V_{TARGET}$  speeds (129 and 134), the maximum runway landing weight (MRLW) for that runway, along with a code indicating the reason for the maximum limit (144,000 lbs with a structural (s) limit), the landing weight (LDW) the crew planned (125, 400 lbs), a display of headwind and crosswind components of the wind used in the calculation (5 knot headwind, 8 knot left crosswind), and stopping margins for each of the three autobrake settings the crew could select. In this example, for AB3, there is a 257 ft. margin and for ABM there is a 693 ft. margin. The dashed line next to the AB2 indicates there is no positive stopping margin for the AB2 setting.

Stopping margins are shown on page 3 of the Landing Data report. An example page 3 is shown in Figure 6.
