## **NATIONAL TRANSPORTATION SAFETY BOARD**

### **Factual Report**

# **OPERATIONAL FACTORS/HUMAN PERFORMANCE**

**DCA19MA086**

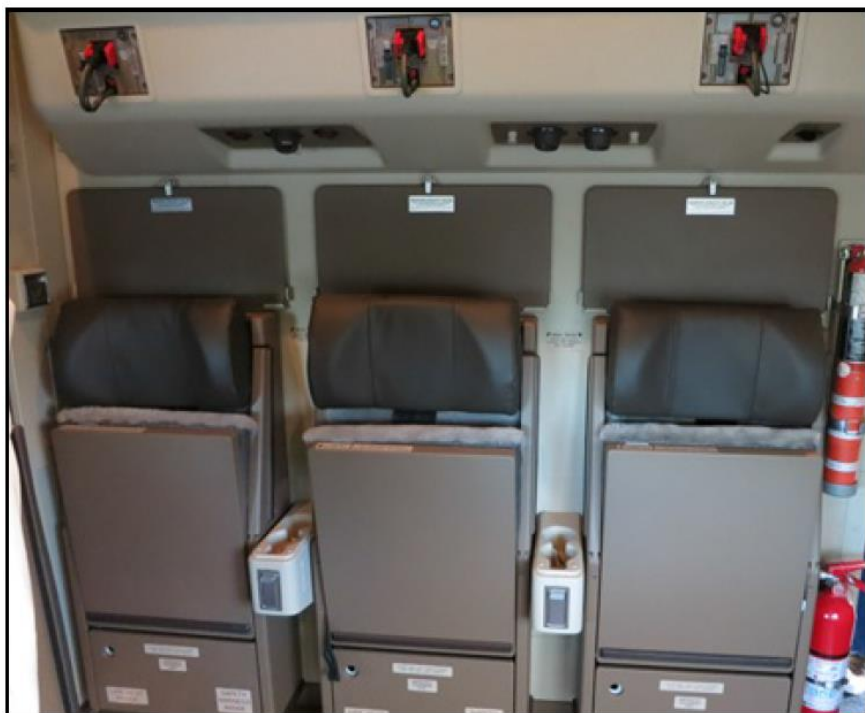
Figure 5.2.4. B767-300BCF Supernumerary Area

Photo 2: B-767-300BCF Supernumerary Area.<sup>109</sup>

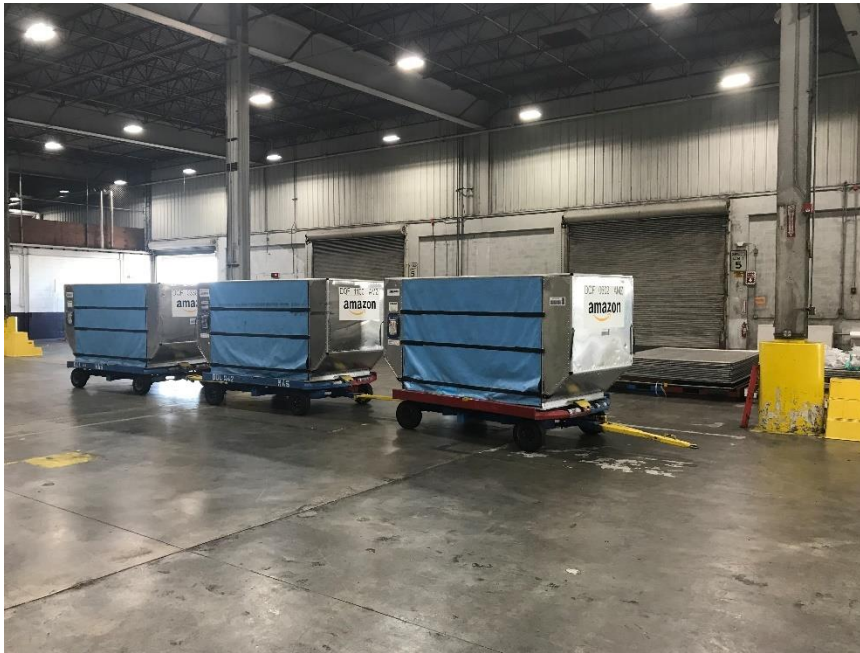
**Photo 9: Photo of sample DQF containers used in the lower cargo compartment on a B-767.<sup>133</sup>**

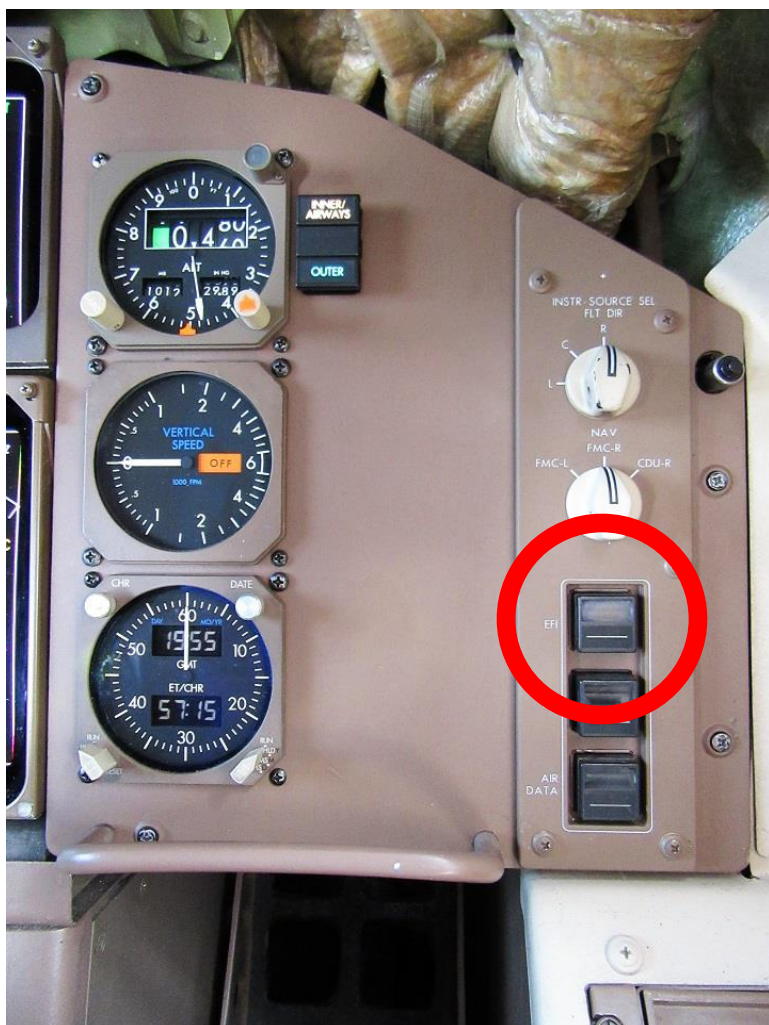
**Photo 13: Photo showing Right Instrument Source Selector Panel (Lower) located on the right (FO) side of the forward control panel on the accident airplane (the EFI switch is indicated by the red circle).<sup>159</sup>**

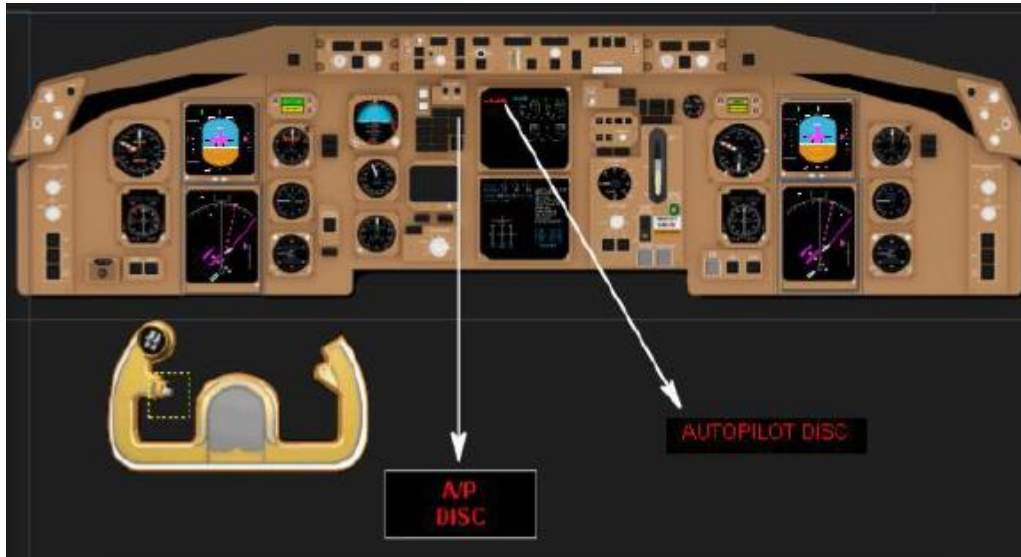
Figure 15: B-767-300 Autopilot disengagement alerts.<sup>162</sup>

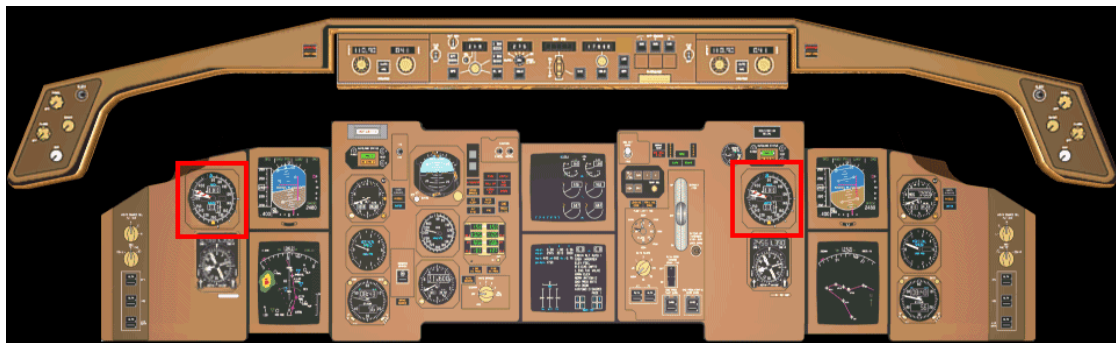
The B-767 was also equipped with two electric mach/airspeed indicators that displayed airspeed, Mach and  $V_{MO}$  from the selected air data source.

The V<sub>MO</sub> pointer indicated the maximum operating airspeed in knots or the equivalent to the maximum operating mach number. The command airspeed bug on each indicator could be automatically positioned from the FMC, or manually from the MCP IAS/MACH selector on the MCP.
