## **NATIONAL TRANSPORTATION SAFETY BOARD**

### **Group Chairman's Factual Report**

# **OPERATIONAL FACTORS**

DCA20IA014

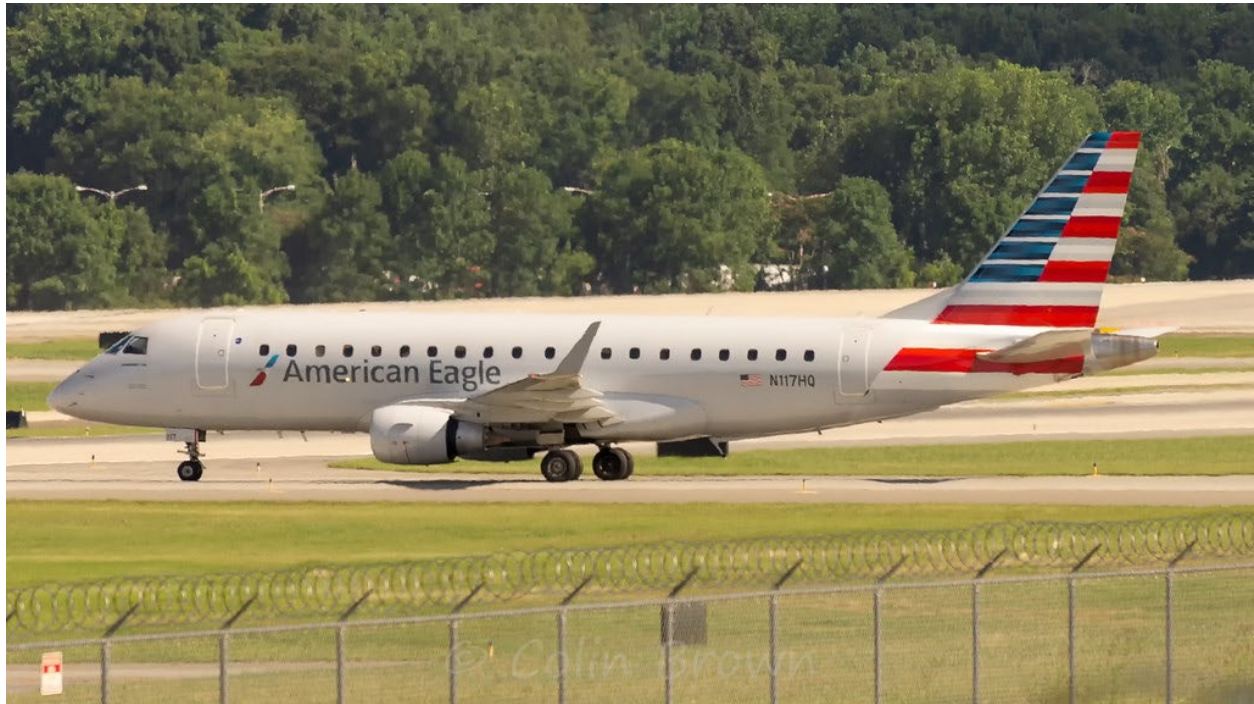
Photo 1: ERJ-170-200LR , Actual Airplane (Photo credit: Colin Brown)

The incident airplane (Registration N117HQ, Serial No. 17000184) was an-Embraer-Empresa Brasileira de Aeronáutica ERJ-170-200 LR. The airplane was built in 2007, registered to Republic Airways, Inc. and held a transport category airworthiness certificated dated September 26, 2007. The airplane was powered by 2 GE CF34-8E5 turbo fan engines, and each were rated at 14,510 pounds of takeoff thrust. The airplane was configured with 2 pilot seats, one cockpit observer seat, 1 forward flight attendant jumpseat, 1 aft flight attendant jumpseat, and 70 passenger seats.

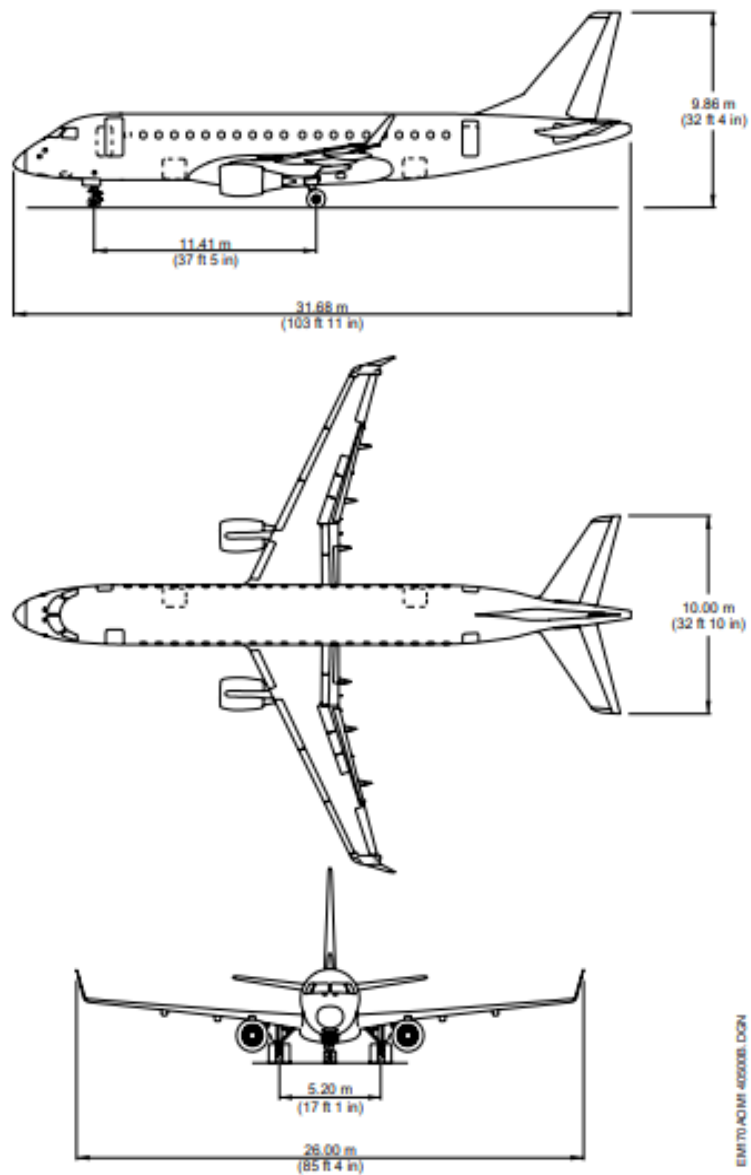
THREE VIEW DRAWING

Photo 2: Embraer Model 175 General Dimensiones<sup>19</sup>

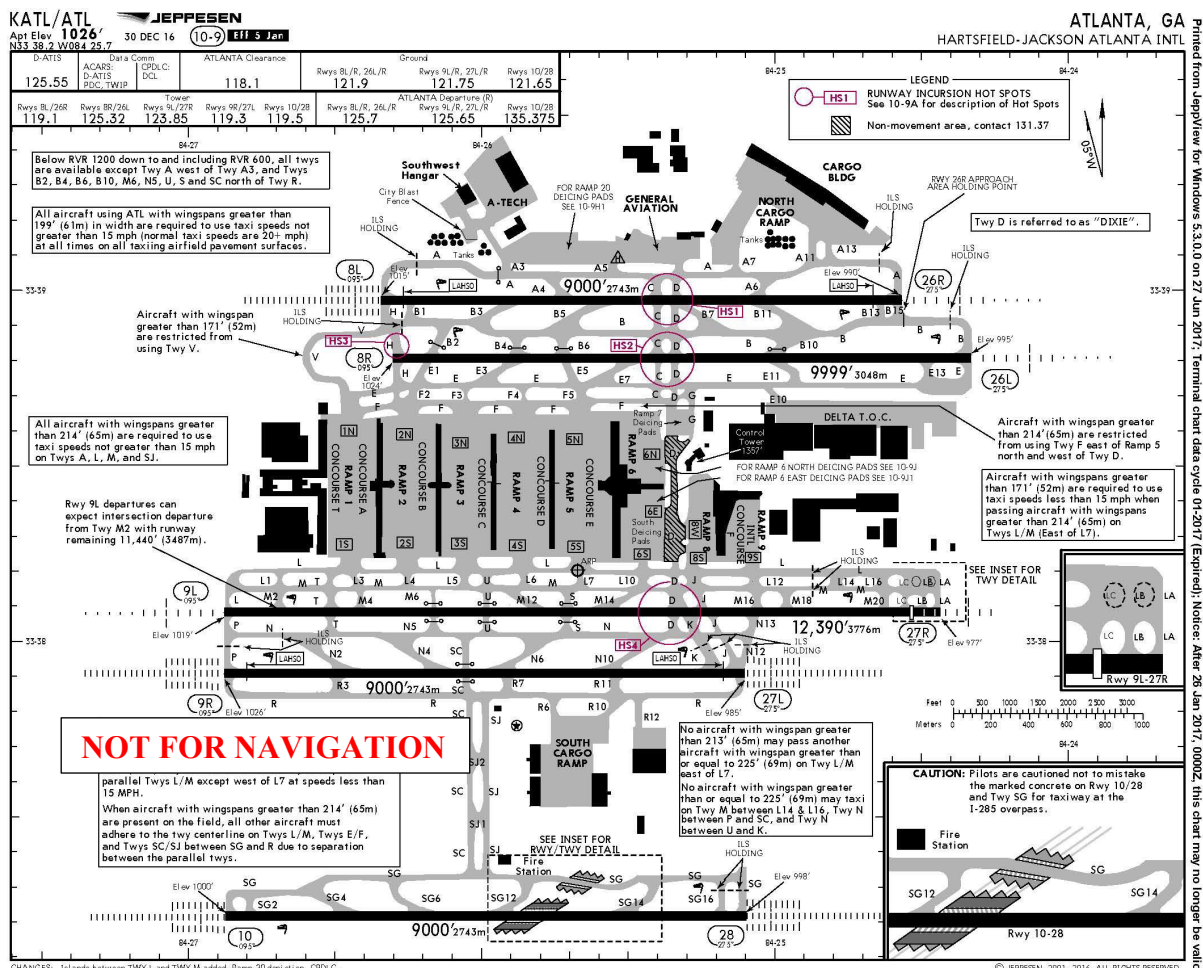
Figure 2: Jeppesen Airport Diagram of Hartsfield-Jackson Atlanta International Airport

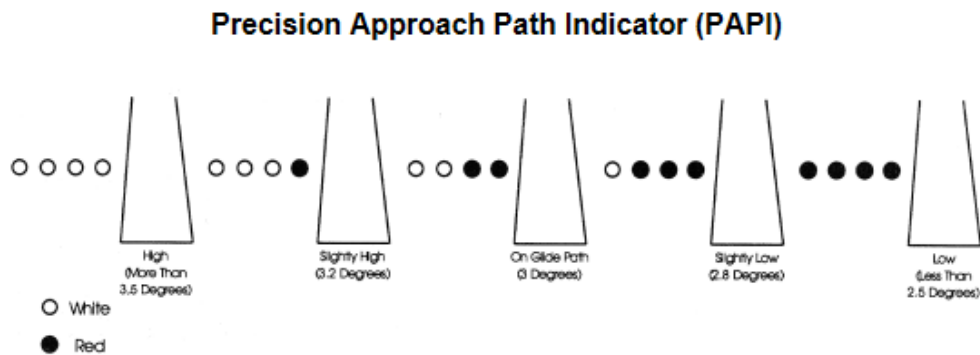
effective visual range of about 5 miles during the day and up to 20 miles at night. PAPIs radiated a directional pattern of high intensity red and white focused light beams which indicated that the flight is "on path" if the pilot sees an equal number of white lights and red lights, with white to the left of the red; "above path" if the pilot sees more white than red lights; and "below path" if the pilot sees more red than white lights.

**Figure 3: Precision Approach Path Indicator<sup>29</sup>**

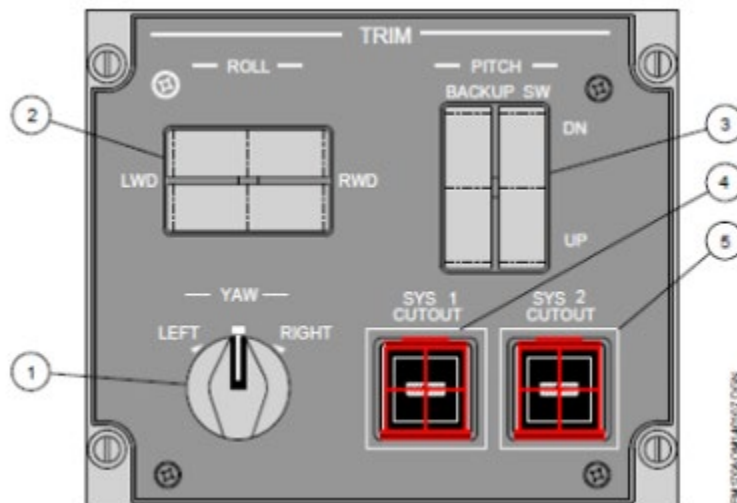
Photo 3: Trim Panel and Description

- 1 - YAW TRIM KNOB (SPRING-LOADED TO NEUTRAL)
  - Actuates the yaw trim to left or right.
  - Manual pilot trim commands are limited to 3 s.
- 2 - ROLL TRIM SWITCH (SPRING-LOADED TO NEUTRAL)
  - Actuates the roll trim to left or right.
  - Manual pilot trim commands are limited to 3 s.
- 3 - PITCH TRIM BACK-UP SWITCH (SPRING-LOADED TO NEUTRAL)
  - Operation of the switch while the autopilot is engaged causes the autopilot to disengage.
  - Manual pilot trim commands are limited to 3 s.
- 4 - PITCH TRIM SYS 1 CUTOUT BUTTON (GUARDED)

The Embraer 170, 175 Airplane Operations Manual, revision 25, page 4/16, Flight Controls, System Description has the following information about the Trim panel:

*The backup trim switches, and the control wheel trim switches are dual split switches which have a 7 second time limitation when actuated separately. If only one half of the switch is actuated for more than 7 seconds, that switch is automatically deactivated. The aural warning “TRIM” triggers for 7 seconds when the control wheel trim or backup trim switches have failed or when only half of the switch is pressed. If the failure persists for more than 7 seconds, the aural message is deactivated, and the applicable advisory pitch trim switch fail message is displayed on EICAS.*

*In order to avoid a possible pitch trim runaway condition, manual pilot trim commands are limited to 3 seconds. After the control wheel trim or backup trim switches have both been halves pressed for more than 3 seconds, the trim stops the horizontal stabilizer control surface movement and if the switch remains pressed, the aural warning “TRIM” triggers. When the*

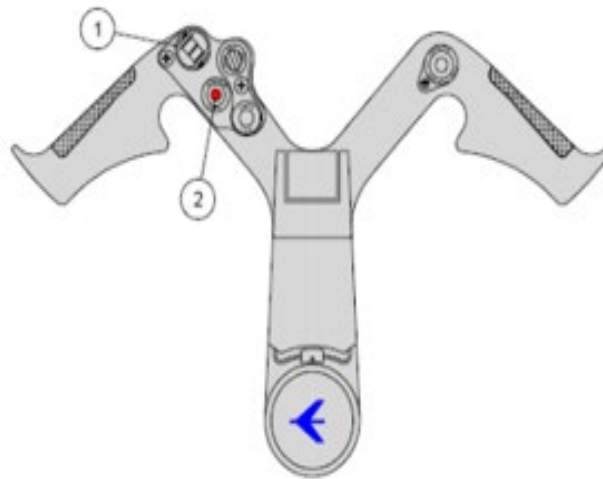
## 7.8 Control Wheel

### 1 - PITCH TRIM SWITCH (SPRING-LOADED TO NEUTRAL)

- Trims the airplane when the autopilot is not engaged.
- If only half of the switch is actuated for more than 7 s, the switch will be automatically deactivated.
- Manual pilot trim commands are limited to 3 s.
