# National Transportation Safety Board

DCA22LA133

## **OPERATIONAL FACTORS**

Group Chair's Factual Report

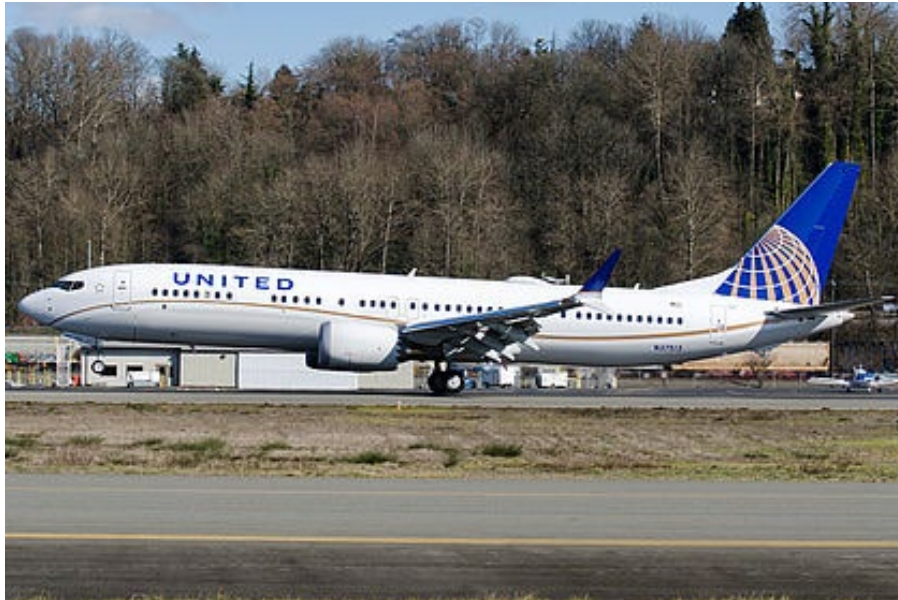
**Figure 4.** Incident Airplane (Source: planespotter.com)

The aircraft was a B737-9, Serial No. 64494 and was manufactured in 2019. It was powered by two CFM International Leap-1B2B engines each capable of producing 28,000 pounds of thrust. The aircraft was purchased by and registered to United Airlines on February 27, 2019.

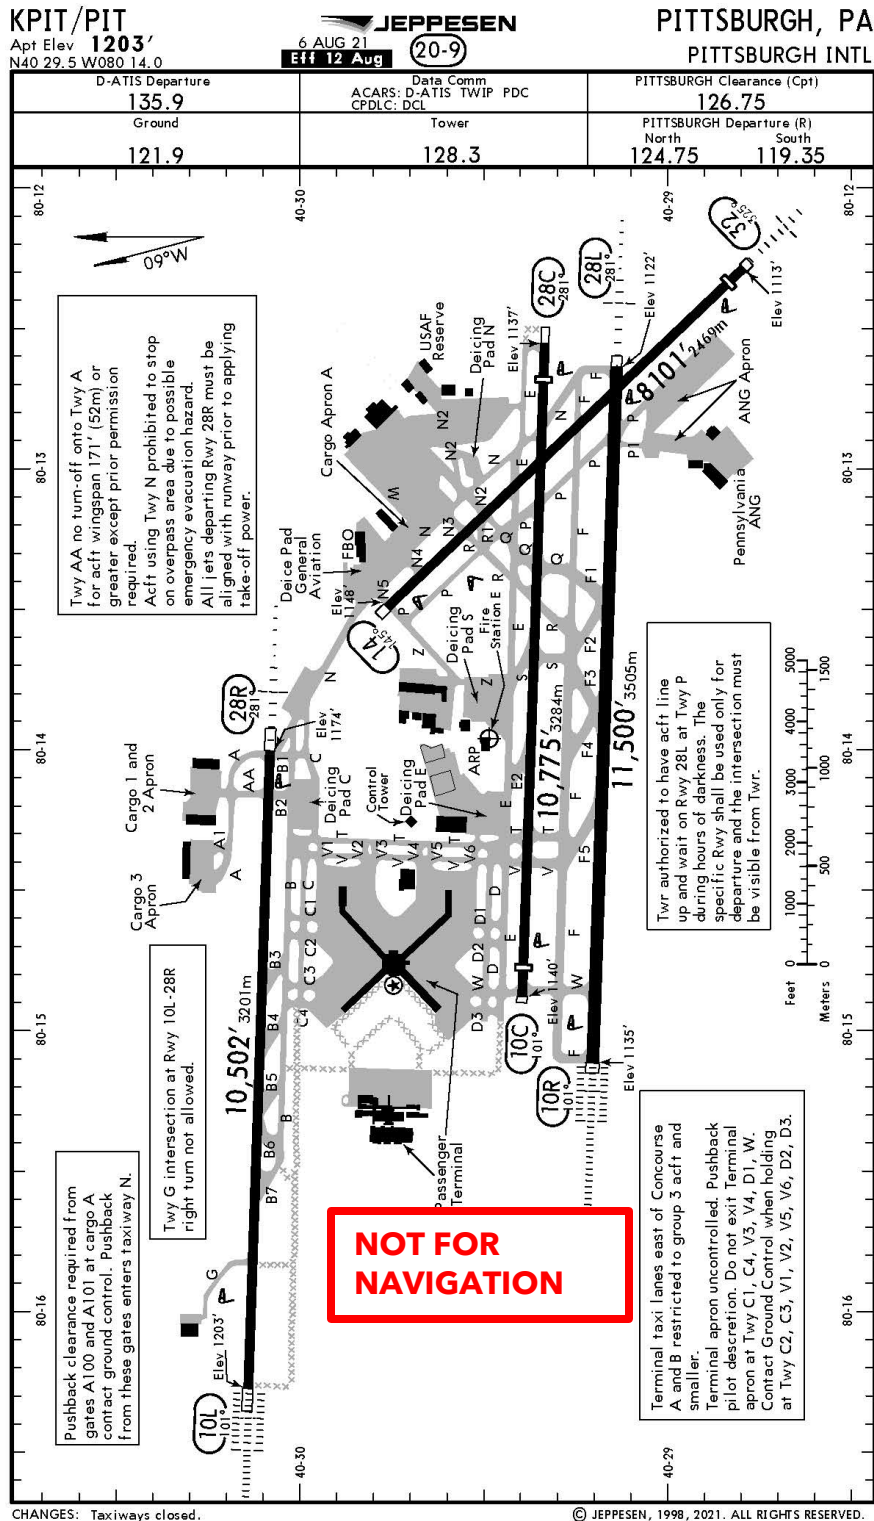
Figure 7. PIT 20-9 Airport Diagram (Source: Jeppesen)

At the time of the incident, PIT, had four paved landing surfaces for airplanes designated as 10R/28L, 10C/28C, 10L/28R, and 14/32. Runway 10R/28L was 11,500 ft long and 200 ft wide and runway 28L was serviced by a 4-light PAPI on the left side of the runway and MALSR approach lights. Runway 10C/28C was 10,775 ft long and 150 ft wide. Runway 28C was serviced by a 4-light PAPI located on the left side of the runway and runway centerline lights.

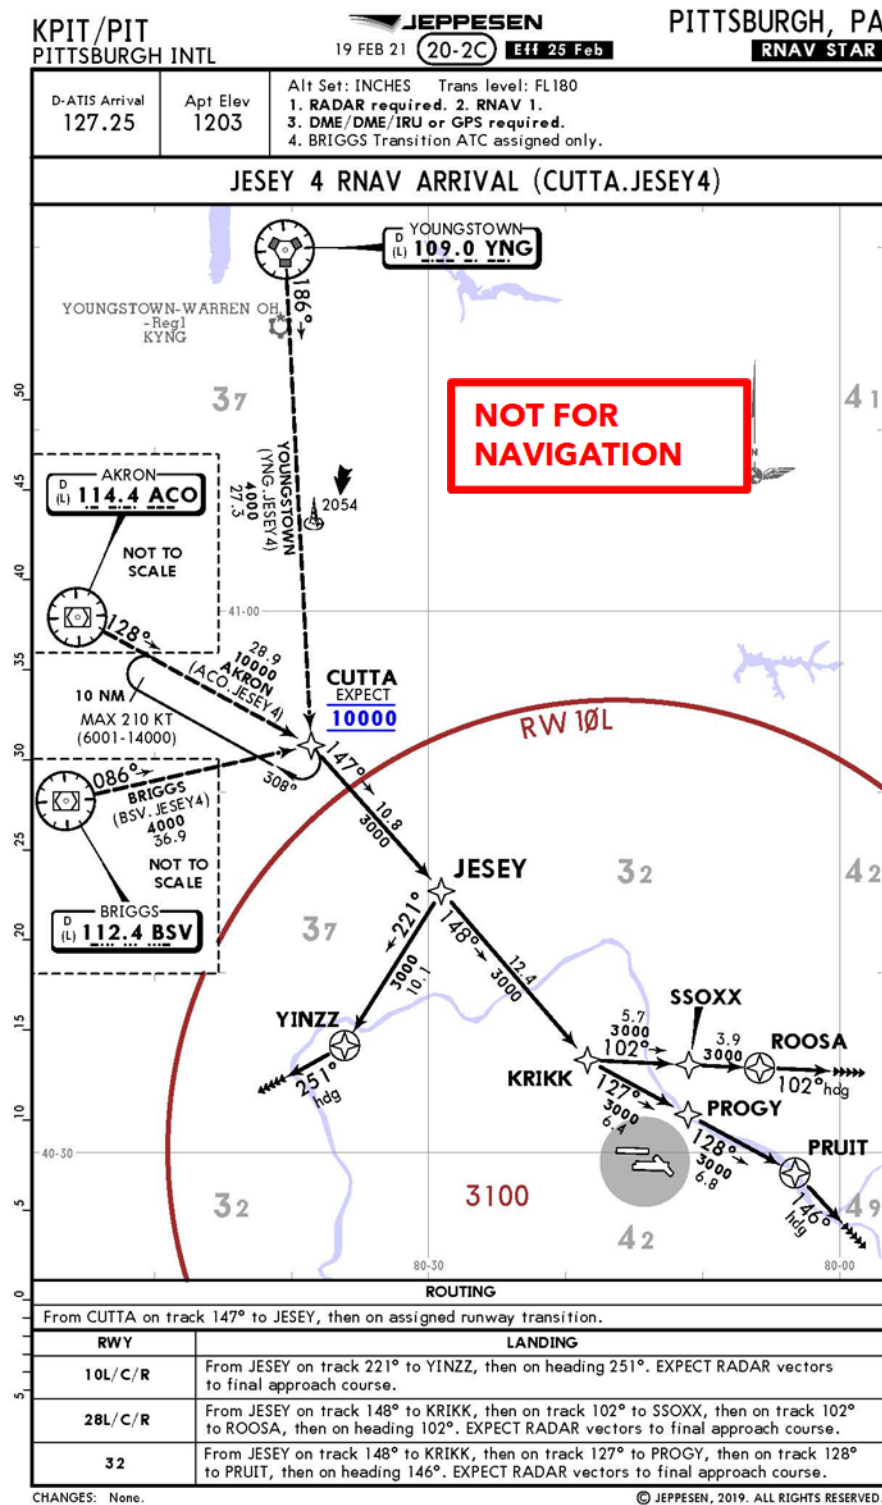
**Figure 9.** JESEY 4 RNAV Arrival [Source: Jeppesen]

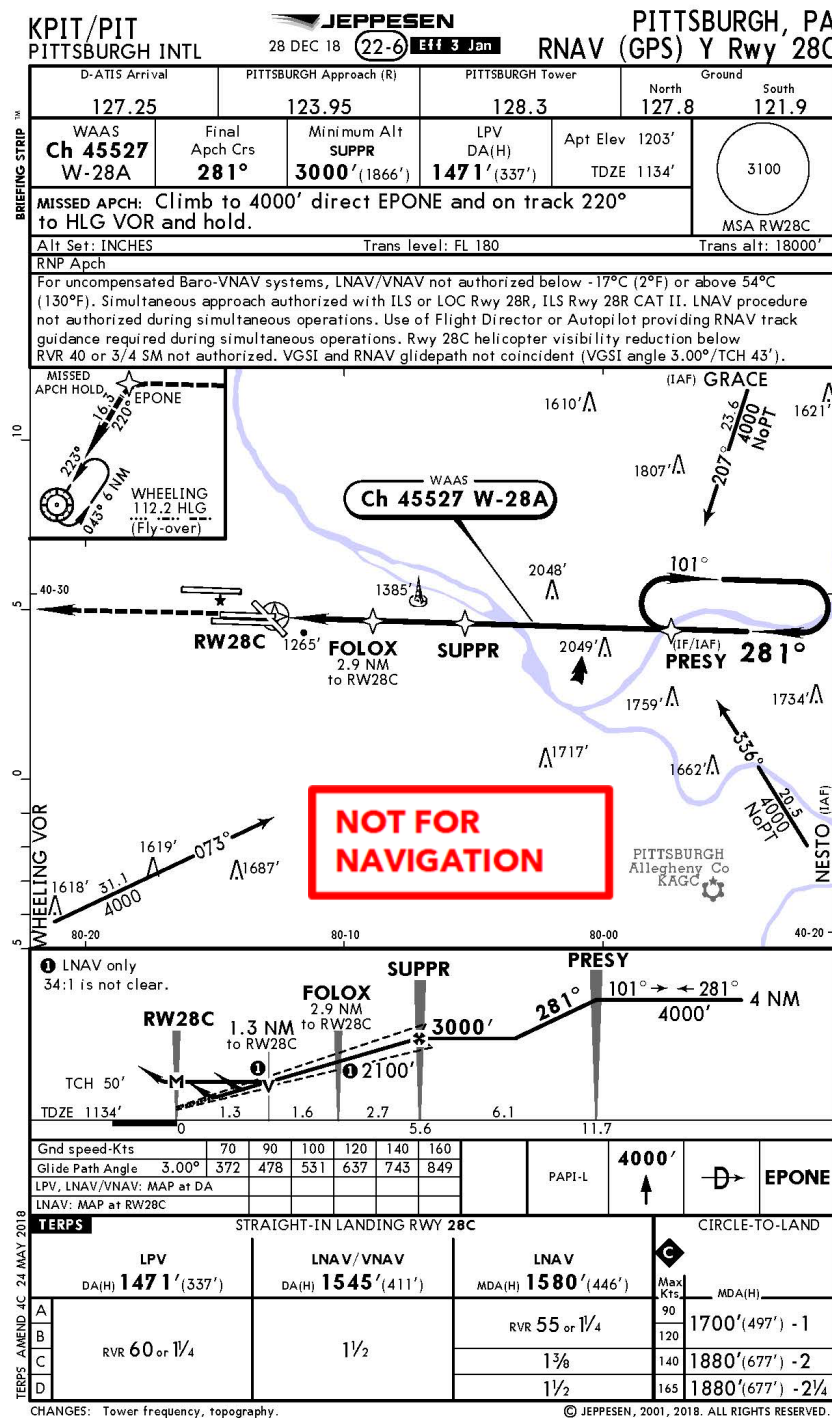
Runway 28C was served by two instrument approach RNAV (GPS) Y and RNAV (RNP) Z. The flight was cleared for, and accepted, the visual approach to runway 28C. The crew utilized the RNAV (GPS) Y for electronic backup guidance.

**Figure 10.** Pittsburgh 22-6 RNAV Y Runway 28C (Source: Jeppesen)
