# National Transportation Safety Board

DCA24LA034

## **OPERATIONAL FACTORS/HUMAN PERFORMANCE**

Group Chairs' Factual Report

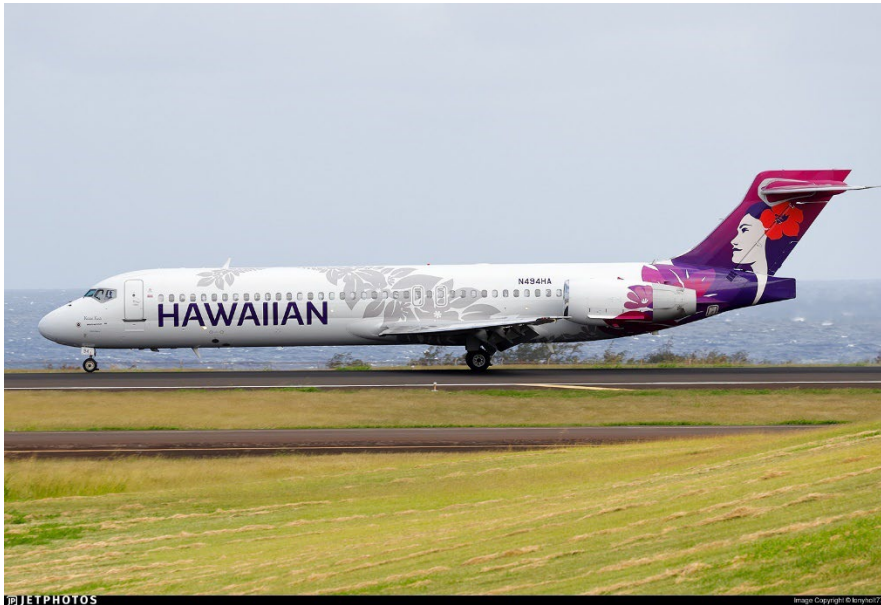
**Figure 1:** Incident Airplane (Source: JetPhotos.com)

The aircraft was a B717-200, Serial No. 55182 and was manufactured in 2004. It was powered by two Rolls-Royce, BR700-715C1-30, turbo fan engines, each capable of producing 21,430 lbs. of thrust. The aircraft was owned by BCC Equipment Leasing Corporation and operated by Hawaiian Airlines, Inc.

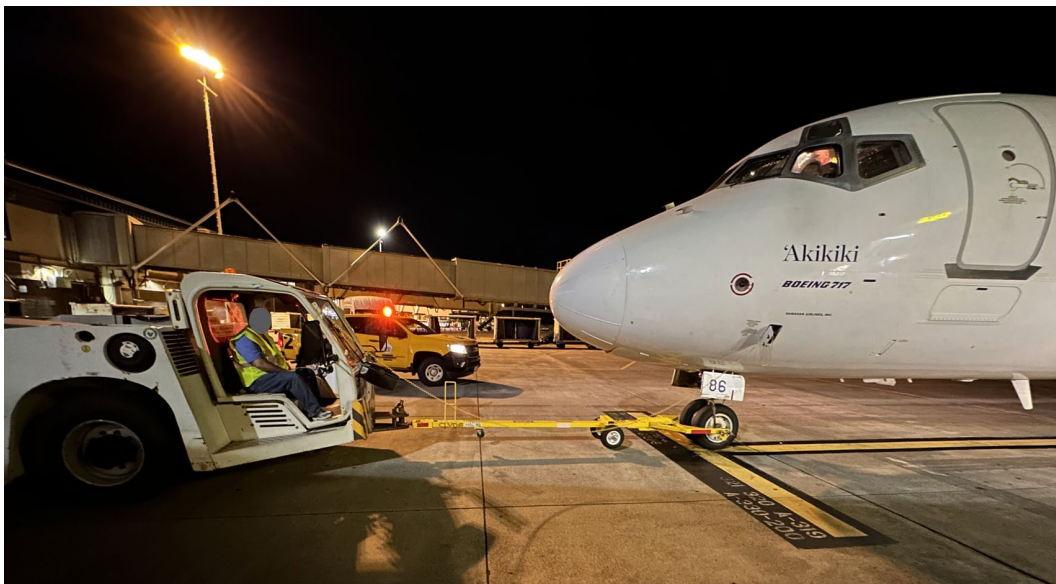
**Figure 2.** Tow tractor connected to the airplane. (Not the accident flight)

During pushback, the airplane was connected to the tug by a metal towbar. A coiled headset communications cable stretched from the tow tractor to an access panel

on the nose of the airplane where the cable was plugged into the flight crew's interphone system.

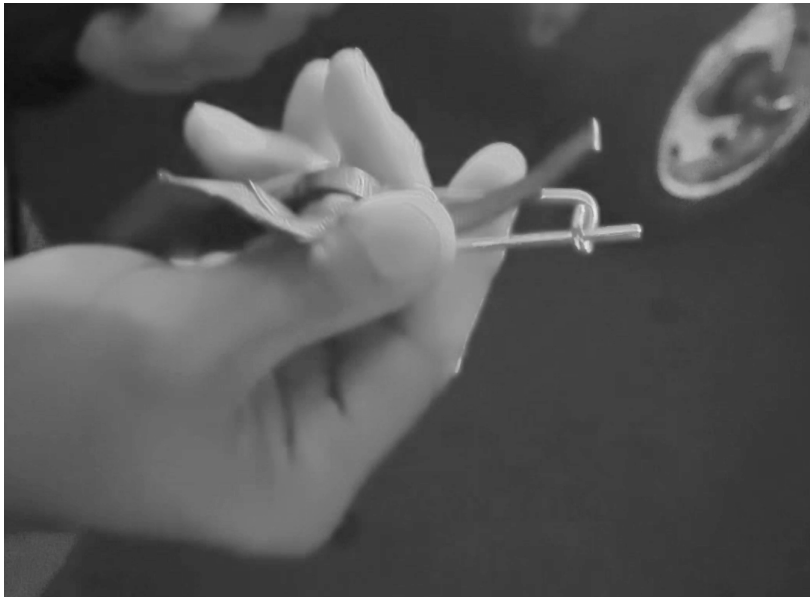
**Figure 3.** Nose gear steering bypass pin.

The airplane's nose gear steering bypass pin was a small metal part with an attached red ribbon approximately two feet in length.

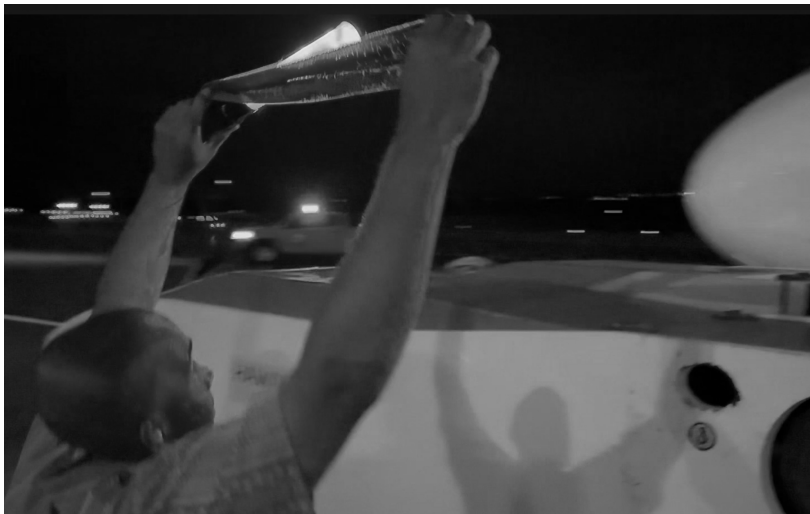
**Figure 4.** A ramp agent displaying the pin and ribbon with a lighted wand. (Not the accident agent)

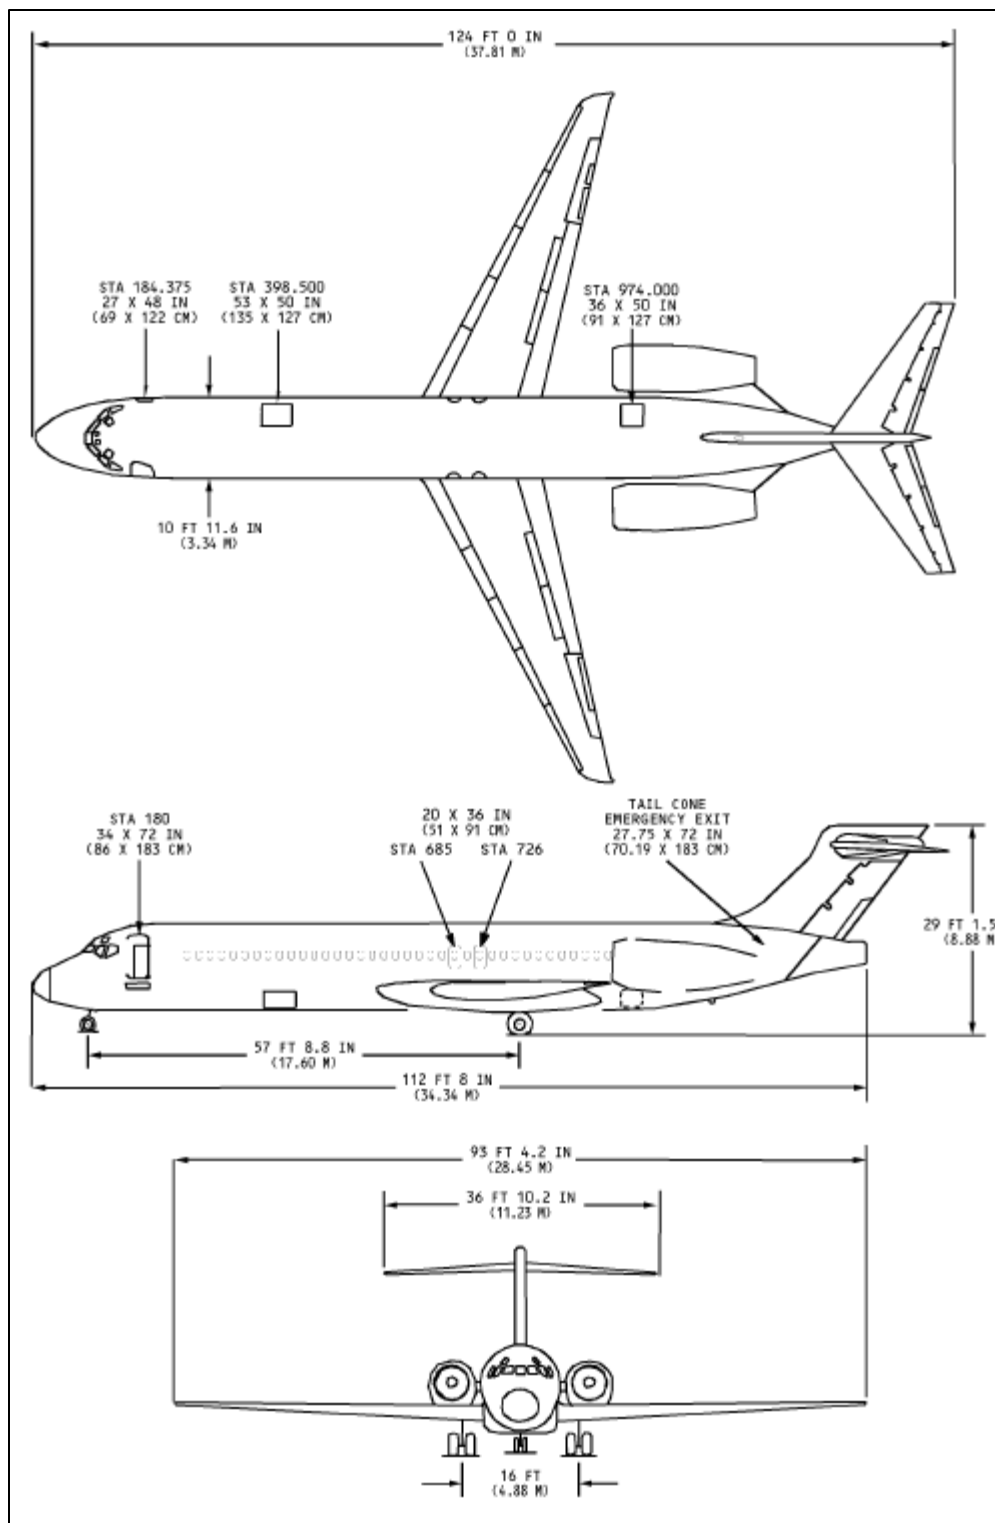
**Figure 5:** B717 Aircraft Dimensions

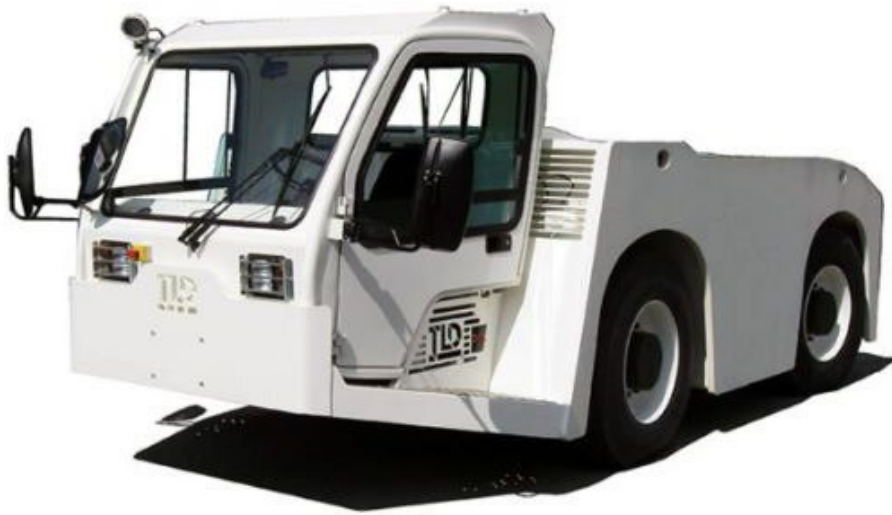
**Figure 6:** Tow Tractor. Note that the exemplar vehicle in this photo does not have a front hitch with a 2.7 diameter tow pin nor does it have a rotating amber beacon mounted on the roof of the cab, both of which the event tow tractor had. (Source: Aero Specialties Website)

The airplane tow tractor was a TMX-350 manufactured by TLD. According to the manufacturers website<sup>36</sup> towing tractor was designed to perform push and pull operations for up to 300 tons. The TMX-350 gross weight was between 53,000 lbs. and 61,600 lbs. depending on the model. The manufacturer had a standard specifications; however, most tow tractors were built per a specification provided by the purchaser (see figure 7 for the TMX-350 catalog data sheet for the standard dimensions). It featured a Cummins QSB4.5 4-cylinder turbo diesel engine, with a powershift transmission with torque converter. The maximum speed when empty was 15 mph forward and 3 mph in reverse. The event model had only front wheel hydraulically-powered steering. The 24-volt DC electrical system powered 10 items of which front head lights, rear LED lights, stop LED lights, flashing beacon and hazard lights were among those items.

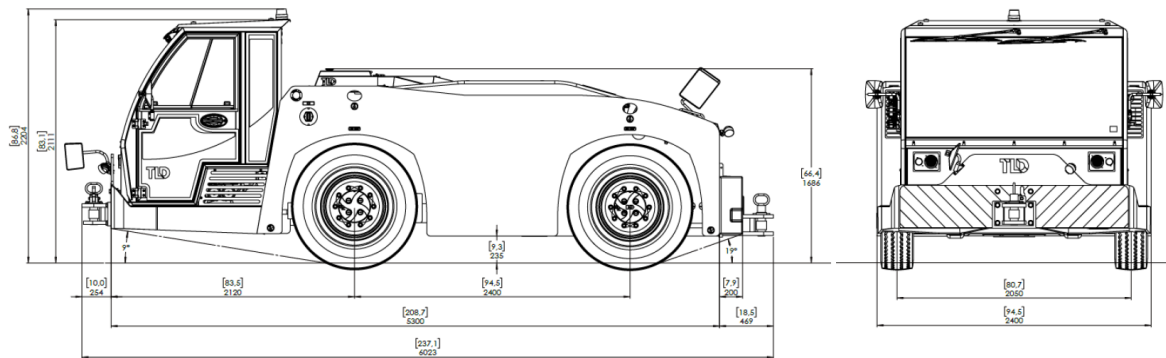
**Figure 7:** Approximate dimensions of a TMX-350 Tow-Tractor (Source: TLD datasheet)

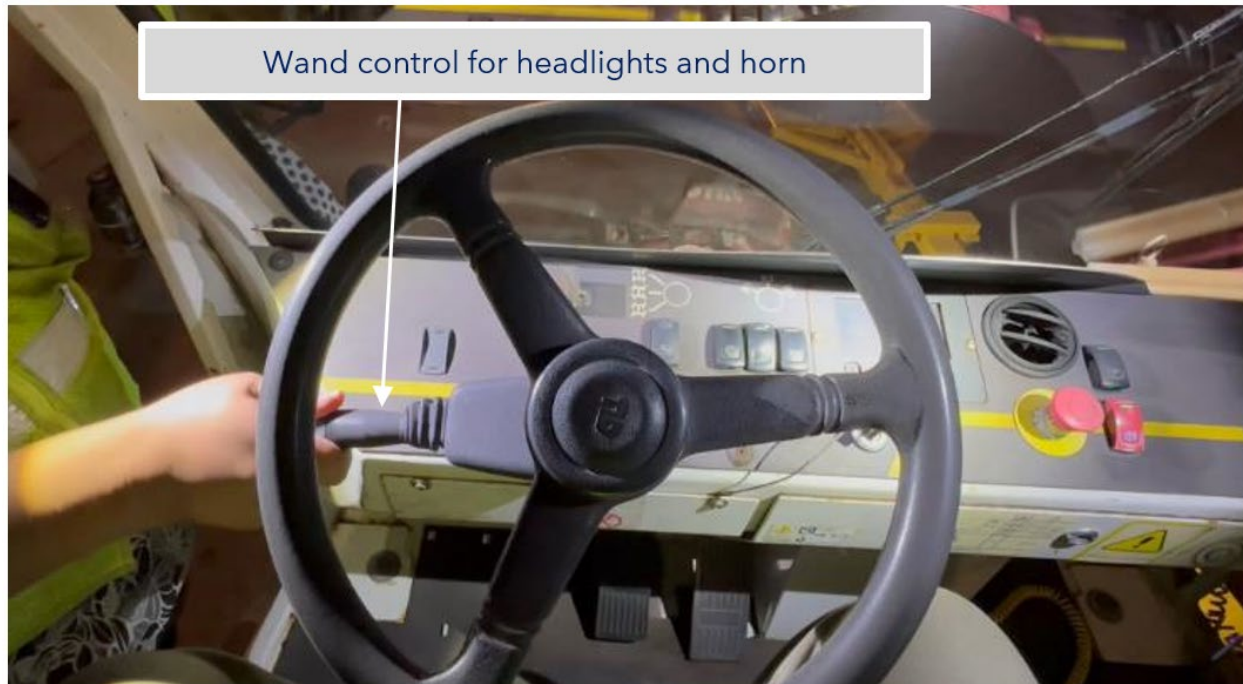
A rotating wand allowed the operator to turn the tow tractors headlights on and off, and a button on the tip of the wand activated the vehicle's horn (figure 8).

**Figure 8:** Wand control for the vehicle's headlights with a horn button on the tip.

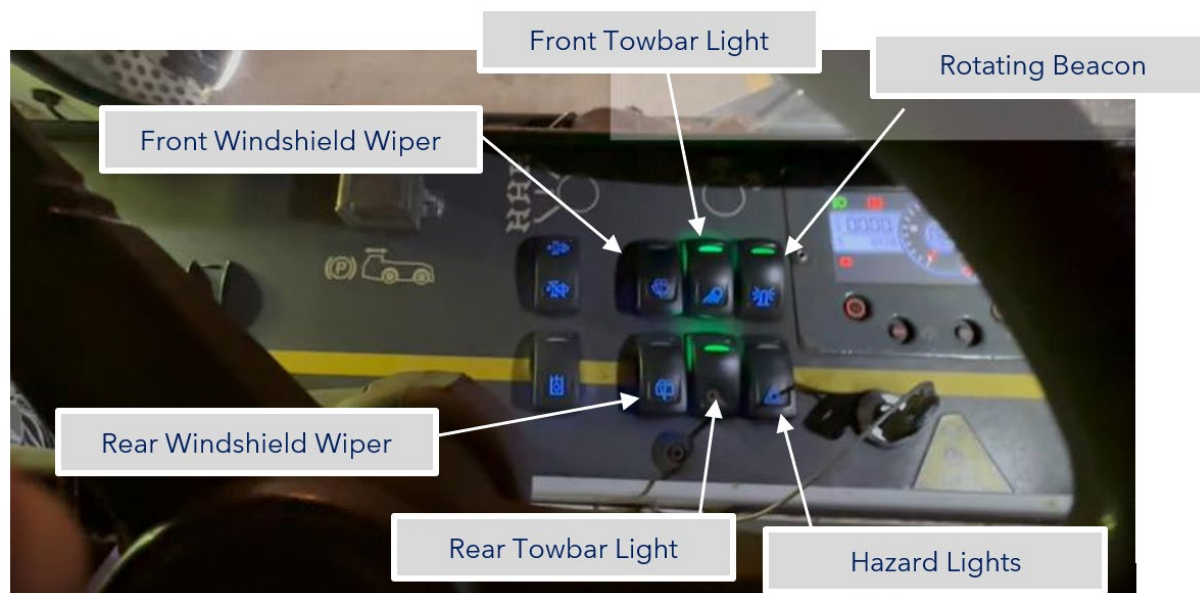
A dashboard rocker switch panel allowed the operator to turn on or off the front and rear tow pin spotlights, front and rear wipers, a rotating amber beacon, and hazard lights (figure 9). An icon on each switch was illuminated by a blue light. When a switch was turned on, a green LED light embedded in the switch became illuminated. When the switch was selected off, the green LED light was extinguished.

**Figure 9:** Switch panel on the dashboard of the tow tractor. In this photo, the front tow pin spotlight, rear tow pin spotlight, and rotating beacon are selected on.

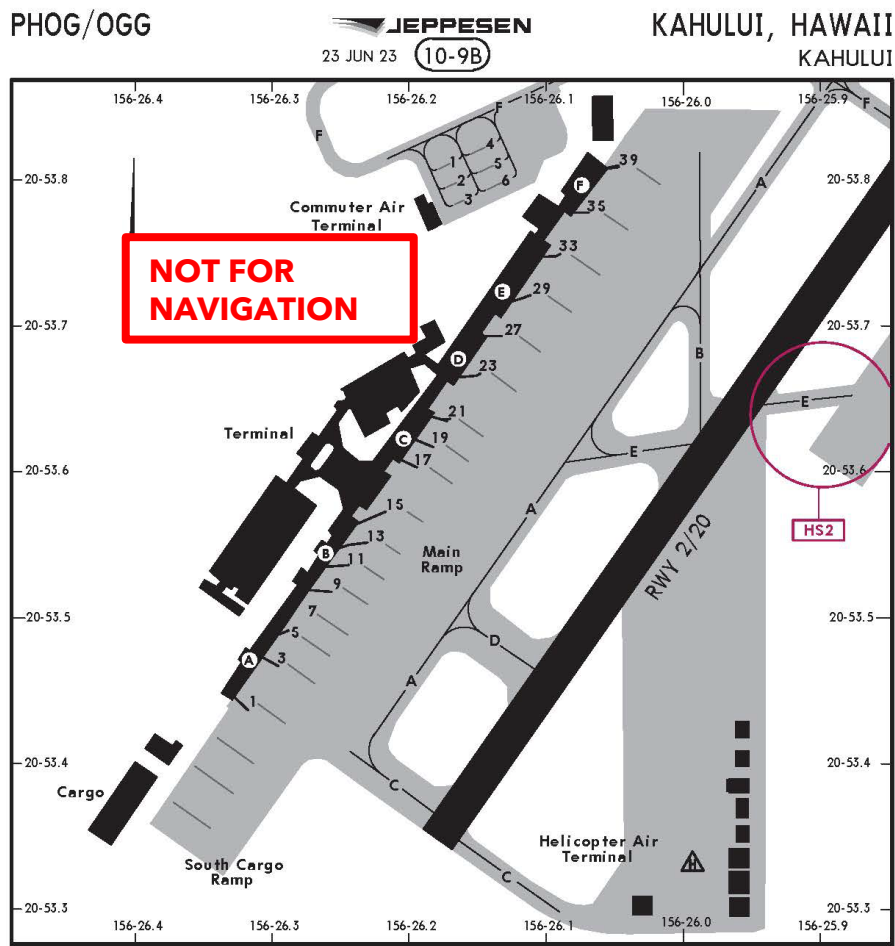
**Figure 11:** Terminal Ramp Gate Locations Diagram (Source: Jeppesen)

The event airplane was parked at and pushed from Gate 17. During the pushback, the tow tractor pushed the airplane so the tail was pointed towards the south southwest and parallel to runway 2/20. The pushback resulted in the captain's side of the airplane being closest to the terminal.

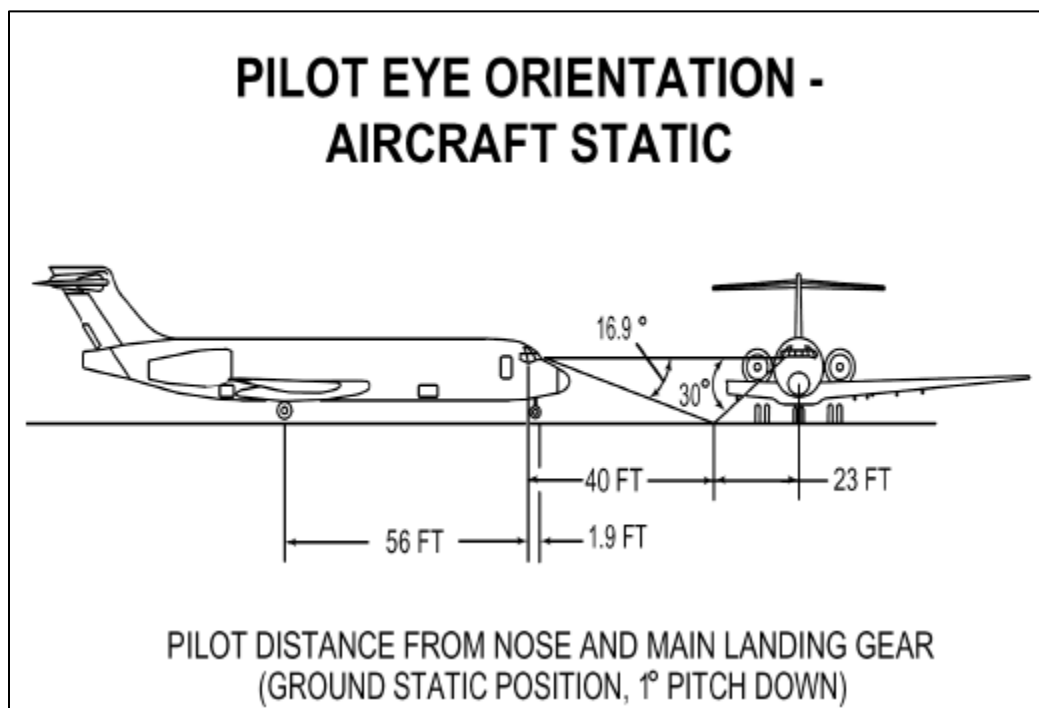
The Hawaiian Airlines, 717 Flight Crew Operating Manual, Chapter SP "Supplemental Procedures" provided a diagram of a pilot's visibility when seated in a cockpit seat. The diagram detailed that if a pilot was looking forward through the windscreen and over the nose it was about a  $16.9^\circ$  angle and when looking at the side window was about a  $30^\circ$  angle when a pilot would be able to view the ground, assuming a  $1^\circ$  pitch down static position. Those angles correlated to the pilot being able to view the ground starting approximately 40 ft in front of the airplane and 23 ft looking out the Clearview<sup>44</sup>. Boeing's 717 Aircraft Maintenance Manual Figure 201/06-00-990-801 indicated that the Clearview height was about 10 ft 6 inches above the ground plus/minus 3 inches depending on vertical excursions due to loading, varying strut and tire inflation, and pavement unevenness.

**Figure 16:** Pilot Eye Orientation Diagram (Source: Hawaiian Airlines 717 FCOM)

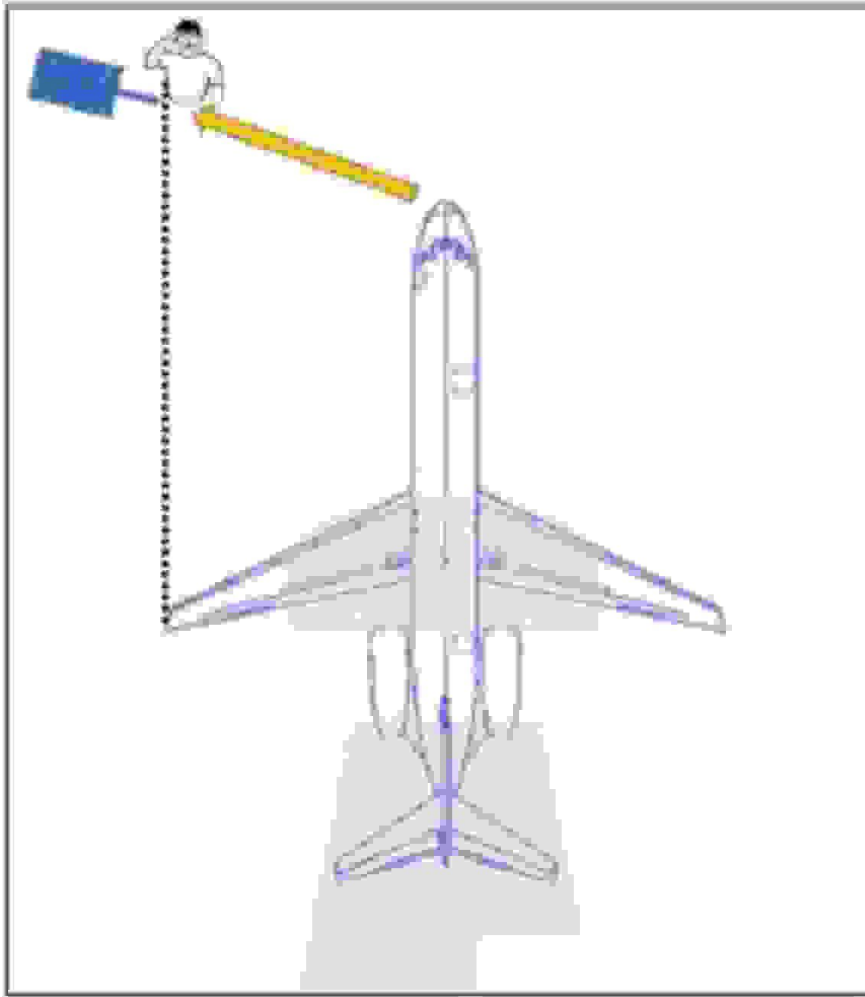
- H. *Once Flight crew confirms engines have been started, they will issue the "clear to disconnect headset" command. The Control Service Agent responds "Cleared to disconnect headset."*
- I. *Control Service agent will relay this to the Escort via the "affirmative" signal (thumb or wand up).*
- J. *The Escort will remove the following, in the order noted below:*
  - 1) *Nose gear steering bypass pin, ensuring that the bypass pin lever is in the proper position*
  - 2) *Interphone jack, ensuring that the communications panel door is closed and secured.*
- K. *The Control Service agent will move the tractor and towbar out of the path of, and facing away from the aircraft. ( Refer to Figure 4-19. Direction may vary, based on pushback direction and/or traffic conditions.)*

**Figure 19:** Control Service Agent Positioning of Tractor and Towbar (Source: Hawaiian Airlines GSM)
