# National Transportation Safety Board

DCA24LA097

## **OPERATIONAL FACTORS**

Group Chair's Factual Report

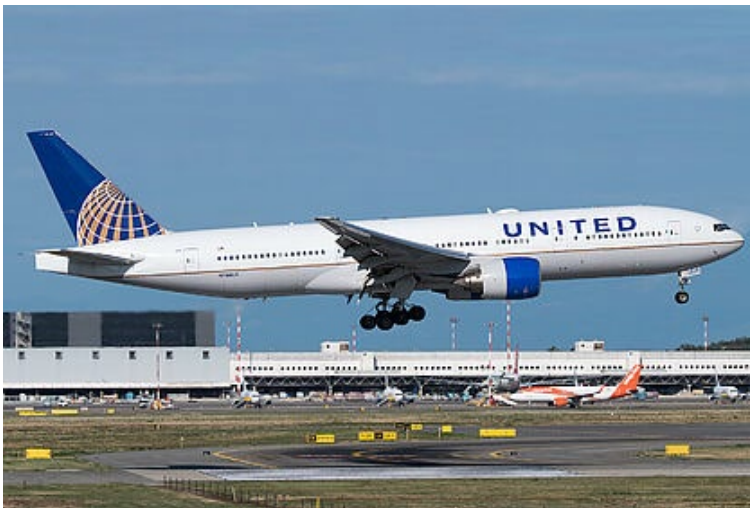
The airplane was a Boeing 777-222ER, manufacturing Serial Number 26942. The airplane was manufactured in 1997, delivered to United Airlines in July of 1997 and it held a transport category airworthiness certificate. The airplane was configured with 4 flight crew seats, 14 flight attendant seats, and 276 passenger seats.

**Figure 1:** Accident Airplane, N788UA (Courtesy of planespotters.net)
