# NATIONAL TRANSPORTATION SAFETY BOARD

DCA24LA330

## **OPERATIONAL FACTORS**

Operational Factors Group Factual Report

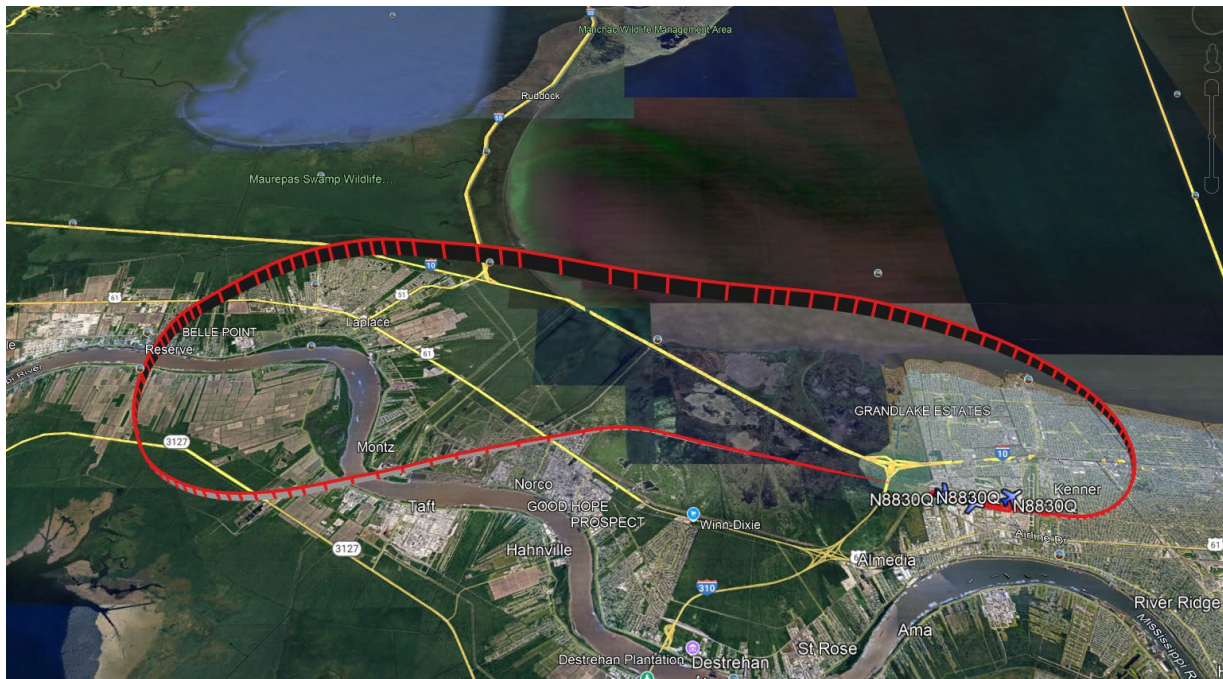
**Figure 1:** Incident Flight Route of Flight (Source: ADSBExchange.com)

Approximately 1426, the airplane landed on runway 11, where it decelerated, and according to the crew, they stopped on the runway to allow ARFF<sup>12</sup> to verify there was no fire noticeable. The airplane subsequently taxied to the gate, and the last recorded data indicated it was on the terminal ramp about 1433:10.
