Air Safety Office  
Parker Hannifin Corporation  
Parker Aerospace  
[REDACTED]  
Irvine, California [REDACTED]

**Subject:** ERA16LA113, Liberty XL2 Brake Exam

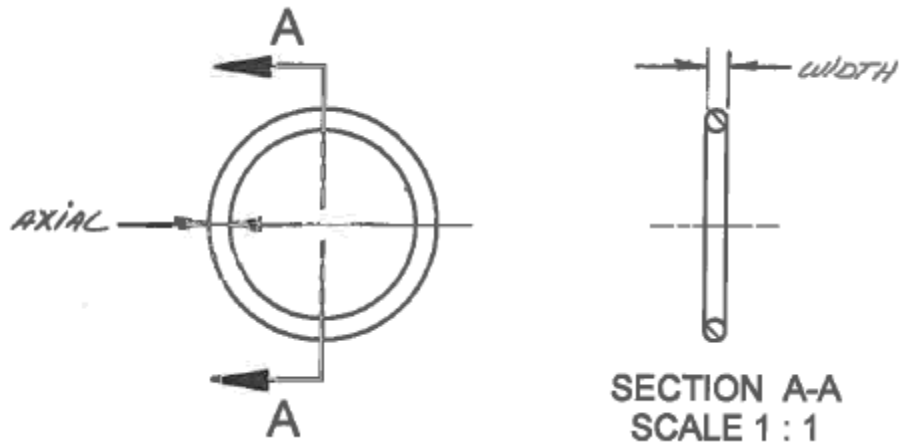
A new O-ring was pulled from stock and measured similar to the LH and RH brake and dimensions noted in the chart below (all dimensions in inches).

The O-ring was removed from the piston. The O-ring appeared intact and was generally in a round condition. The O-ring was placed on a calibrated cone and corresponded to a -218 O-ring. The drawing specifies an MS28775-218 (AS28775-218 is equivalent). The O-ring cross section width and axial dimensions were measured in 4 locations around the O-ring and noted in chart below.
