# Pilot's Handbook of Aeronautical Knowledge

U.S. Department of Transportation  
Federal Aviation Administration

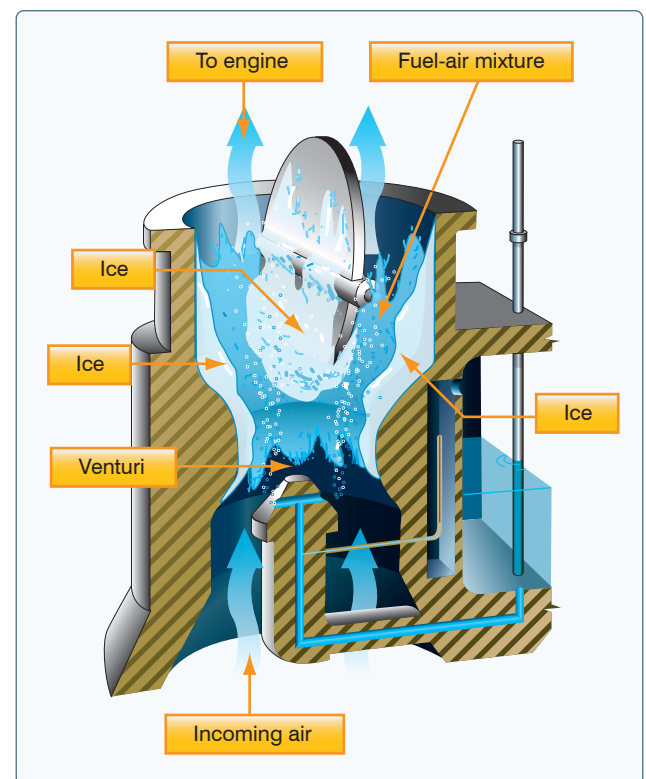
**Figure 7-11.** The formation of carburetor ice may reduce or block fuel-air flow to the engine.

As mentioned earlier, one disadvantage of the float-type carburetor is its icing tendency. Carburetor ice occurs due to the effect of fuel vaporization and the decrease in air pressure in the venturi, which causes a sharp temperature drop in the carburetor. If water vapor in the air condenses when the carburetor temperature is at or below freezing, ice may form on internal surfaces of the carburetor, including the throttle valve. [Figure 7-11]

The reduced air pressure, as well as the vaporization of fuel, contributes to the temperature decrease in the carburetor. Ice generally forms in the vicinity of the throttle valve and in the venturi throat. This restricts the flow of the fuel-air mixture and reduces power. If enough ice builds up, the engine may cease to operate. Carburetor ice is most likely to occur when temperatures are below 70 degrees Fahrenheit (°F) or 21 degrees Celsius (°C) and the relative humidity is above 80 percent. Due to the sudden cooling that takes place in the carburetor, icing can occur even in outside air temperatures as high as 100 °F (38 °C) and humidity as low as 50 percent. This temperature drop can be as much as 60 to 70 absolute (versus relative) Fahrenheit degrees ( $70 \times 100/180 = 38.89$
