Piper Aircraft, Inc.  
Single/Twin Engine  
Structural Damage Report and Repair Request

Model: PA-31-350 S/N: 31-8152057 Registration #: N4078J

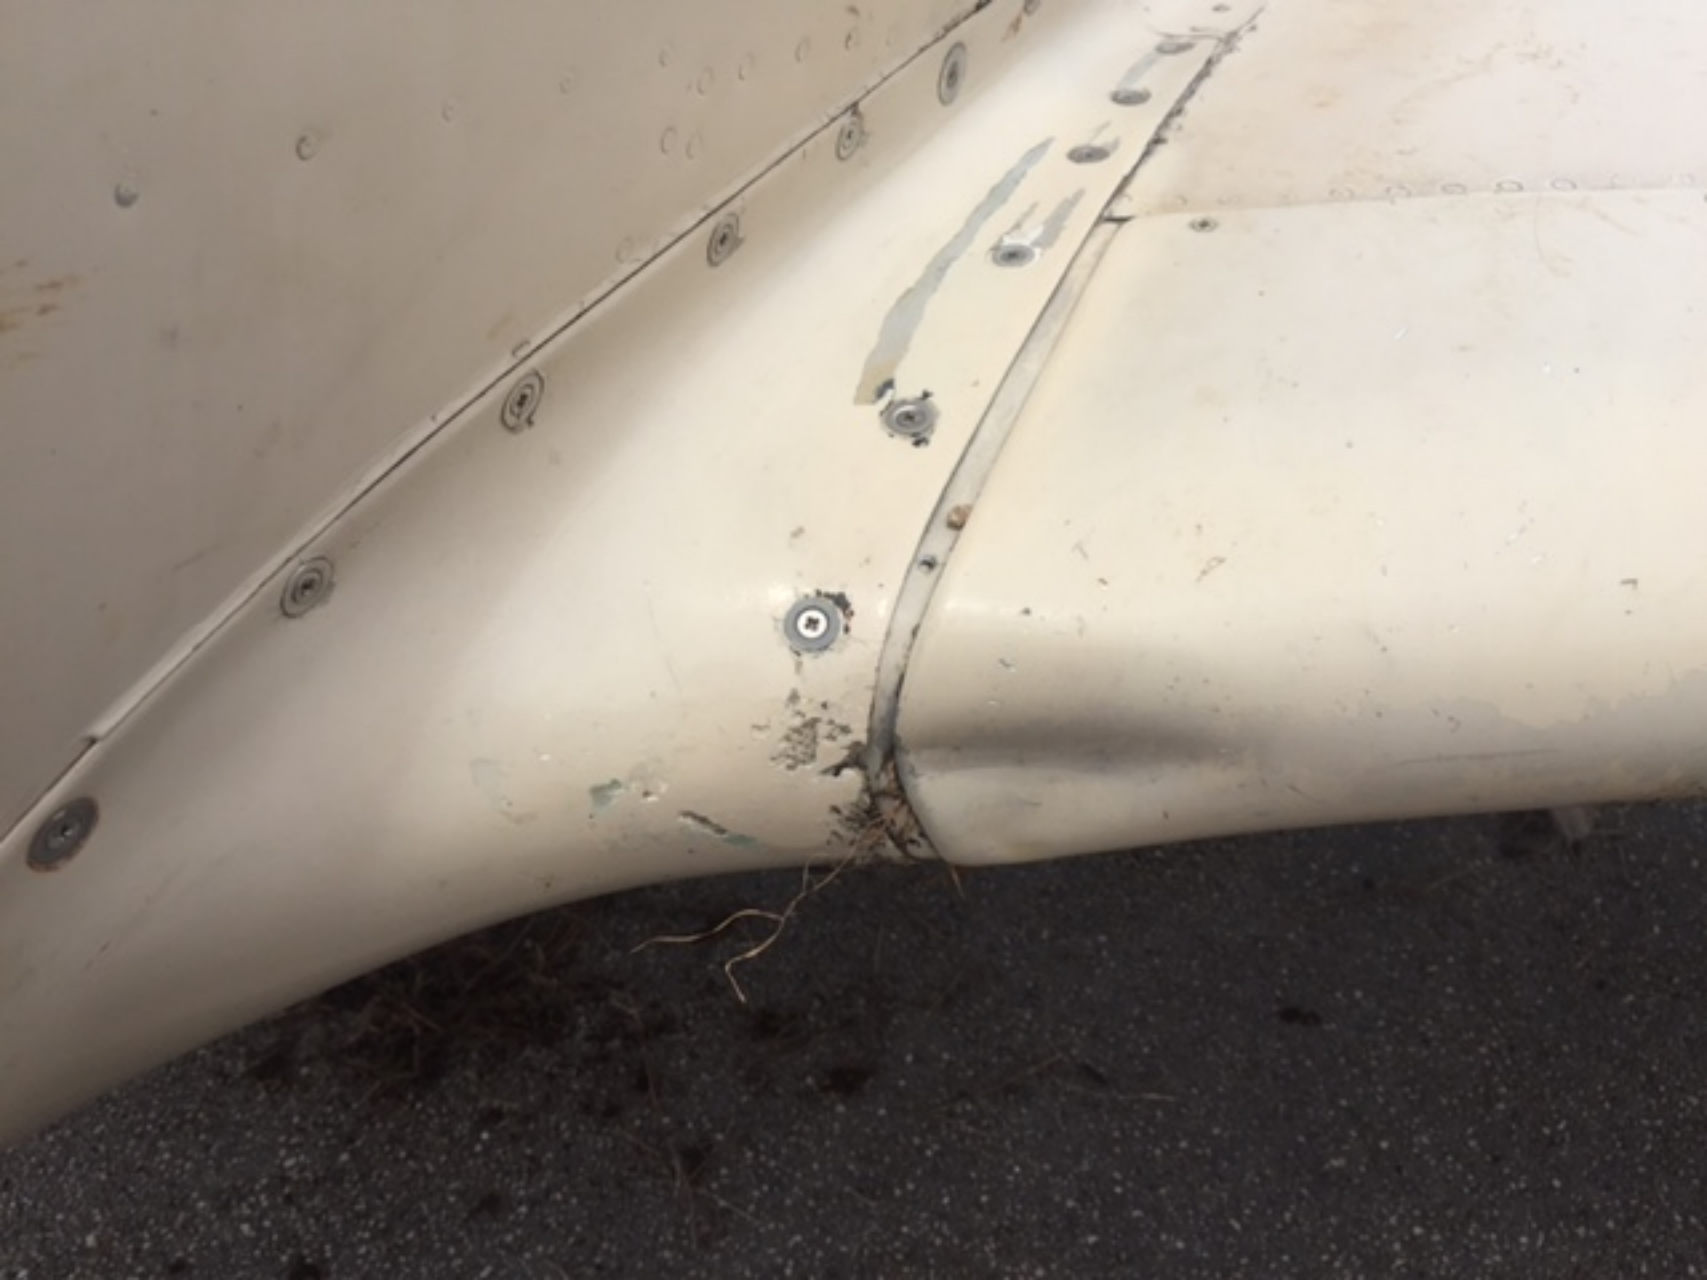
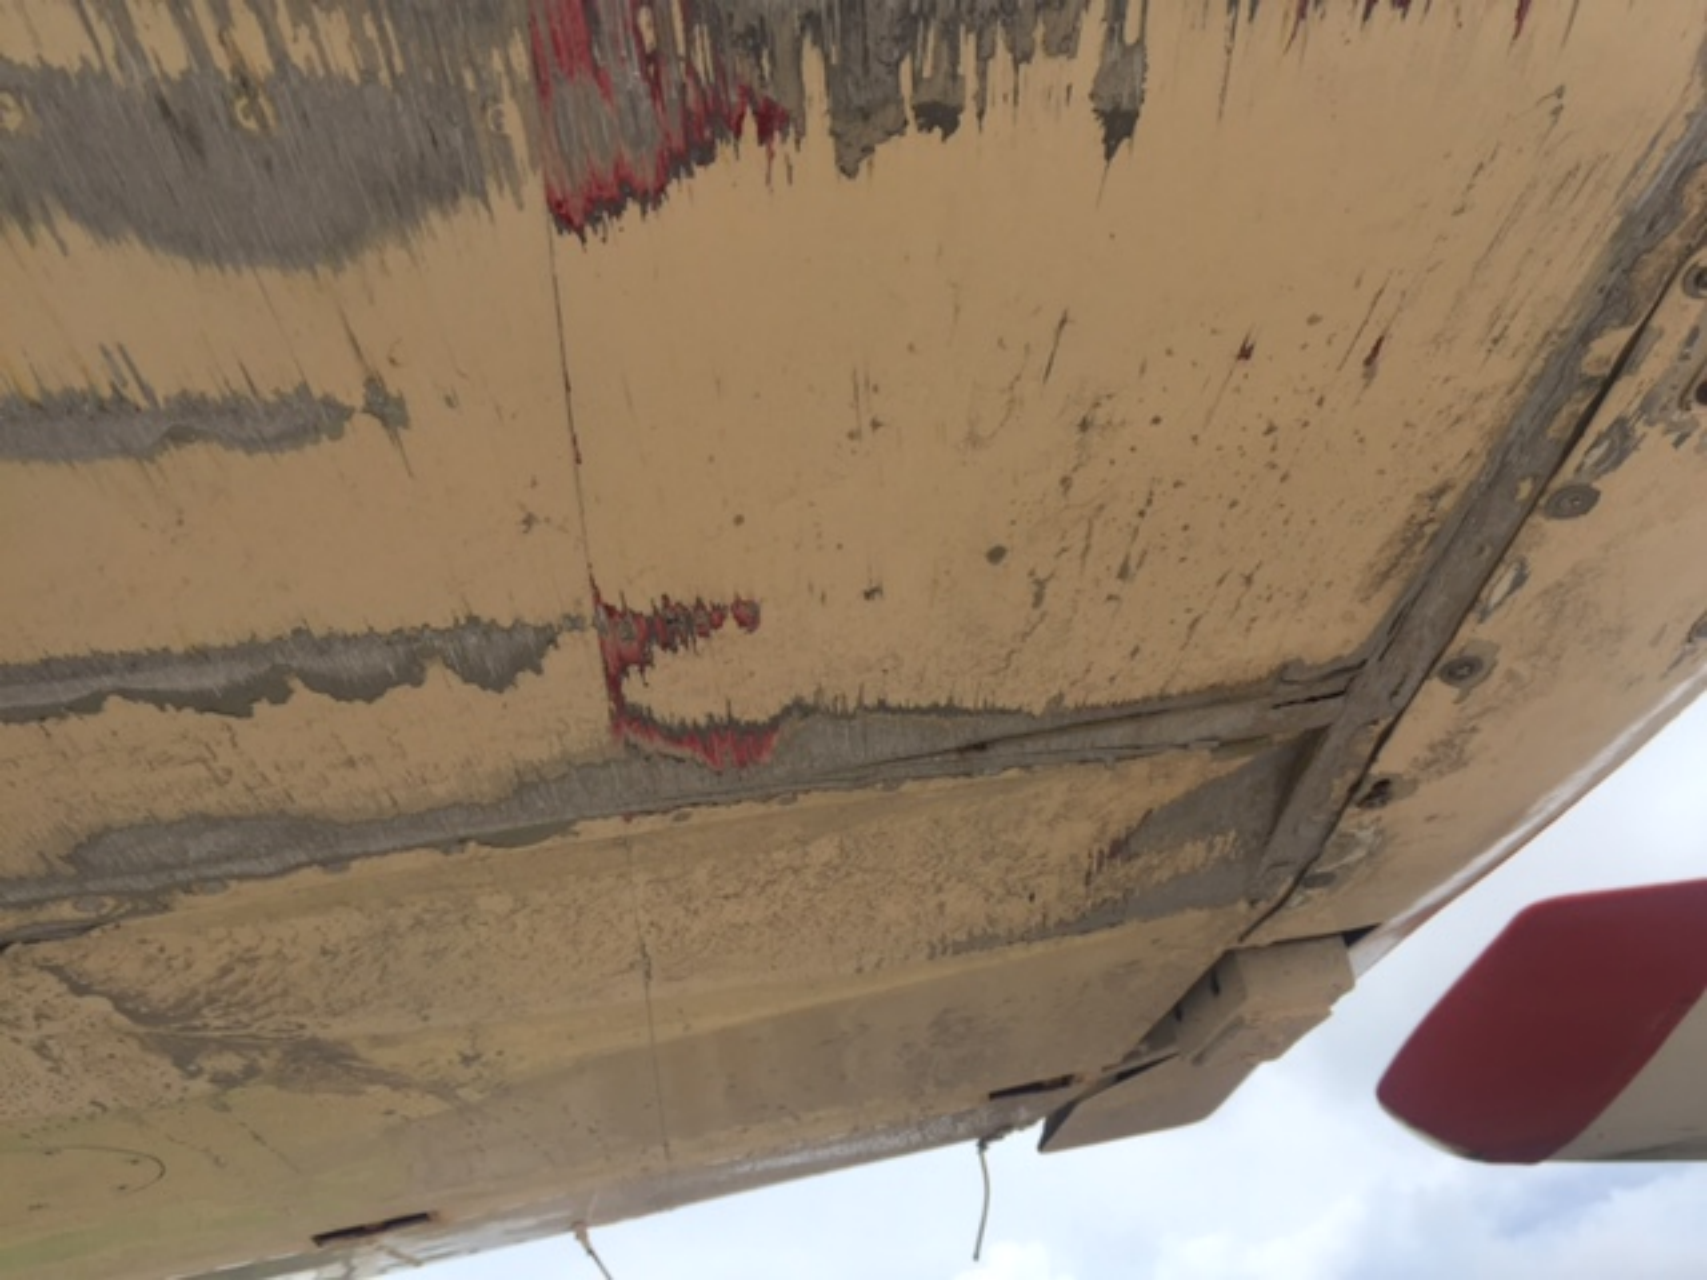
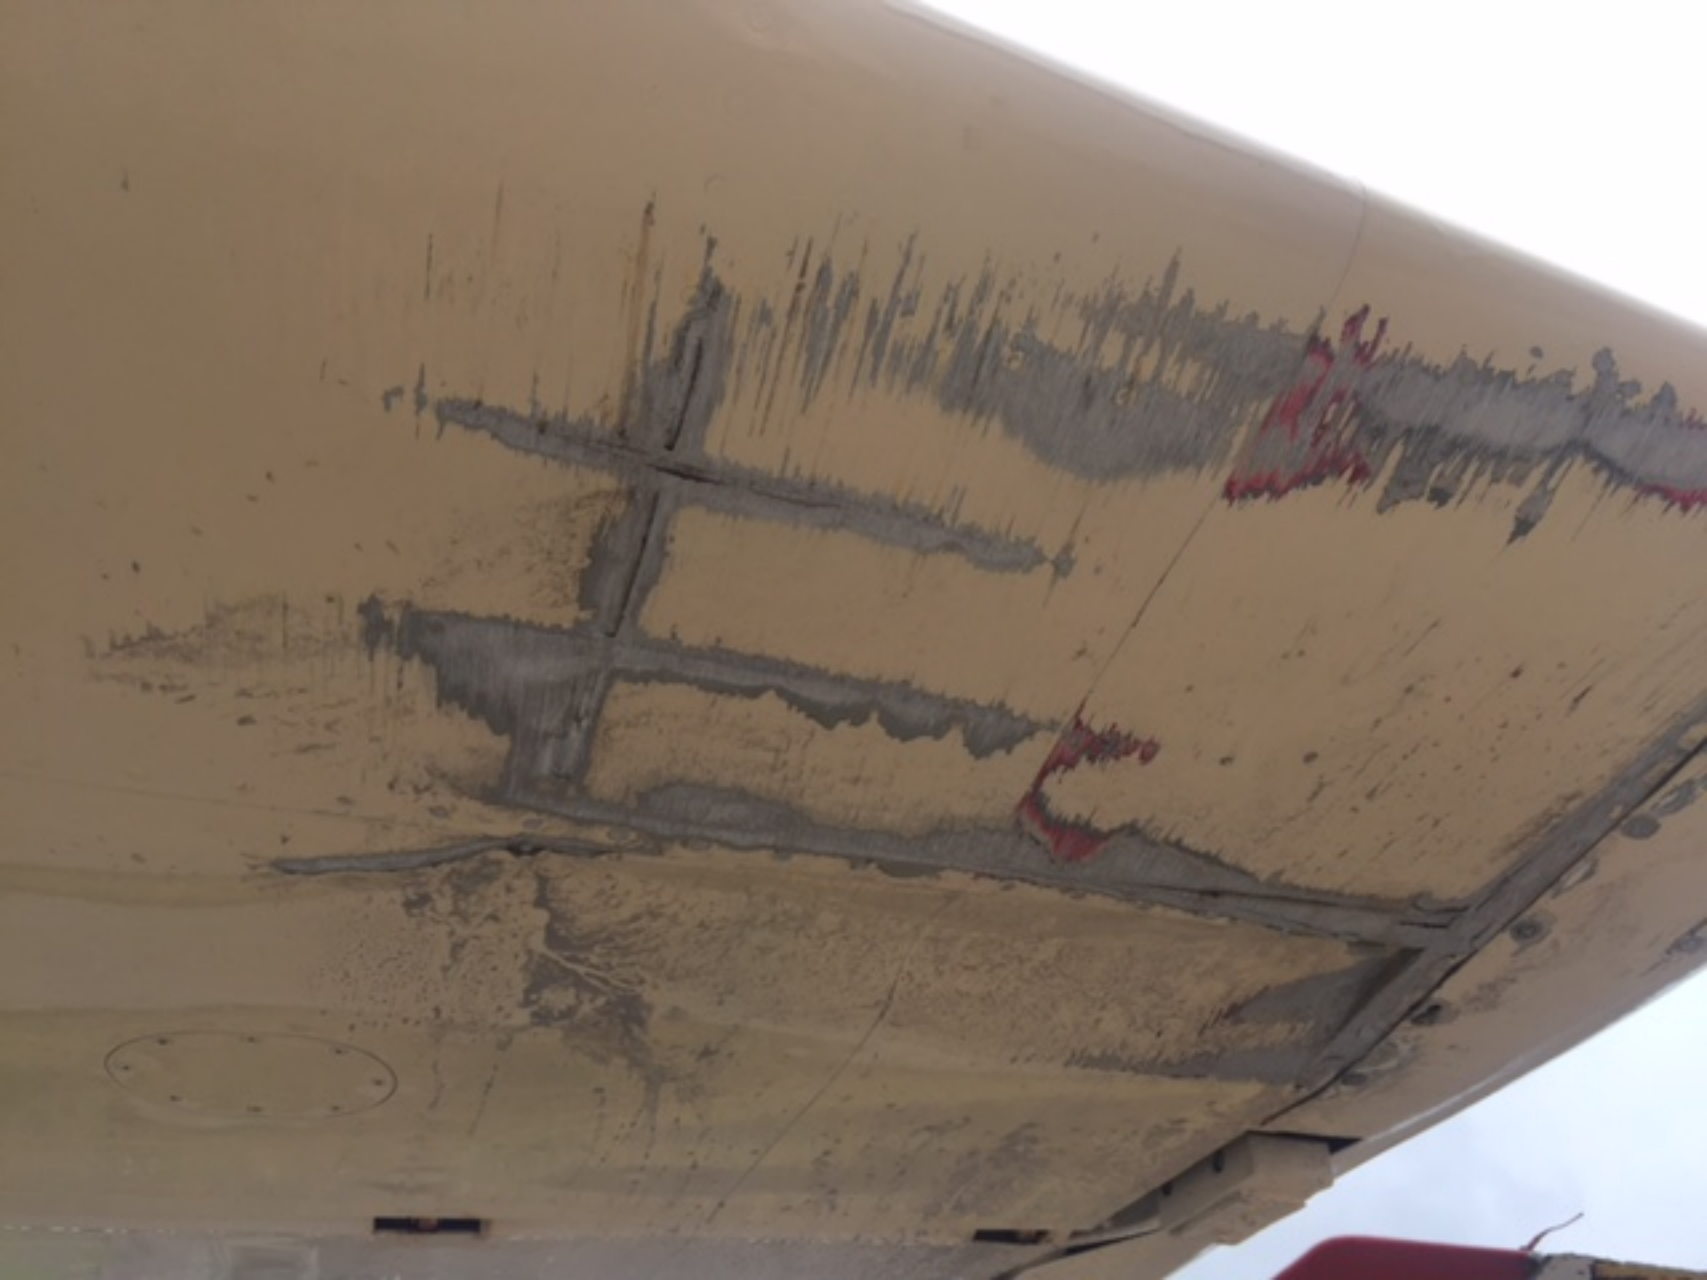
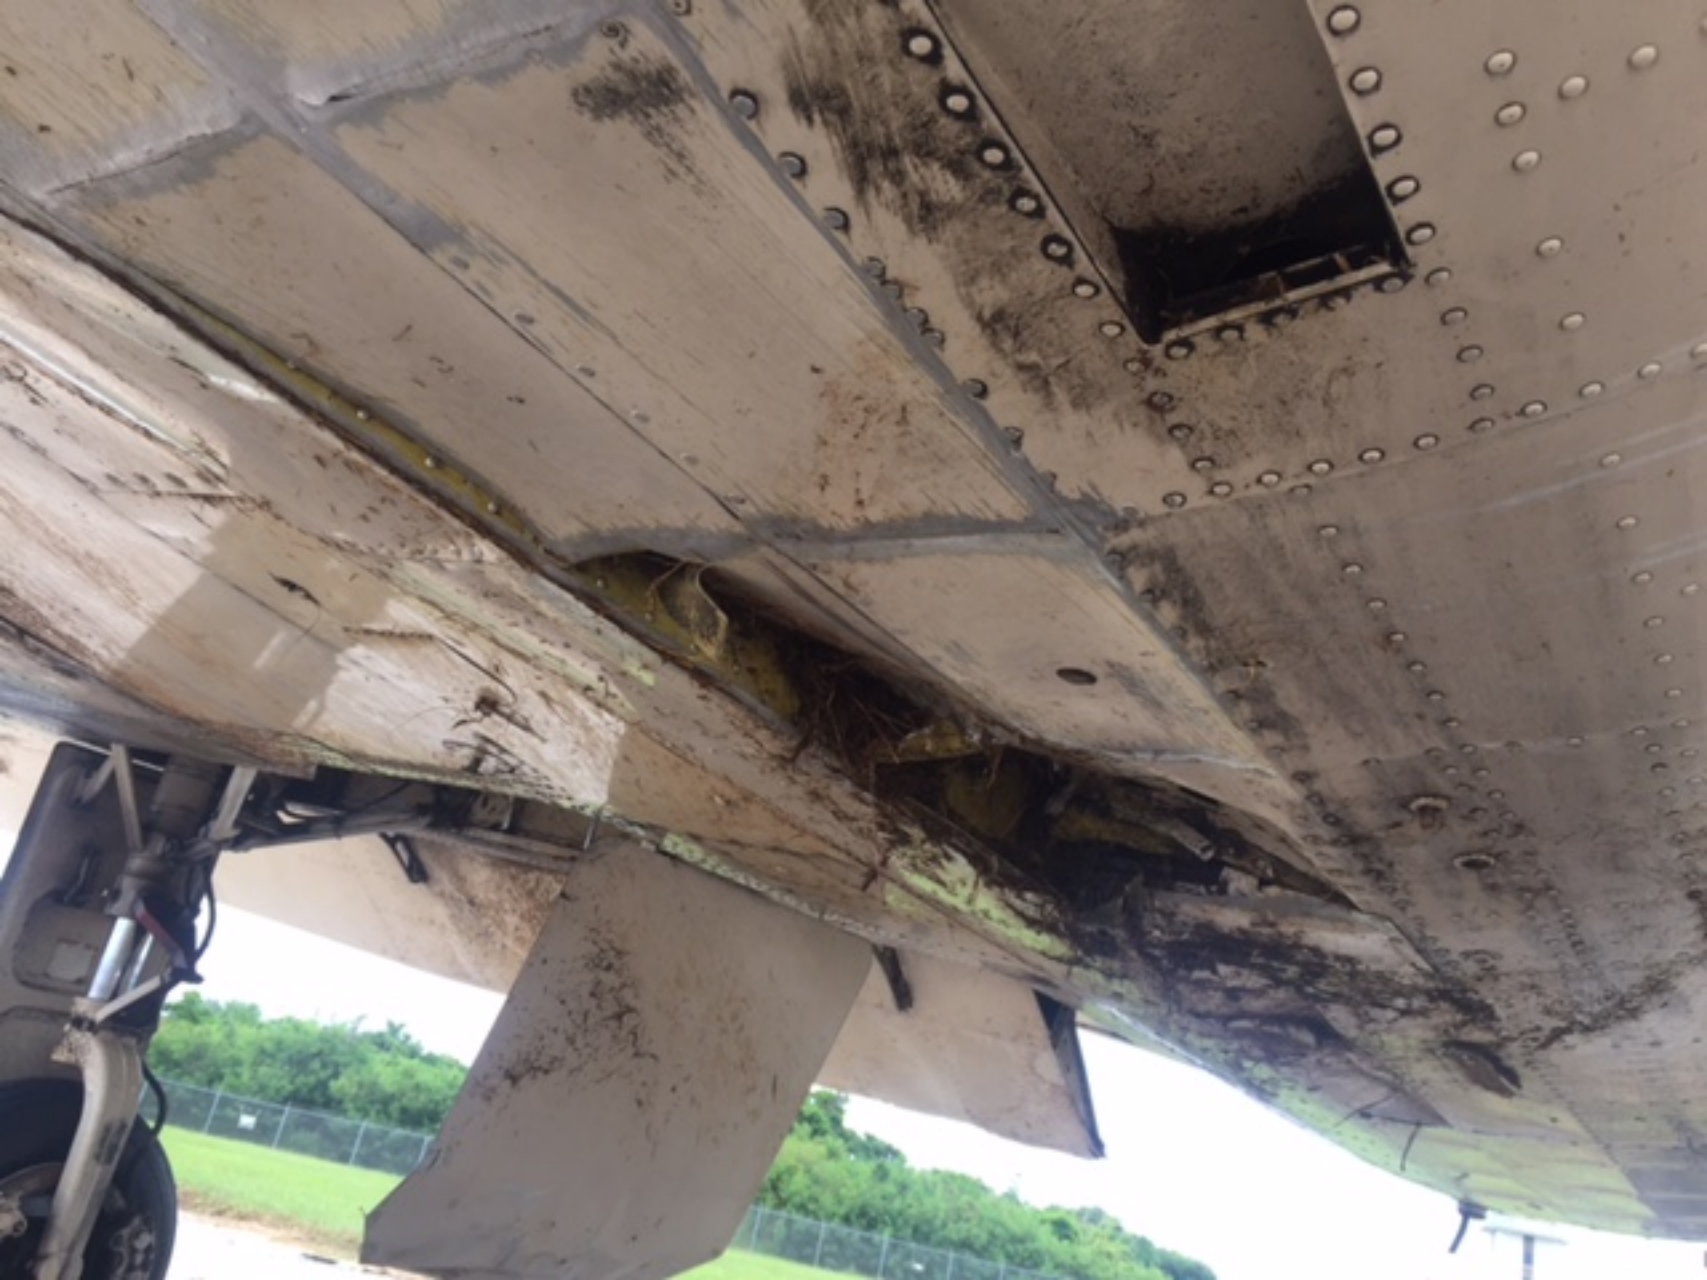
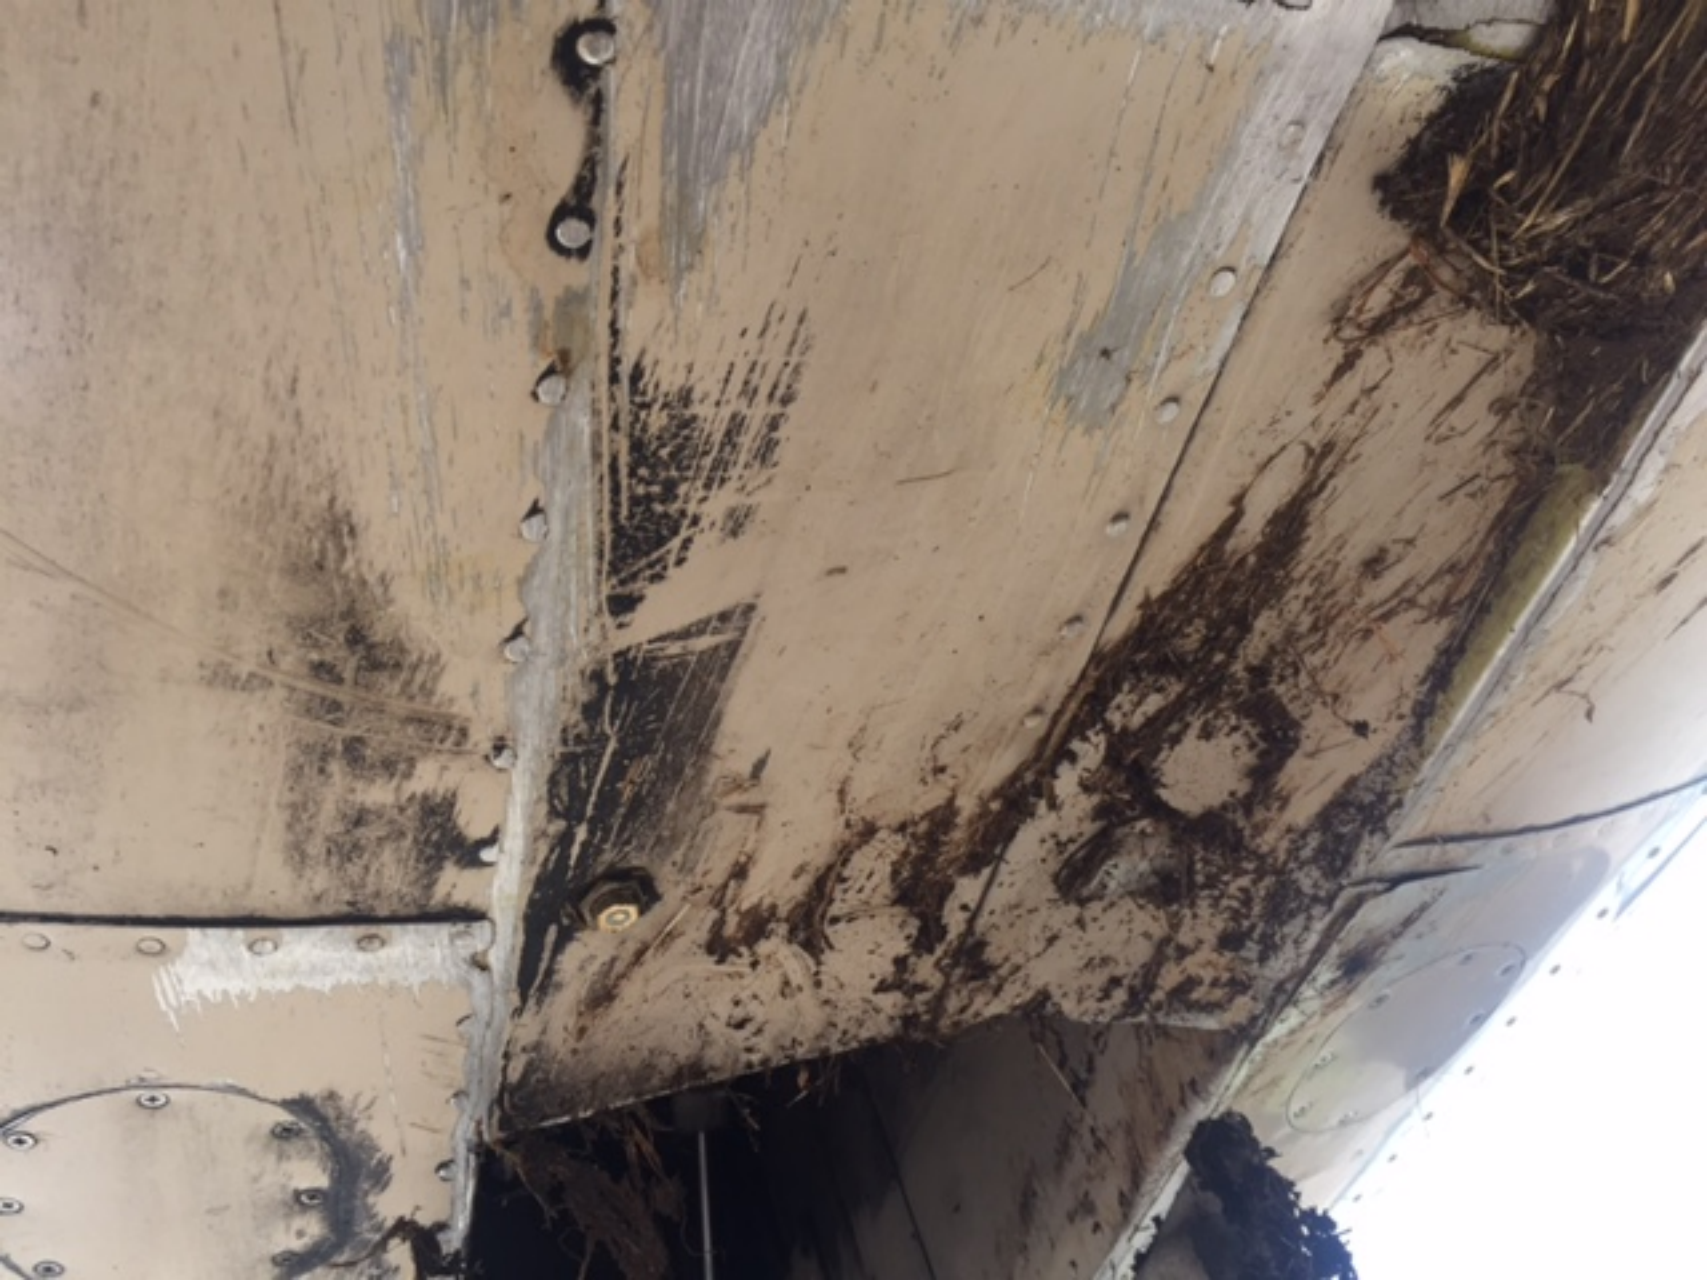
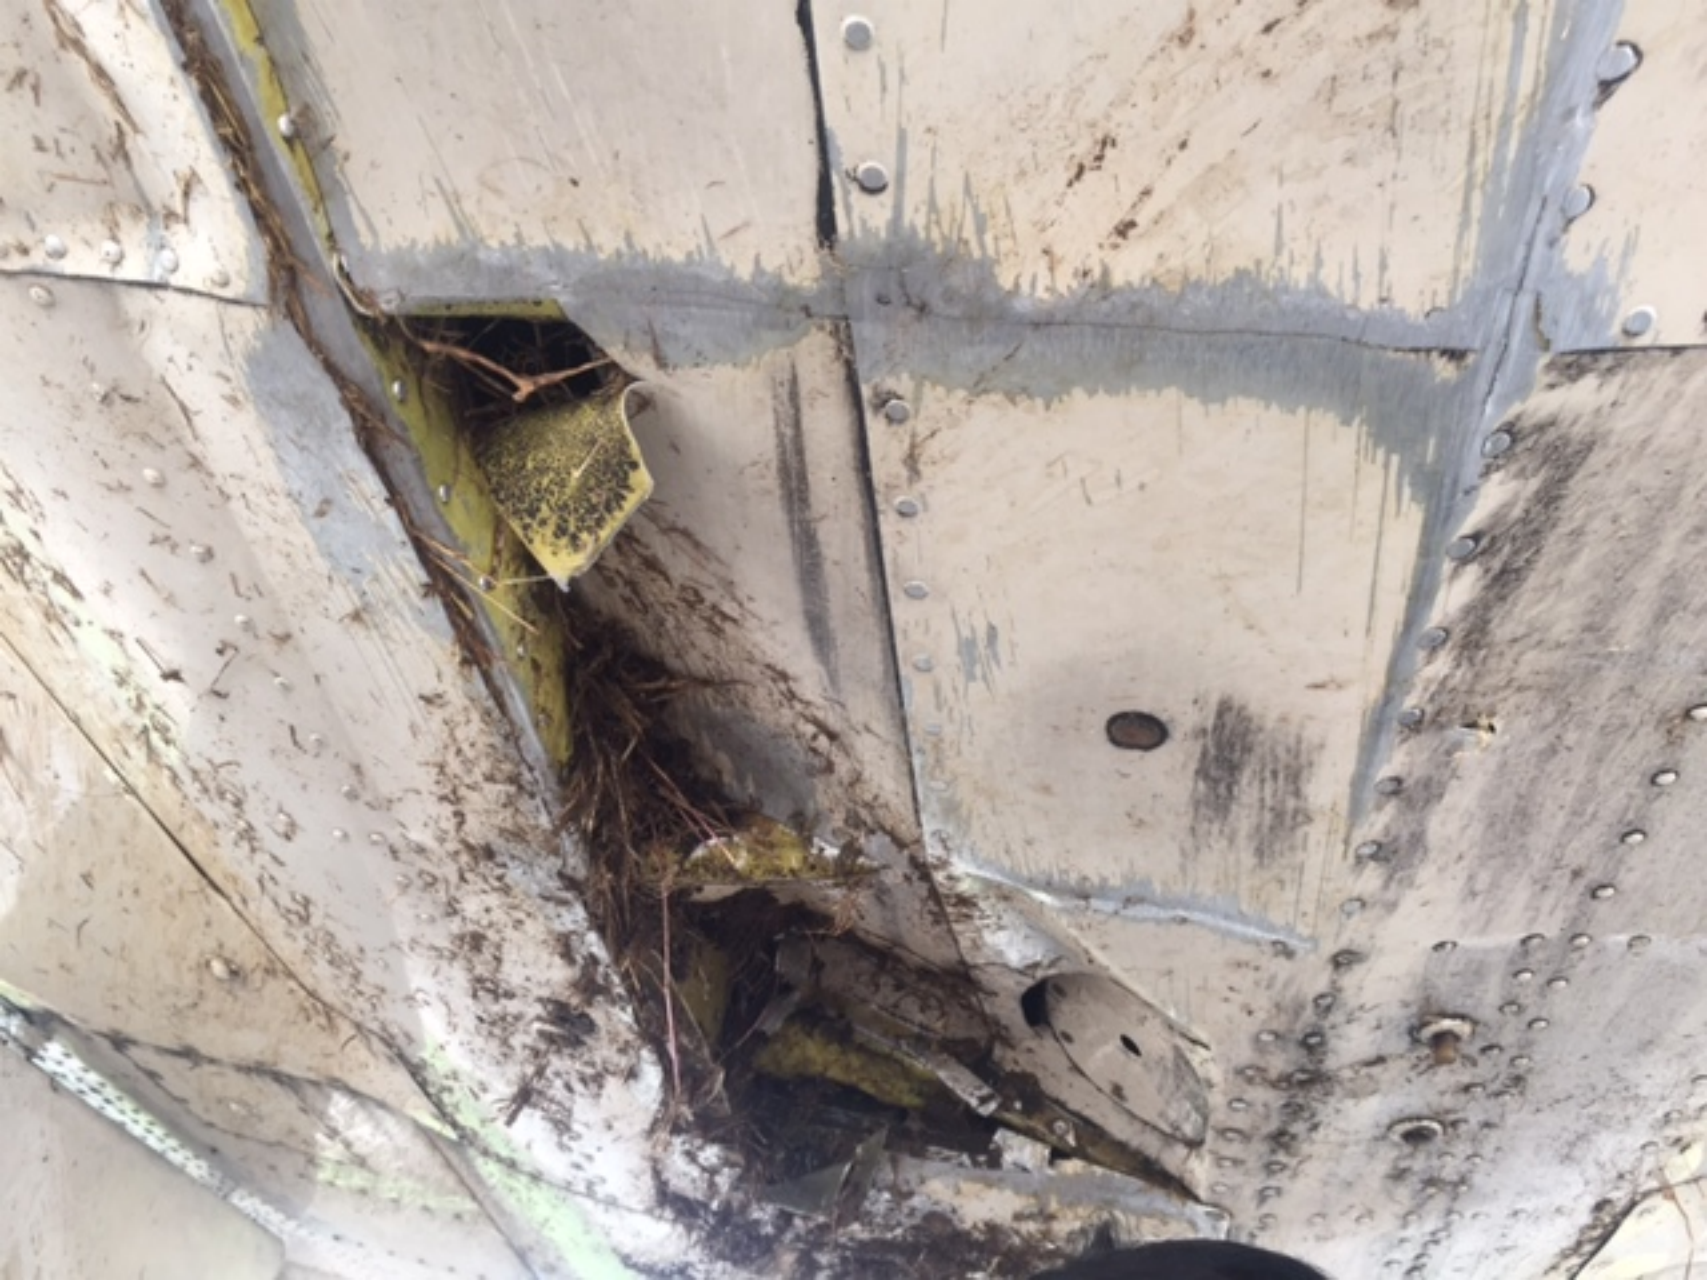
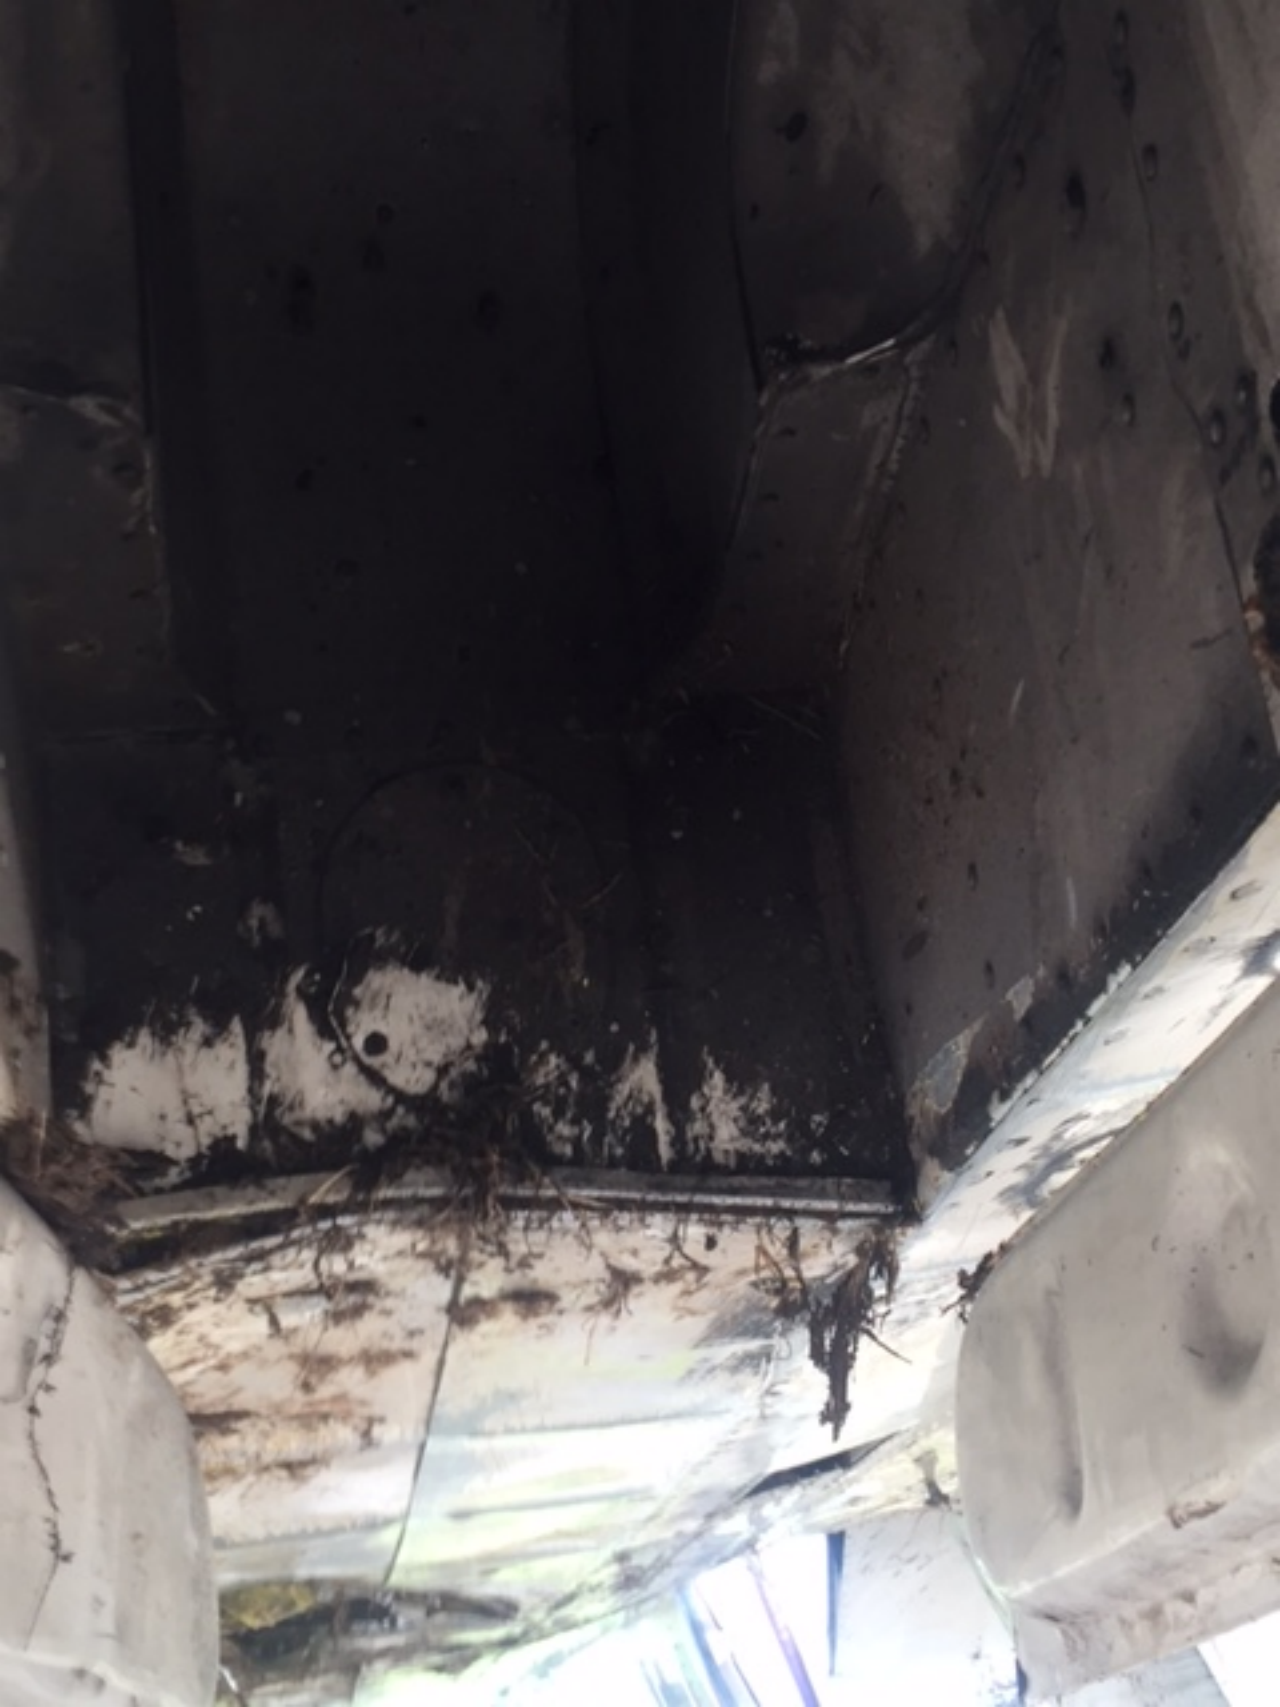
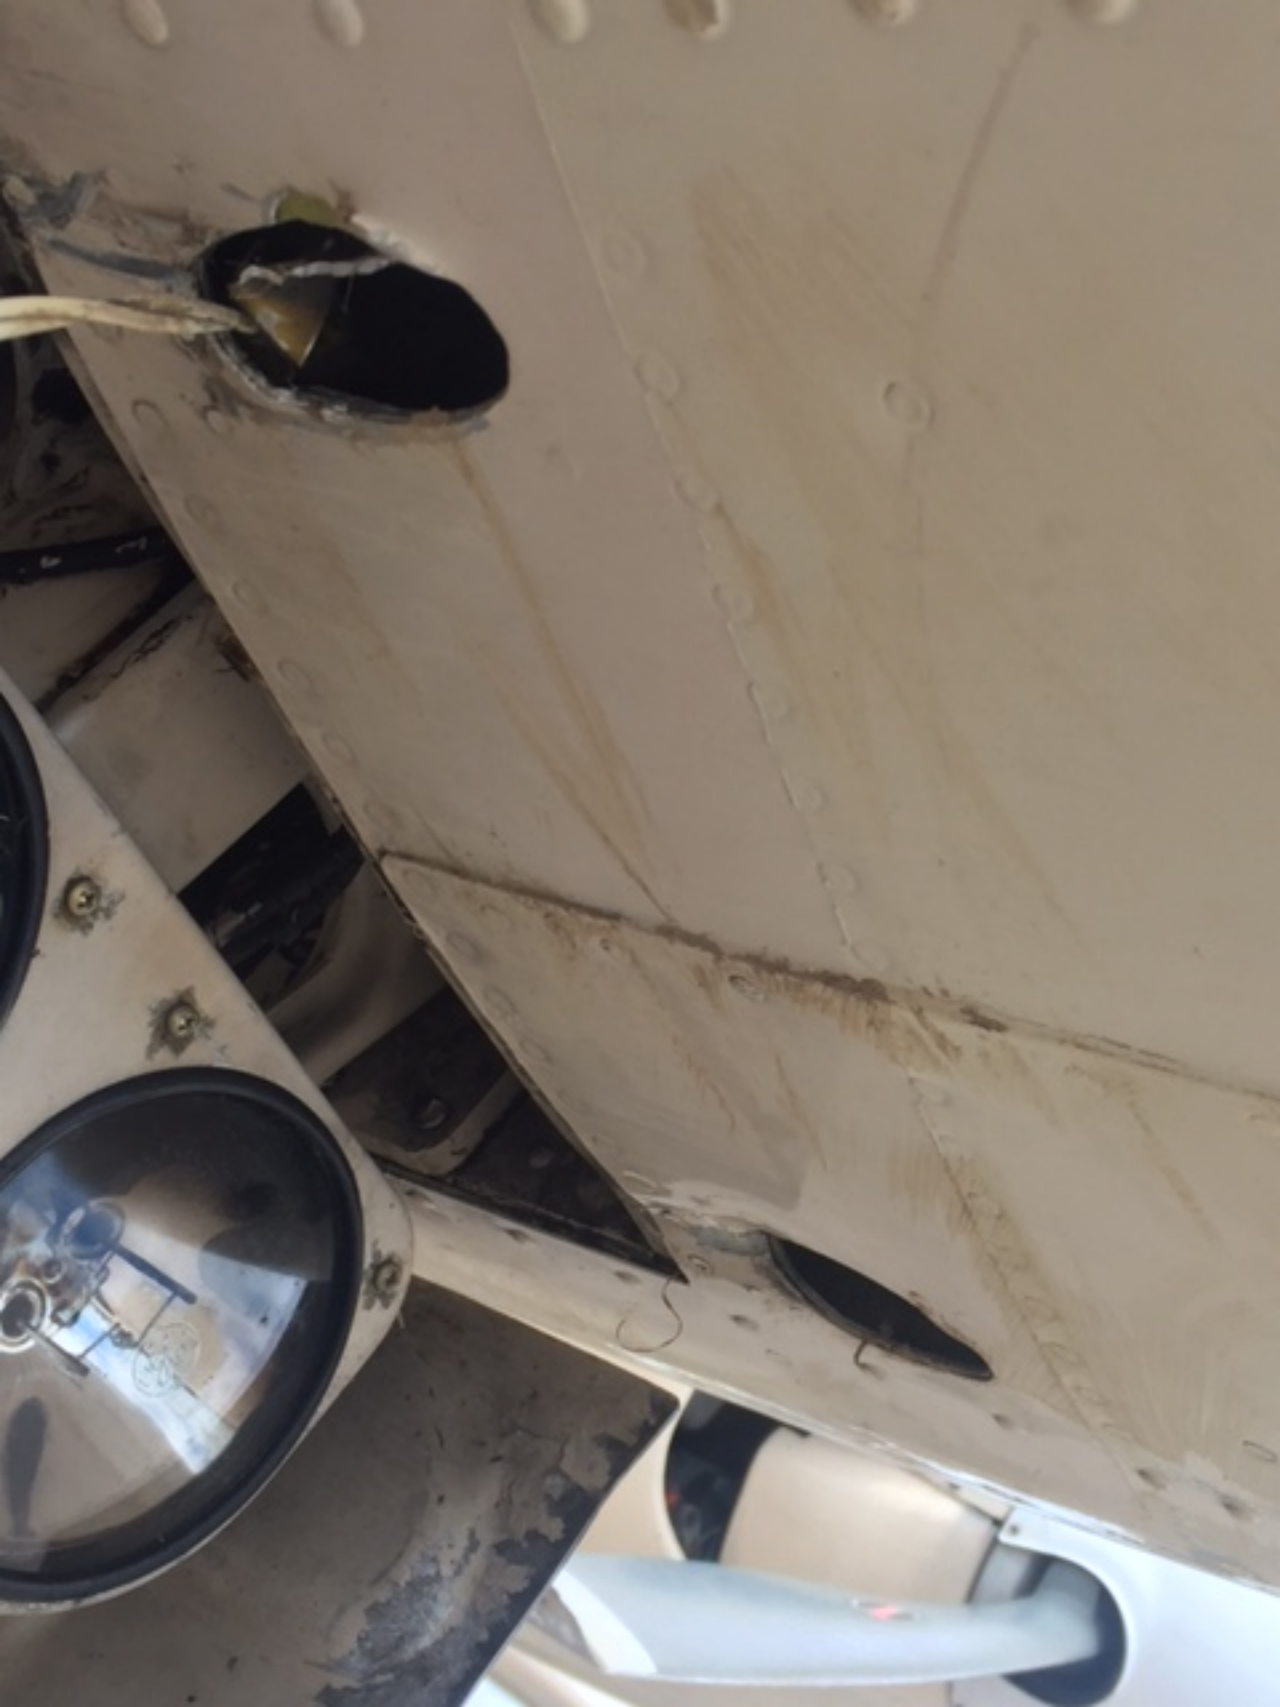
Aircraft sustained damage to lower fuselage, landing gear inboard doors, and lower left wing outboard area due to landing with malfunctioning gear. Only right main gear was partly extended, but unlocked left wing contacted ground before settling on fuselage.

| ITEM | Major Assembly or Part Number | Damage Location (FS / BL / WS) | Damage Detection Method | Damage Description |
|---|---|---|---|---|
| 1 | 52146-03 | FS 7 to 162.6 WL -18 | Visual | Ground damage including worn rivet heads and skin punctures (pics. attached) |
