**WPR16FA126**

**Piper PA-23-150; N1270P**

**NTSB Aircraft Examination Report**

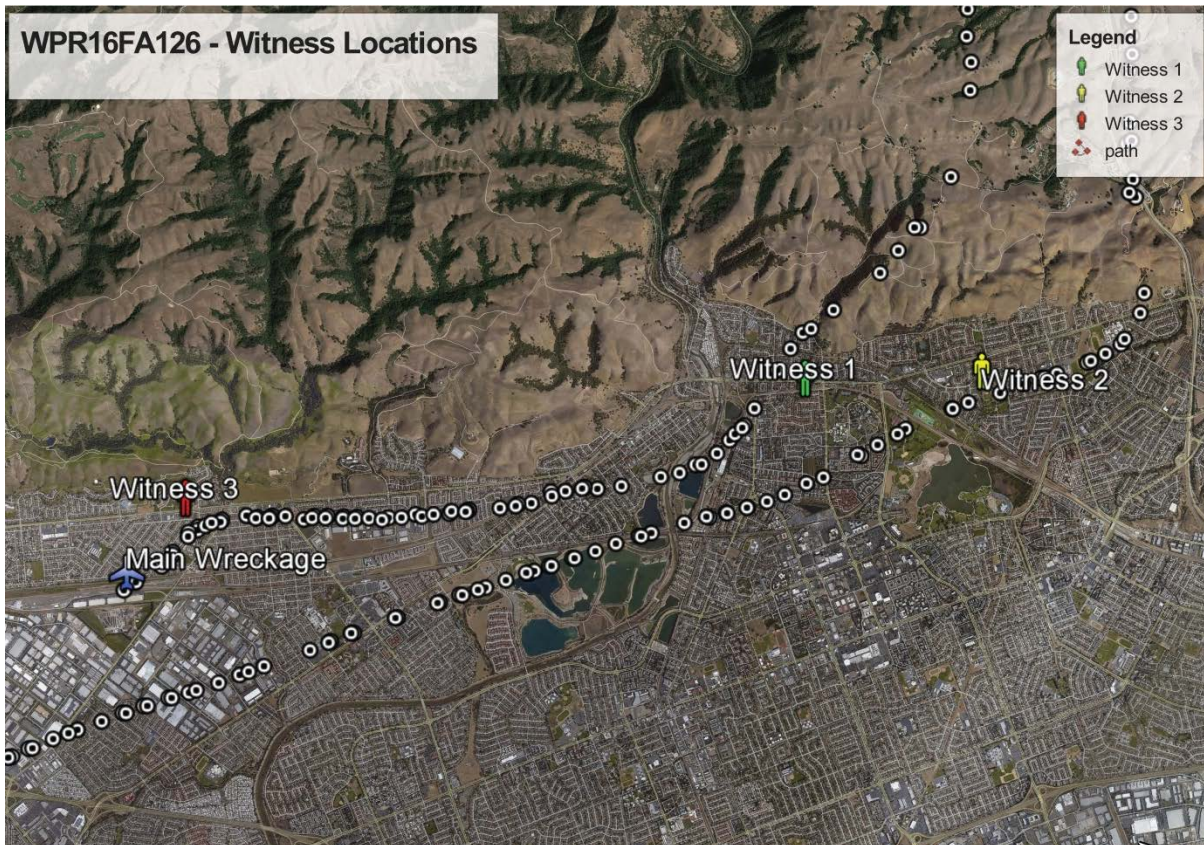
Figure 1 – Witness Locations

located one half mile from the accident site in a nearby graveyard. Please refer to *Figure 1* below for a graphical depiction of the witness locations.

Witness 1 reported that she heard the airplane and an abnormal sound from inside her home. She went outside and observed an airplane approaching her house from a group of hills located to the east. The airplane appeared to be losing altitude and the engine made a "sputtering sound," which she also described as "cutting out." The sound repeated when the airplane reached her property and again seconds later after it passed her home.

Witness 2 stated that he was working in his yard all morning and initially observed a red and white colored airplane on a southeastern heading at approximately 1,750 feet. He never observed any smoke, but heard a sound that resembled an engine "backfiring." The airplane subsequently made a left turn and proceeded eastbound and disappeared behind a group of hills. About 30 minutes later he observed an airplane northeast of his house flying towards the airport. The witness reported hearing more sounds that resembled an engine "popping" and "backfiring." He added that he did not observe any smoke, FOD, or fluids coming from the airplane, but clarified that the engine "backfiring" sounds were much louder during the airplane's inbound leg.

According to Witness 3, he observed an airplane flying abnormally low over a group of houses before noon on the day of the accident. The airplane suddenly entered a steep left bank angle, with the right wing approximately 70 degrees to the horizon. The airplane then disappeared behind a residential area. Approximately 10 seconds later he heard a sound that resembled a bat striking an aluminum shed; shortly thereafter plumes of smoke emerged from the airplane's direction. The witness stated that he observed the airplane in a wings level descent for a few seconds before it entered the steep turn. He added that he may have been downwind of the accident because he smelled fuel burning.
