## ENGINE EXAMINATION REPORT

| ENGINE MODEL | IO-550-N50B conv. to turbo-normalized TAT STC |
| AIRCRAFT MAKE & MODEL | Cirrus SR22 |
| AIRCRAFT REGISTRATION | N764CT |

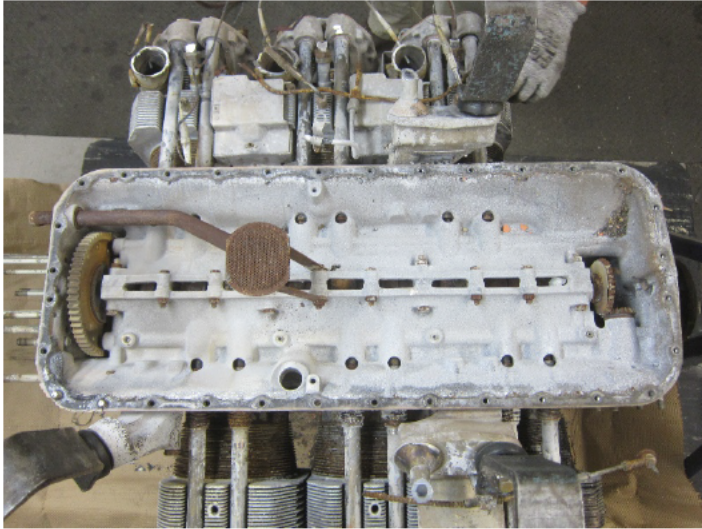
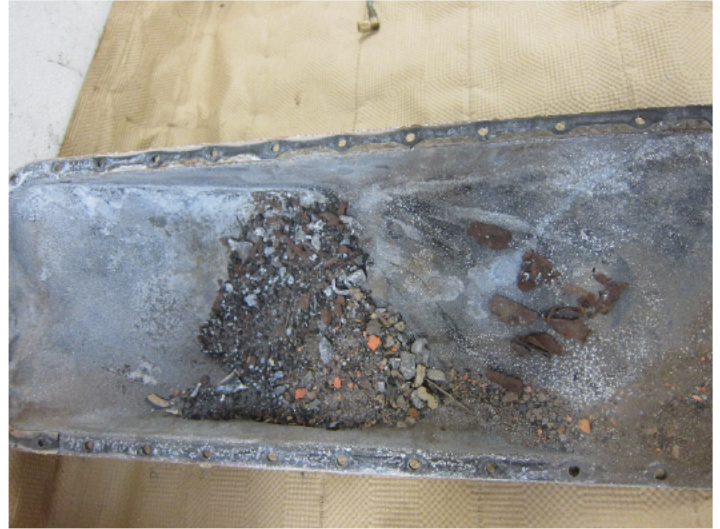
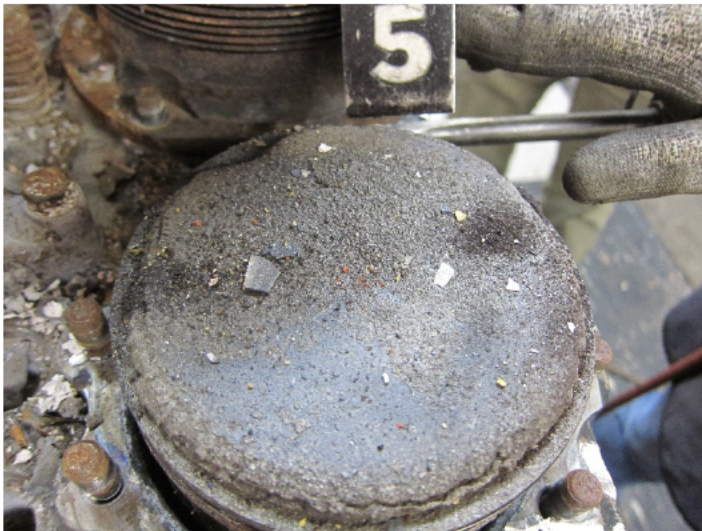
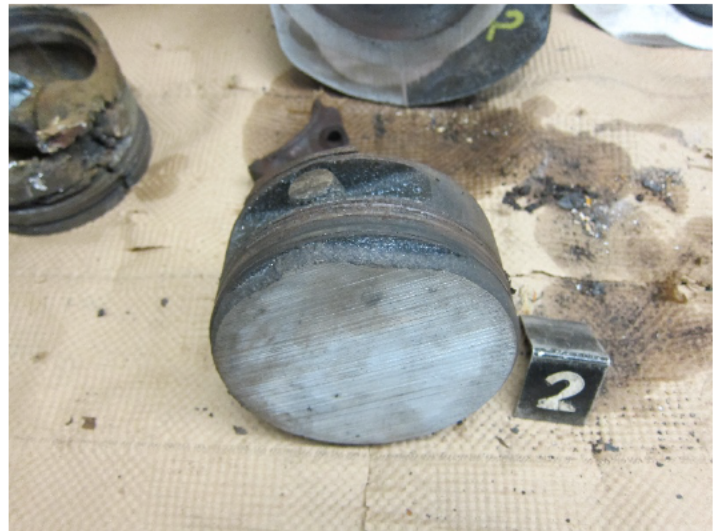
### INTERNAL INSPECTION OF ENGINE

**NOTE:** The cylinders and connecting rods had to be cut to facilitate the disassembly of the engine.

Following a preliminary examination in July 2018, the engine was sent to Continental's manufacturing facility for a teardown examination. The engine teardown revealed that the #2 and #5 pistons experienced a pre-ignition/detonation event that partially eroded the pistons. The eroded pistons permitted the pressurization of the crankcase, which resulted in an oil starvation. The lack of lubrication resulted in the destruction of the #2 connecting rod bearing and the fracture of the #2 connecting rod. All of the connecting rod bearings displayed some degree of thermal distress and distortion due to a lack of lubrication. The cause of the pre-ignition/detonation event could not be determined.
