## **NATIONAL TRANSPORTATION SAFETY BOARD**

### **Group Chairman's Factual Report**

# **METEOROLOGY**

WPR19FA084

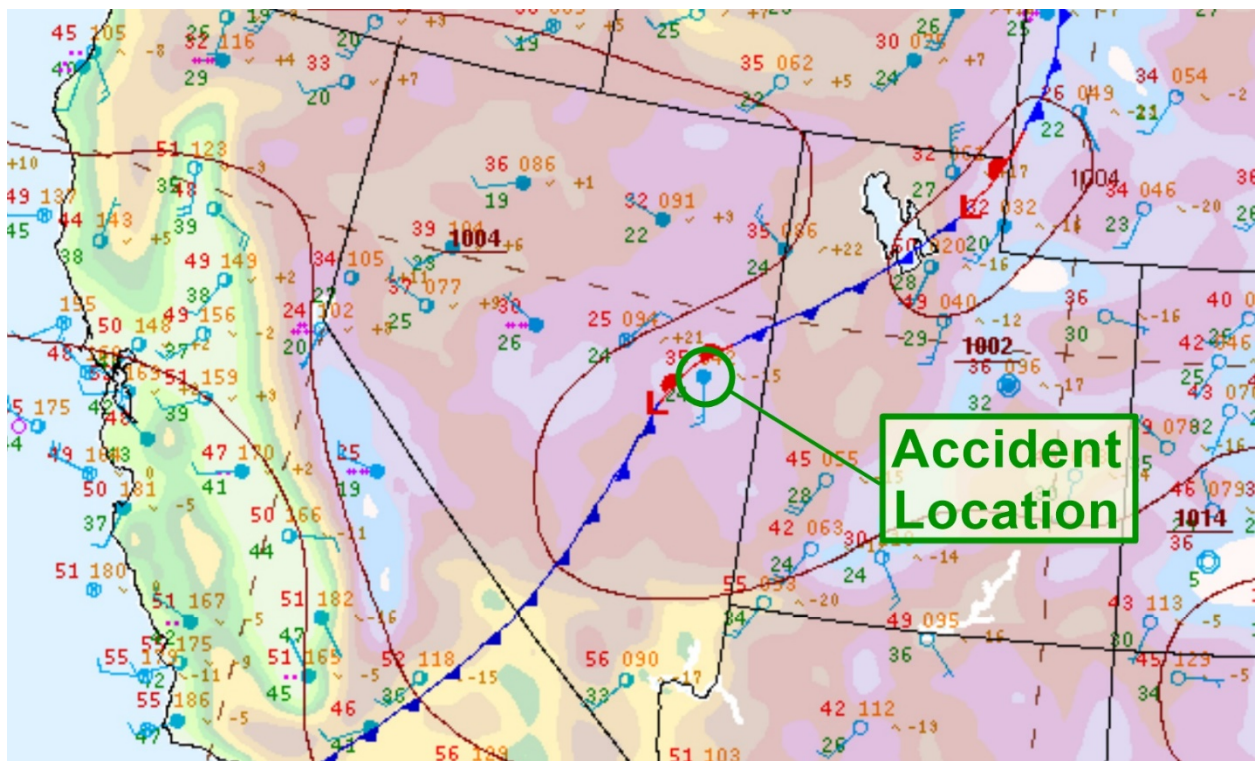
**Figure 1 - NWS Surface Analysis Chart for 1600 PST.**

The National Weather Service (NWS) Surface Analysis Charts for 1600 and 1900 PST are presented in figures 1 and 2. These surface analysis charts show a cold front northwest of the accident location at 1600 PST advancing southeast. At this time, the chart depicted a section of the front immediately northwest of the accident location as a warm front. A low pressure center was located immediately southwest of the accident location. By 1900 PST this front was southeast of the accident location and the entire front was depicted as a cold front. Continuous light snow was identified near the accident location at 1900 PST. Overcast skies were depicted near the accident site at both times.

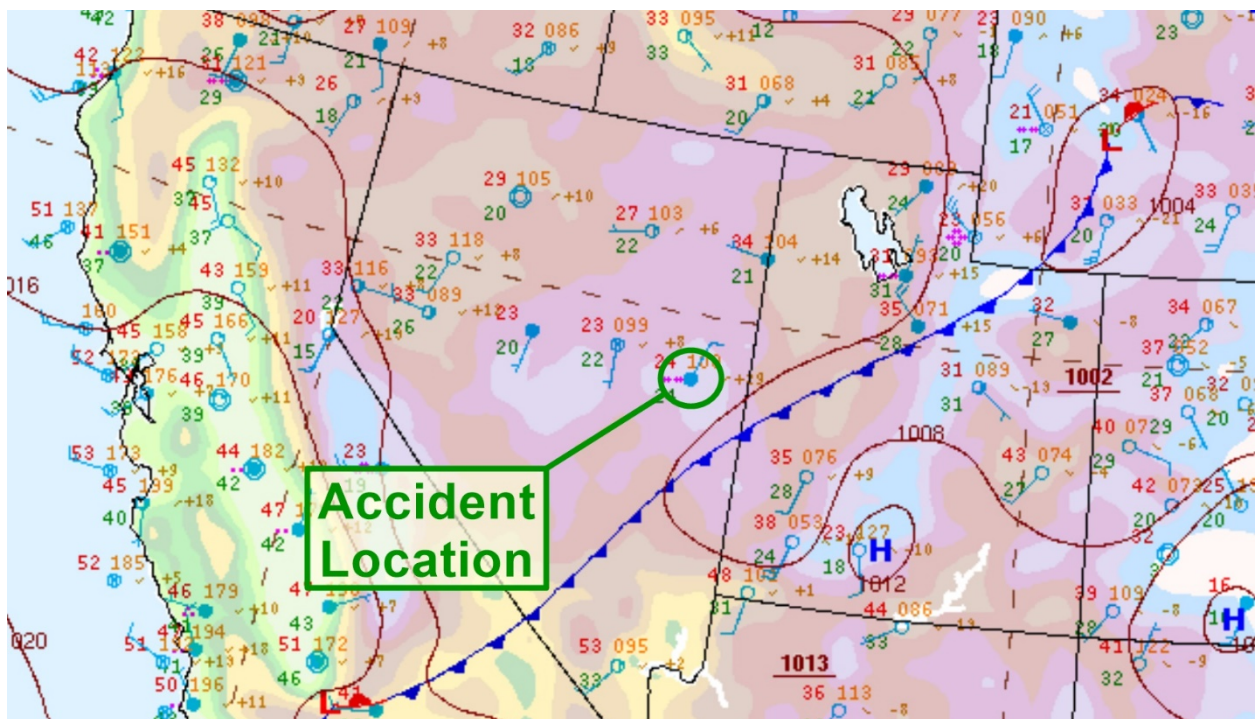
**Figure 2 - NWS Surface Analysis Chart for 1900 PST.**

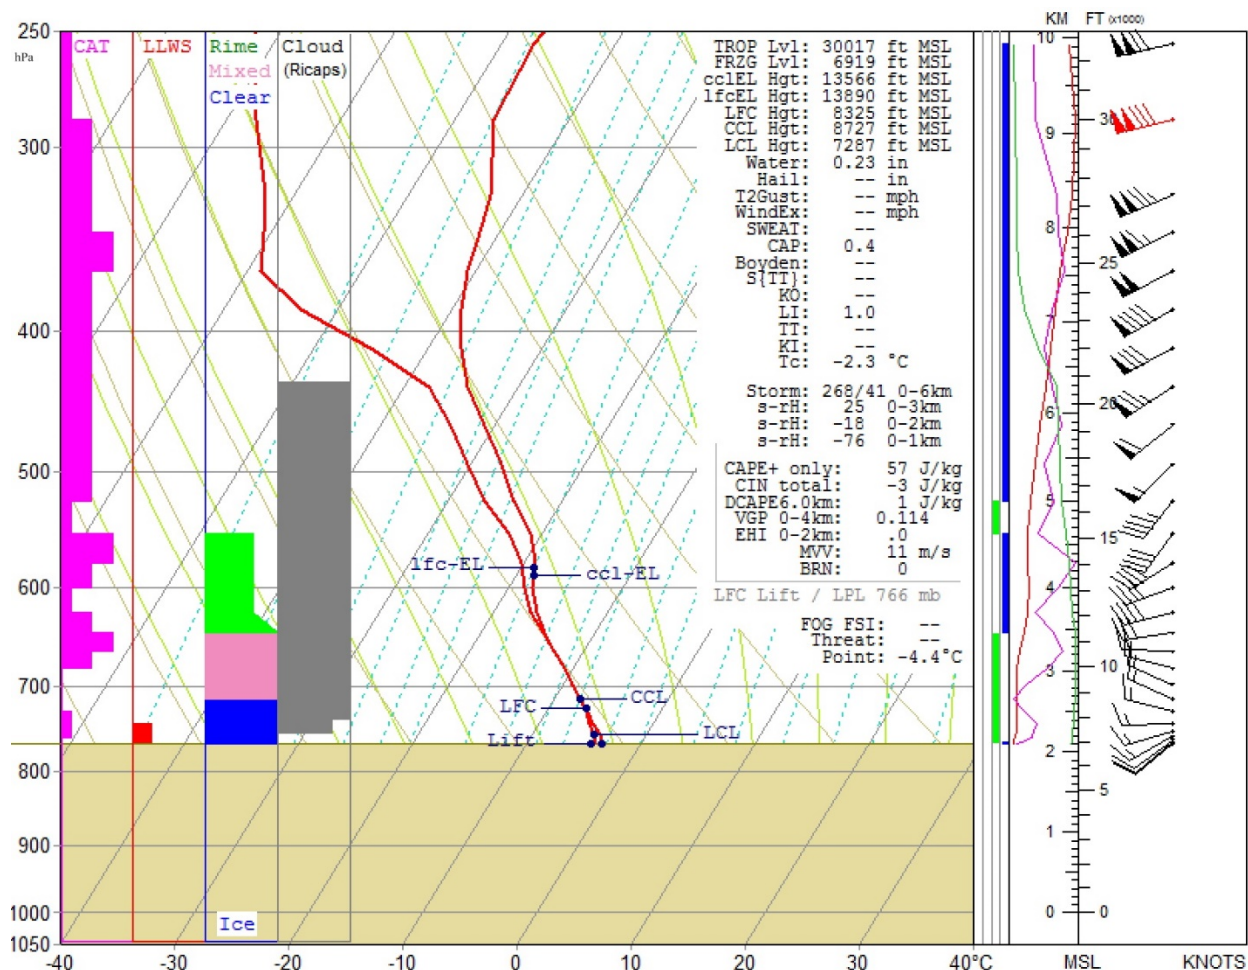
**Figure 4** – HRRR model sounding data in SkewT/LogP format for 1800 PST at the accident site, surface to 250 hPa.

High-Resolution Rapid Refresh (HRRR) model<sup>17</sup> soundings for the accident site at 1700 PST (figure 3) and 1800 PST (figure 4) were retrieved from the National Oceanic and Atmospheric Administration's Air Resources Laboratory.

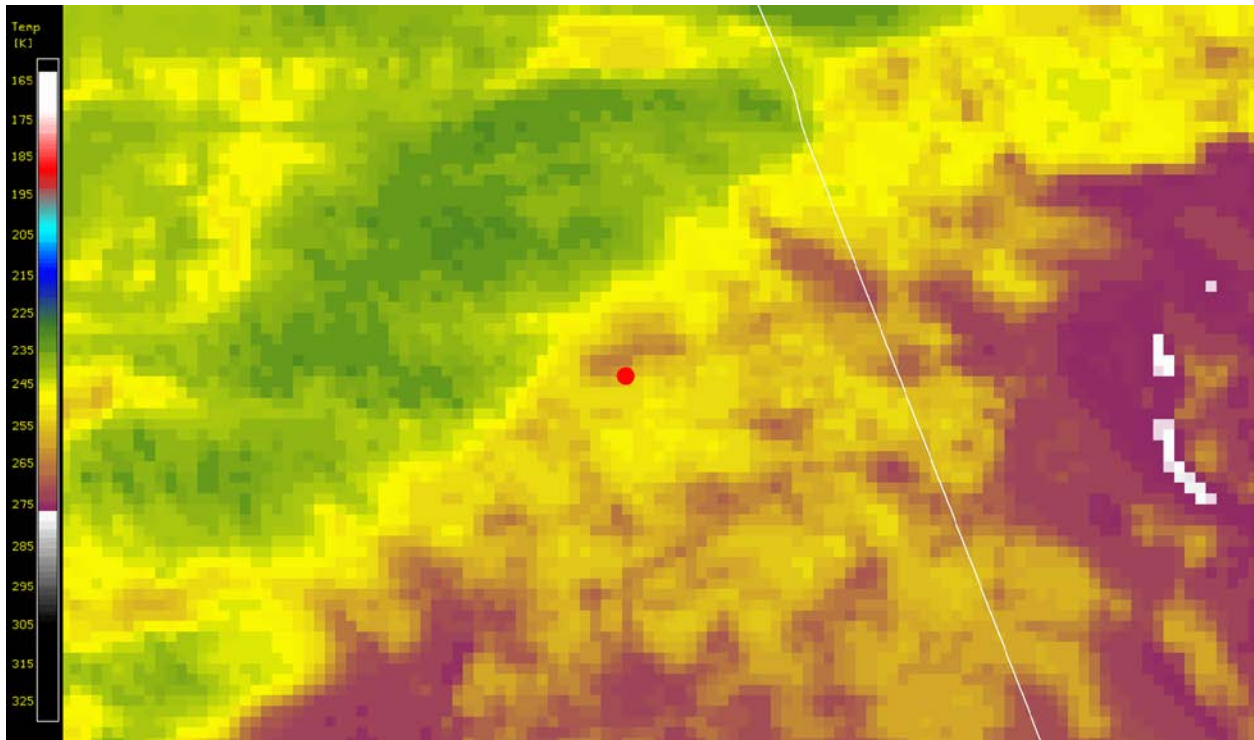
**Figure 5** – GOES-17 infrared imagery (brightness temperature in degrees Kelvin) from 1632 PST. Accident location denoted by red dot. This image has not been corrected for any parallax error.

Geostationary Operational Environmental Satellite (GOES)-17 infrared (10.3 $\mu$ m) data were obtained from an archive at the Space Science Engineering Center at the University of Wisconsin-Madison. Imagery from 1632, 1702, 1717 and 1732 PST are presented in figures 5-8. The GOES-17 infrared imagery depicted an area of relatively high cloud, oriented in a southwest-to-northwest fashion, advancing to the southeast and through the accident region around the accident time. Infrared cloud-top temperatures for these relatively high clouds were about -37°C ( $\pm$  2°C), which, when considering the 1700 PST HRRR sounding, corresponded to cloud top heights of about 22,200 feet. Brightness temperatures in the area immediate ahead of these advancing clouds in the accident region at 1632 PST were about -8°C, which, according to the 1700 PST HRRR sounding, corresponded to cloud top heights of about 9,500 feet.

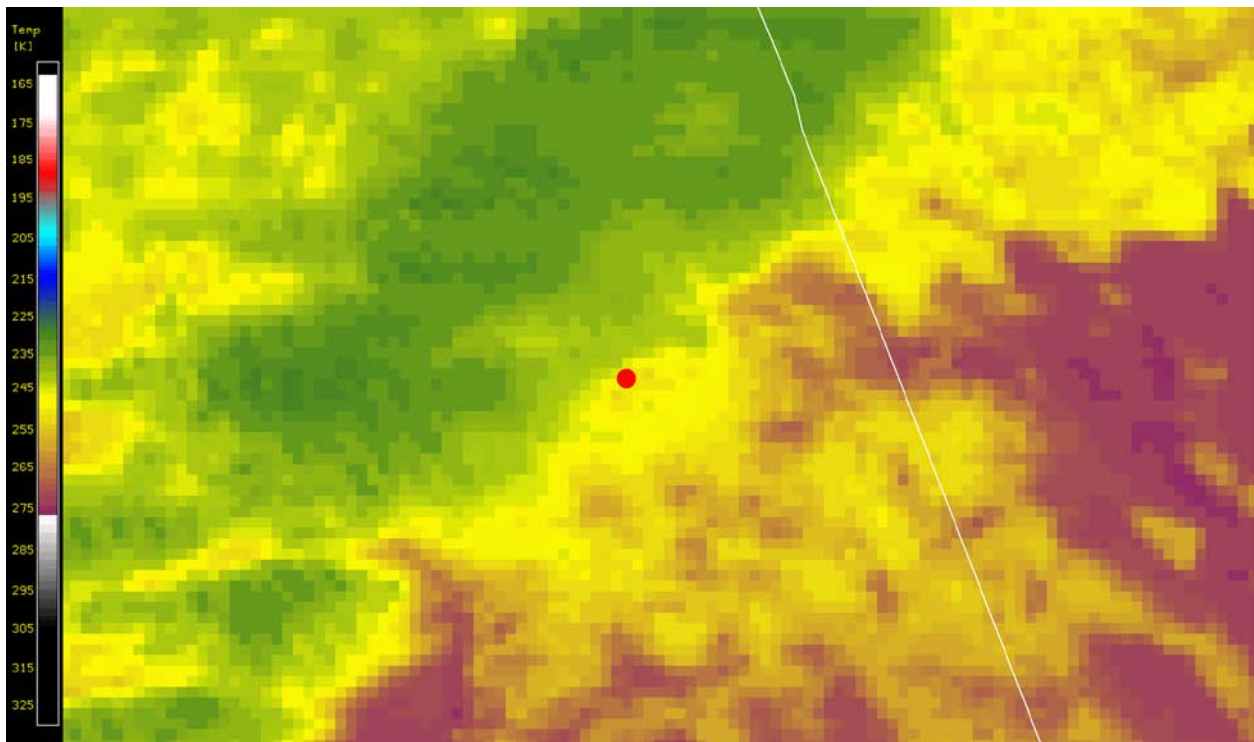
**Figure 6** – GOES-17 infrared imagery (brightness temperature in degrees Kelvin) from 1702 PST. Accident location denoted by red dot. This image has not been corrected for any parallax error.

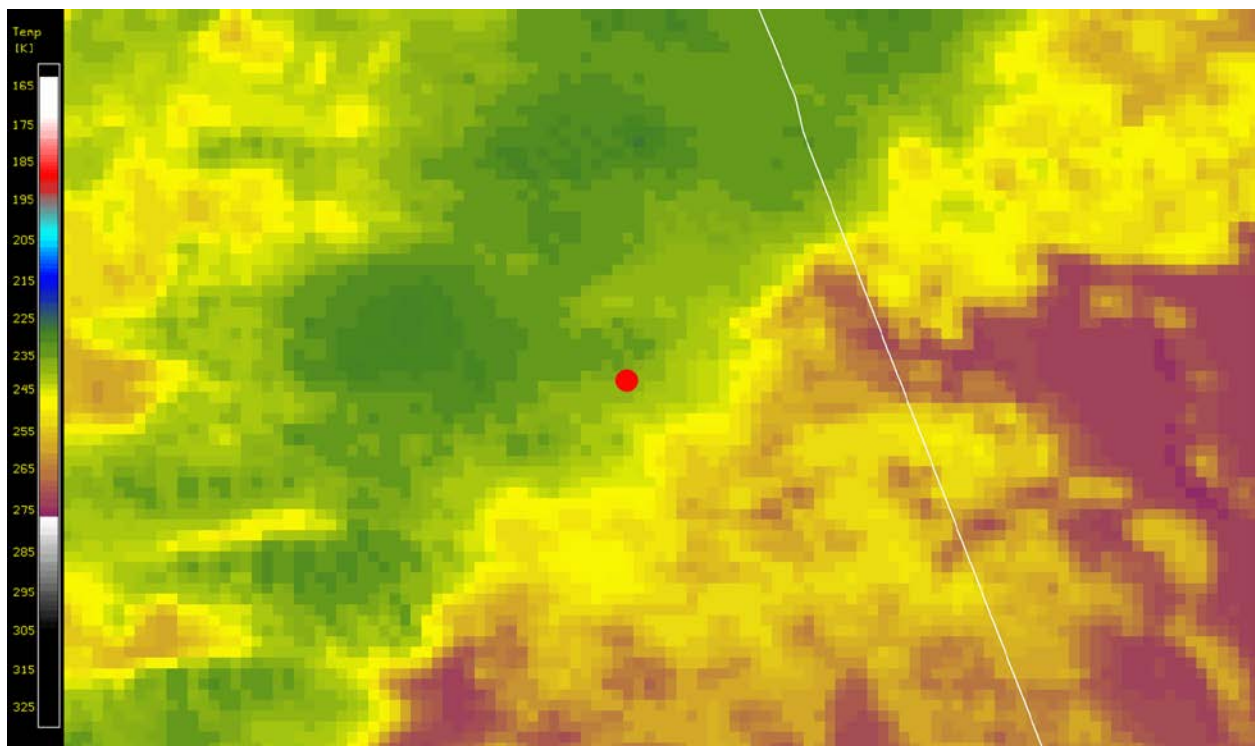
**Figure 7** – GOES-17 infrared imagery (brightness temperature in degrees Kelvin) from 1717 PST. Accident location denoted by red dot. This image has not been corrected for any parallax error.

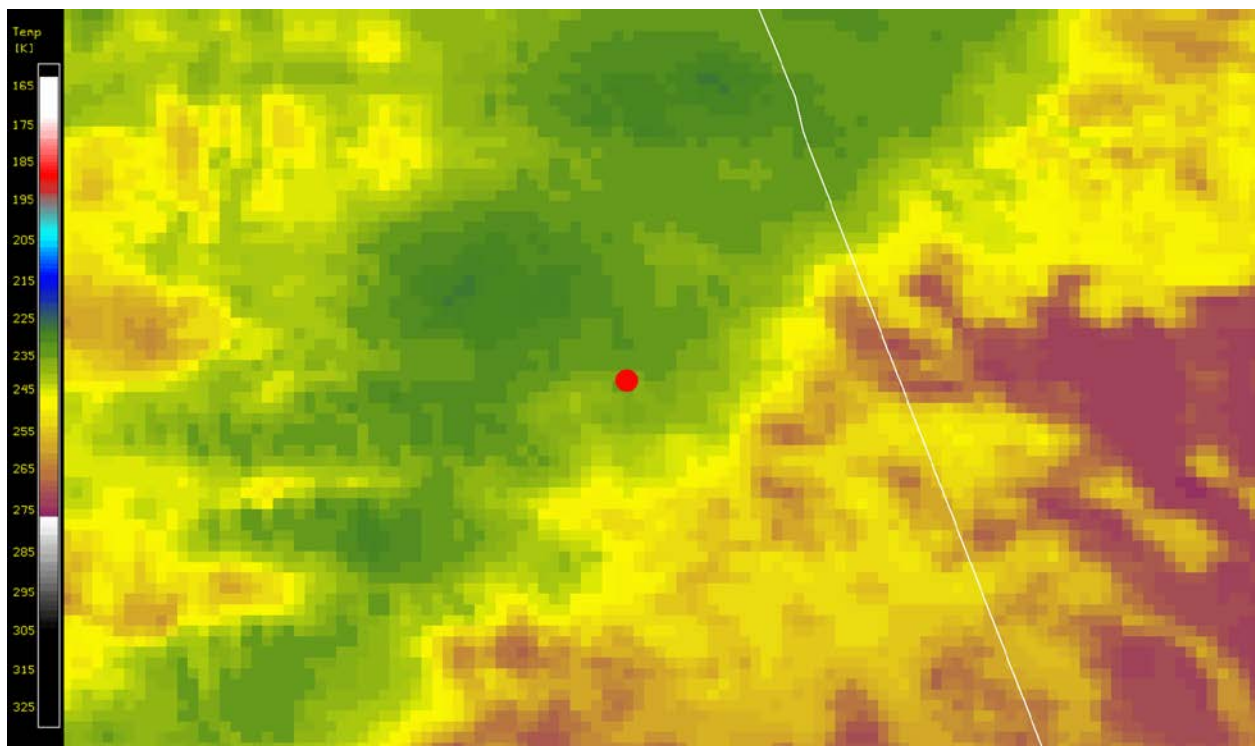
**Figure 8** – GOES-17 infrared imagery (brightness temperature in degrees Kelvin) from 1732 PST. Accident location denoted by red dot. This image has not been corrected for any parallax error.

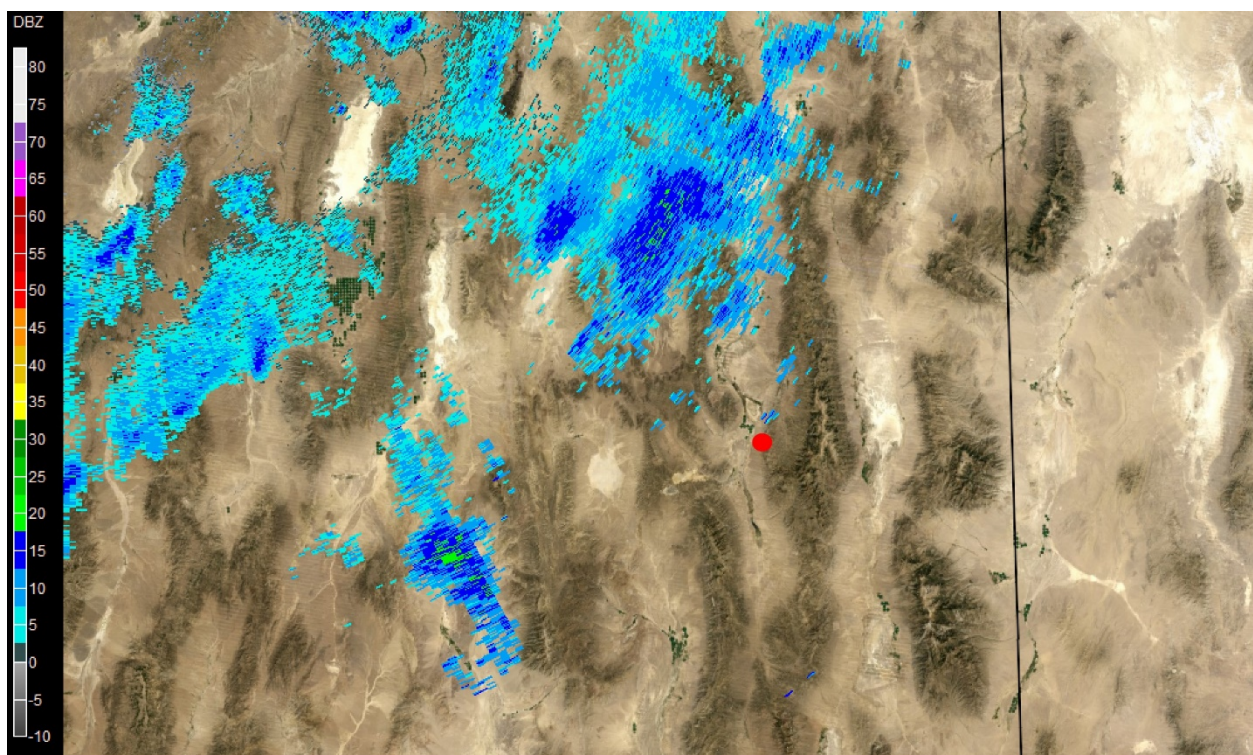
**Figure 9** – KLRX 0.483° Level-II reflectivity product from a sweep initiated at 1725:16 PST. Accident location marked by red circle.

The WSR-88D<sup>18</sup> Level-II weather radar imagery from the KLRX site is presented in figure 9. KLRX was located approximately 125 miles northwest of the accident location at an elevation of about 6,760 feet. Assuming standard refraction and considering the 0.95° beam width<sup>19</sup> for the WSR-88D radar beam, the KLRX 0.483° tilt would have “seen” altitudes above the accident location of between about 17,200 and 29,800 feet. Around the time of the accident, light values of reflectivity were seen to the north, northwest and west of the accident location.
