## RECORD OF CONVERSATION

**Date: March 31, 2022**  
**Person Contacted: Mr. Frank Motter (FAA Inspector)**  
**NTSB Accident Number: WPR20LA237**

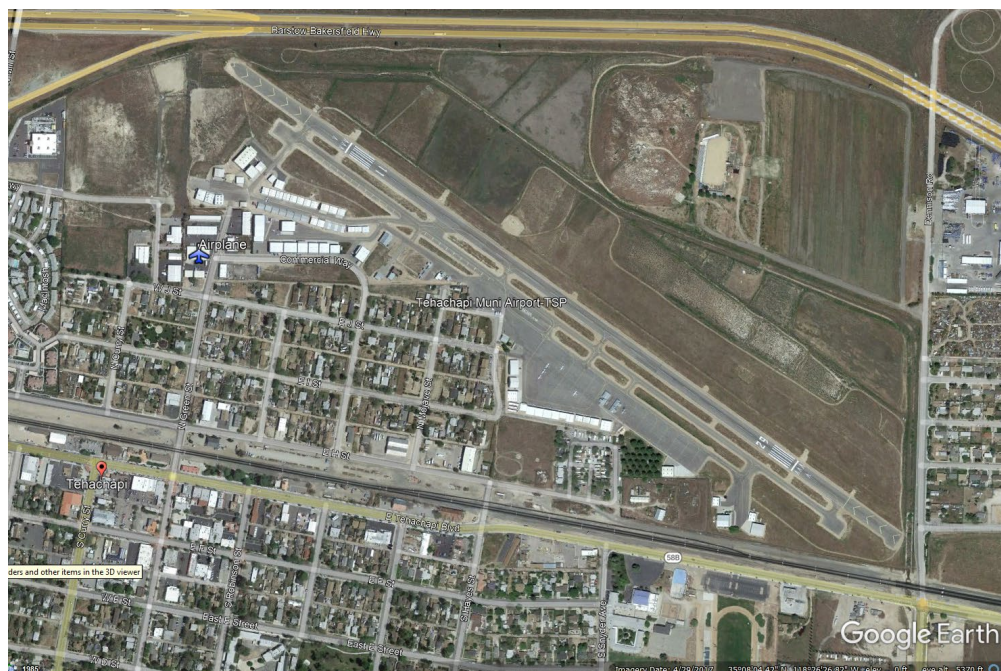
The airplane went through the roof of a building about 350 yards southwest of the runway. The airplane entered the roof, went through a wall, and came to rest on top of a second wall. The wings were bent aft; and the left wing was lower than the right. The aft fuselage and empennage extended upward and remained above the roofline. Mr. Motter provided the below map.

*Figure 1: Airplane in Relation to the Runway*
