## **NATIONAL TRANSPORTATION SAFETY BOARD**

### **Group Chairman's Factual Report**

# **OPERATIONAL FACTORS**

WPR21FA286

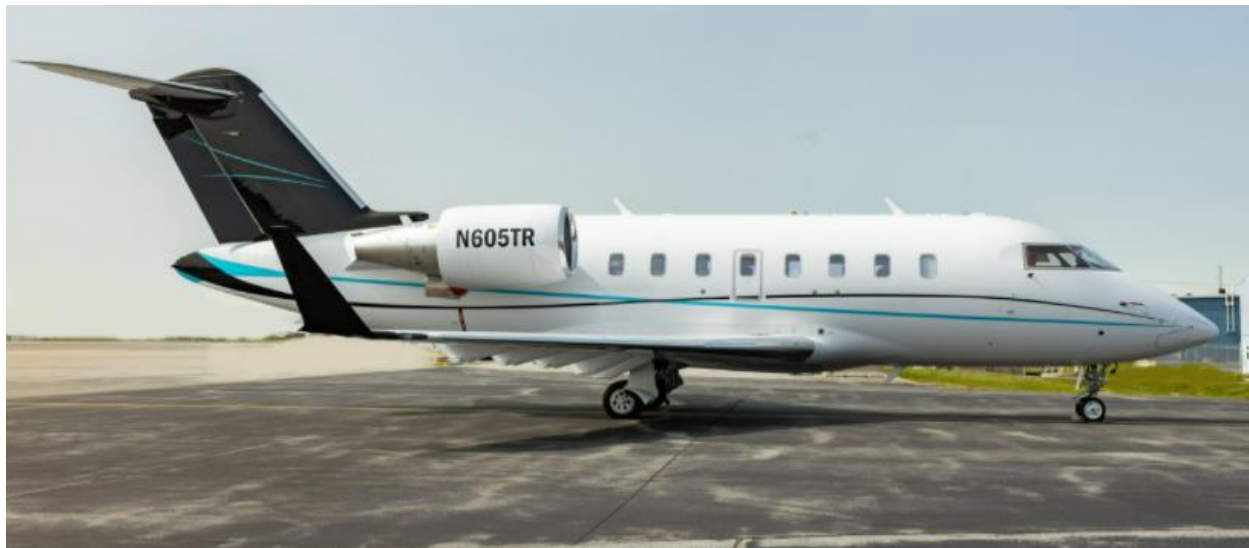
**Photo 1: Photo of accident airplane N605TR.**<sup>67</sup>

The accident airplane was a Challenger 605, registration N605TR and serial number 5715. It was a sweptwing, twin-engine monoplane, certified as a CL-600, model 2B16 airplane in accordance with 14 *CFR* Part 25, 14 *CFR* Part 36 and their amendments. FAA records did not list a manufacture date or engine manufacturer.<sup>68</sup> The registered owner was Tarco Aircraft Funding LLC in Fort Lauderdale, Florida. The airplane was designed for two crew members, with accommodation for up to 19 passengers.

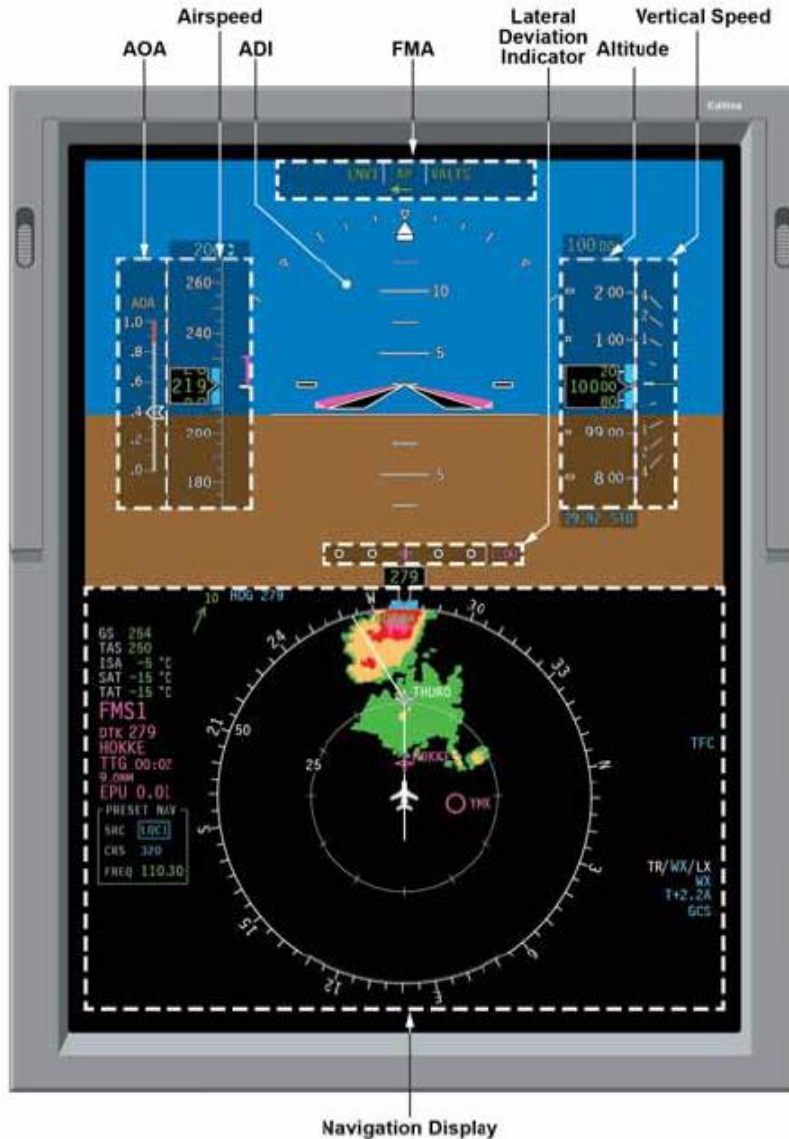
**Figure 16: CL-605 Primary Flight Display.<sup>110</sup>**

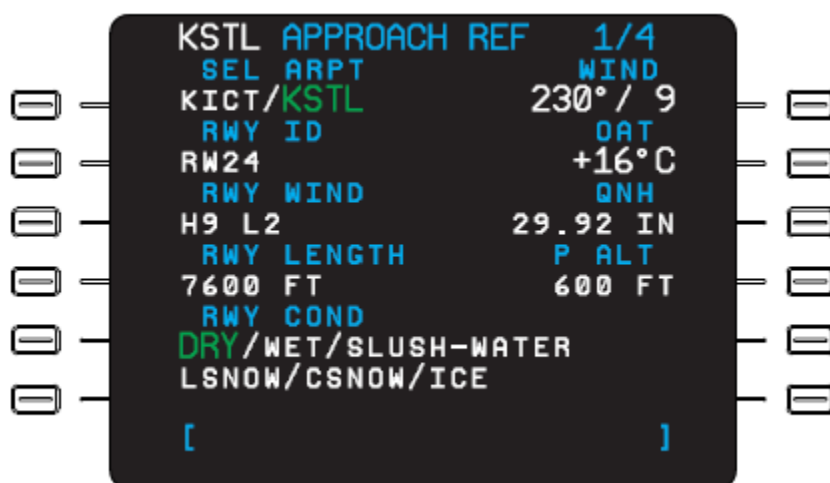
According to Rockwell Collins FMS v4.0 Flight Management System for the Challenger 605 Operator's Guide, the APPROACH REF page 1/4 showed the approach runway information and the ambient meteorological conditions used for determining approach V-speeds (VREF, VAC, VFTO). This information was also used to determine MLW and LFL. The information provided on the APPROACH REF pages was for the active flight plan only.

**Figure 23: FMS Control Display Unit (CDU) showing an example of APPROACH REF page 1/4.**<sup>119</sup>

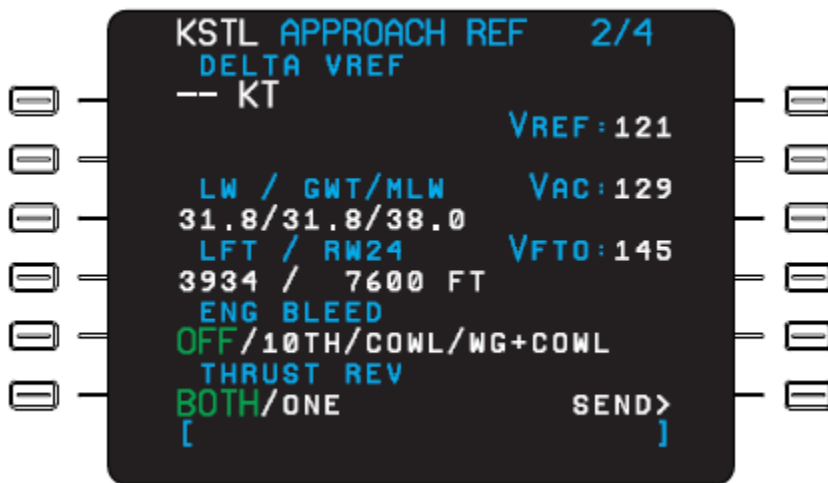
The APPROACH REF page 2/4 showed data fields for approach V-speeds, landing weight data, and landing runway length data. It also allowed for selection of the computed approach V-speeds for display on the PFD airspeed scale.

**Figure 24: FMS Control Display Unit (CDU) showing an example of APPROACH REF page 2/4.**<sup>120</sup>

The SEND line select key (LSK) on the APPROACH REF 2/4 page was used to transmit the APPROACH REF V-speeds to the PFD for display. When the SEND command was initiated, the status message IN PROGRESS showed above the SEND LSK. If the V-speed values were correctly transferred to the PFD, COMPLETE replaced IN PROGRESS as the status message.
