# NATIONAL TRANSPORTATION SAFETY BOARD

## MATERIALS LABORATORY FACTUAL REPORT

Report No. 21-071

Place : Los Angeles, California  
Date : November 6, 2020  
Vehicle : Agusta A109S, N109EX  
NTSB No. : WPR21LA039  
Investigator : Fabian Salazar (AS-WPR)

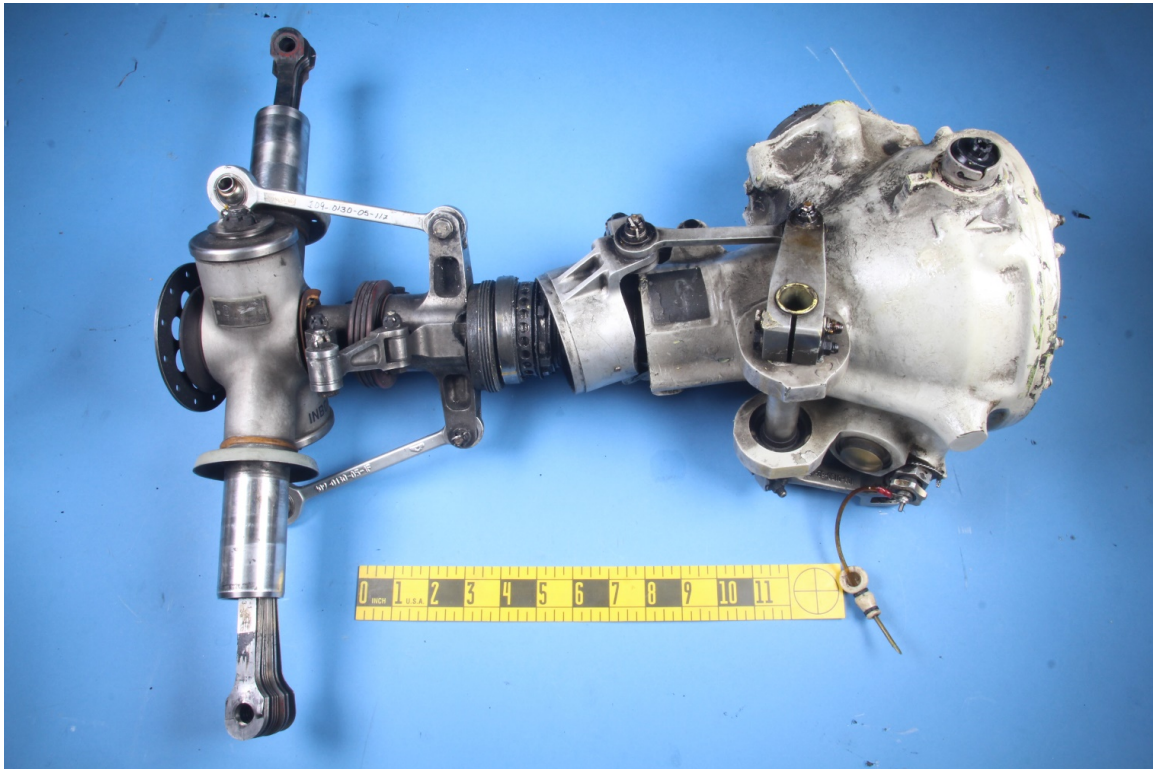
The tail rotor gearbox (TRGB) was submitted to the NTSB Materials Laboratory still assembled, but with the sleeve disengaged from the mating locking nut. Overall photos of the TRGB from opposite sides of the assembly are shown in Figures 1 and 8.

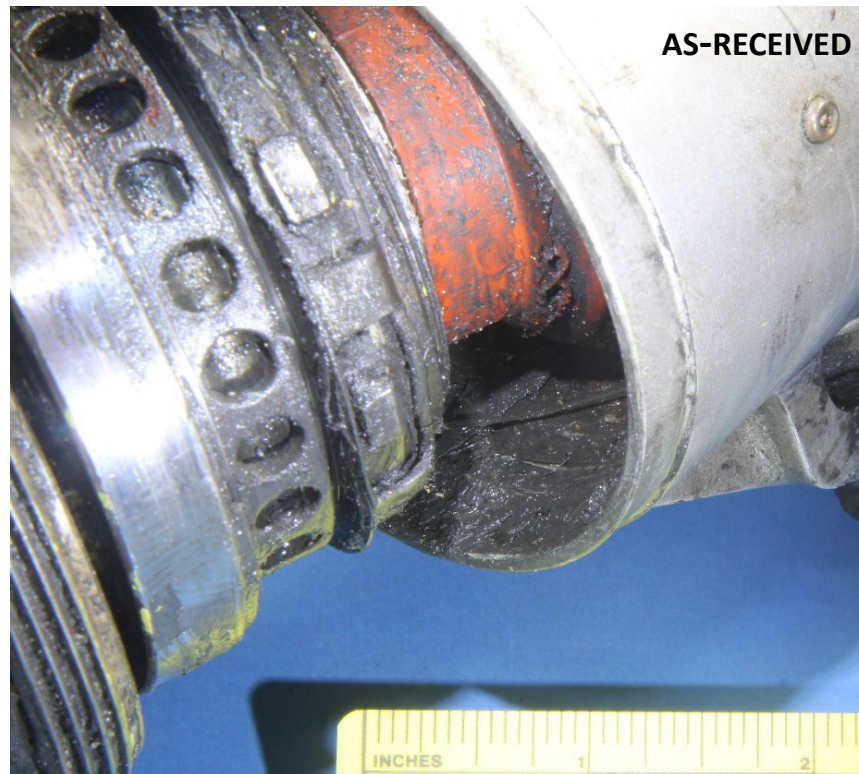
The visible portions of the components were examined for evidence of engagement and any damage noted was documented. No safety wire was observed attached to the holes in the locking nut or sleeve, as indicated by the yellow dotted circles in Figures 2 and 9. Yellow arrows in Figure 3 point to a snap ring installed outboard of the locking nut. The threads on the outer diameter (OD) of the locking nut (outlined by yellow dotted line in Figure 4) appeared intact. The threads on the inner diameter (ID) of the mating sleeve were caked with grease and not visible. A light wipe was performed in one area, circled by a yellow dotted line in Figure 5, and the revealed threads appeared intact.

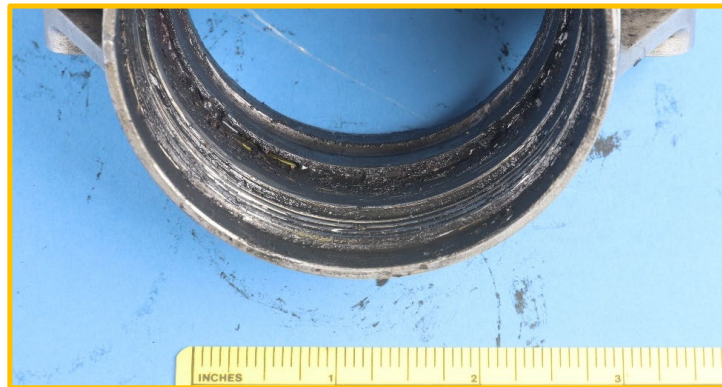
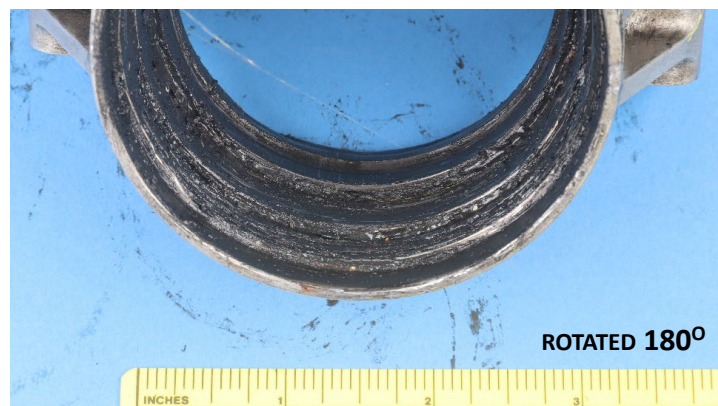
Primer paint was visible on the ID thread surfaces of the sleeve (red arrows, Figures 14 and 15). Primer paint was allowable on the threads per manufacturer specifications. Damage was observed on the crests of the ID threads on the sleeve, as indicated by the black arrows in Figures 14 and 15. The spacing of the damage was compared to the spacing of the balls in the adjacent ball bearing but did not match. Deformation was observed around both lock wire holes of the sleeve (black arrows, Figure 16). Damage was visible along the edge of the sleeve adjacent to the holes (red arrows, Figure 16).
