# National Transportation Safety Board

WPR22FA172

## **AIR TRAFFIC CONTROL**

Group Chair's Factual Report

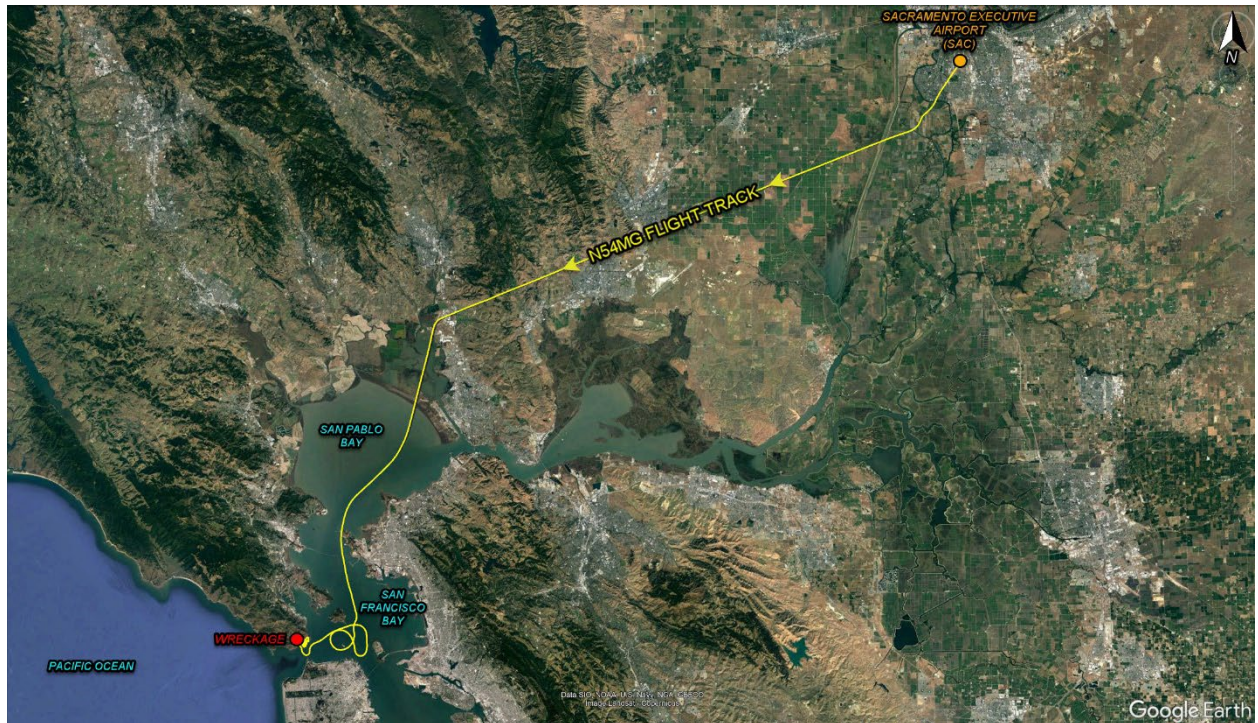
**Figure 1.** Overhead view of accident flight track overlaid in onto satellite imagery.

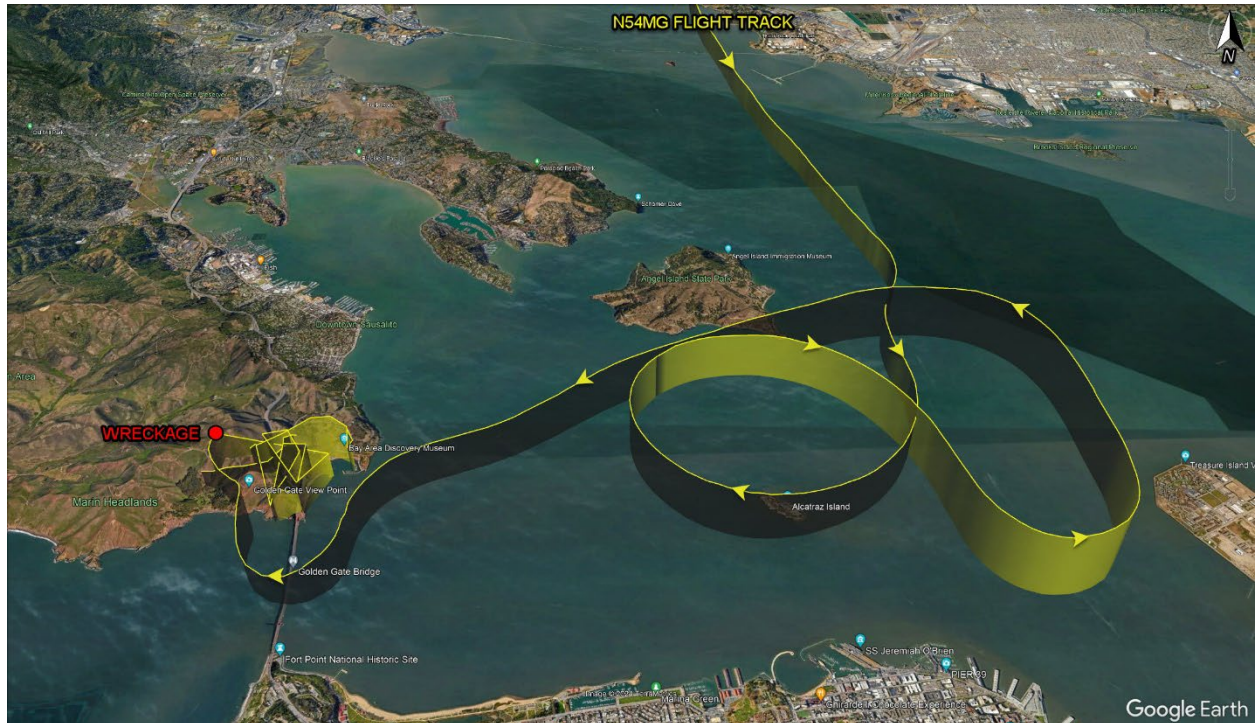
**Figure 2.** Profile view of final segment of the accident flight overlaid onto satellite imagery.

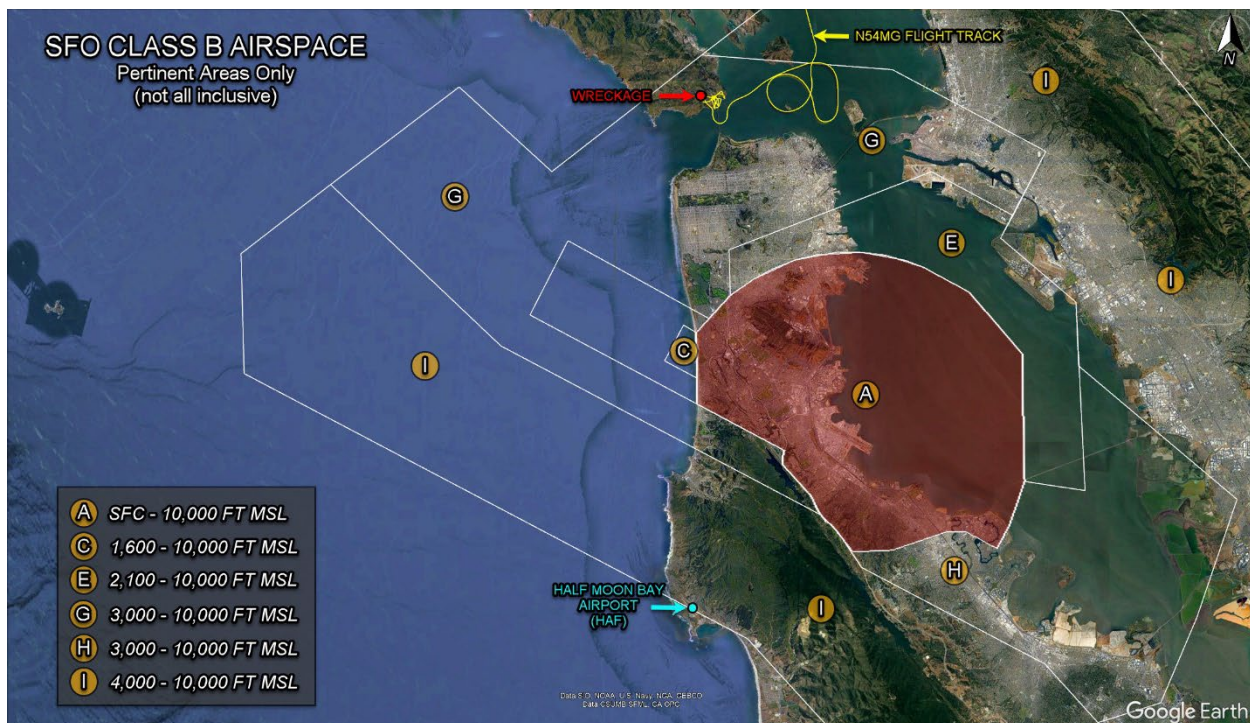
**Figure 3.** Overhead view of final segment of accident flight with pertinent SFO Class B airspace areas depicted with their corresponding altitudes.

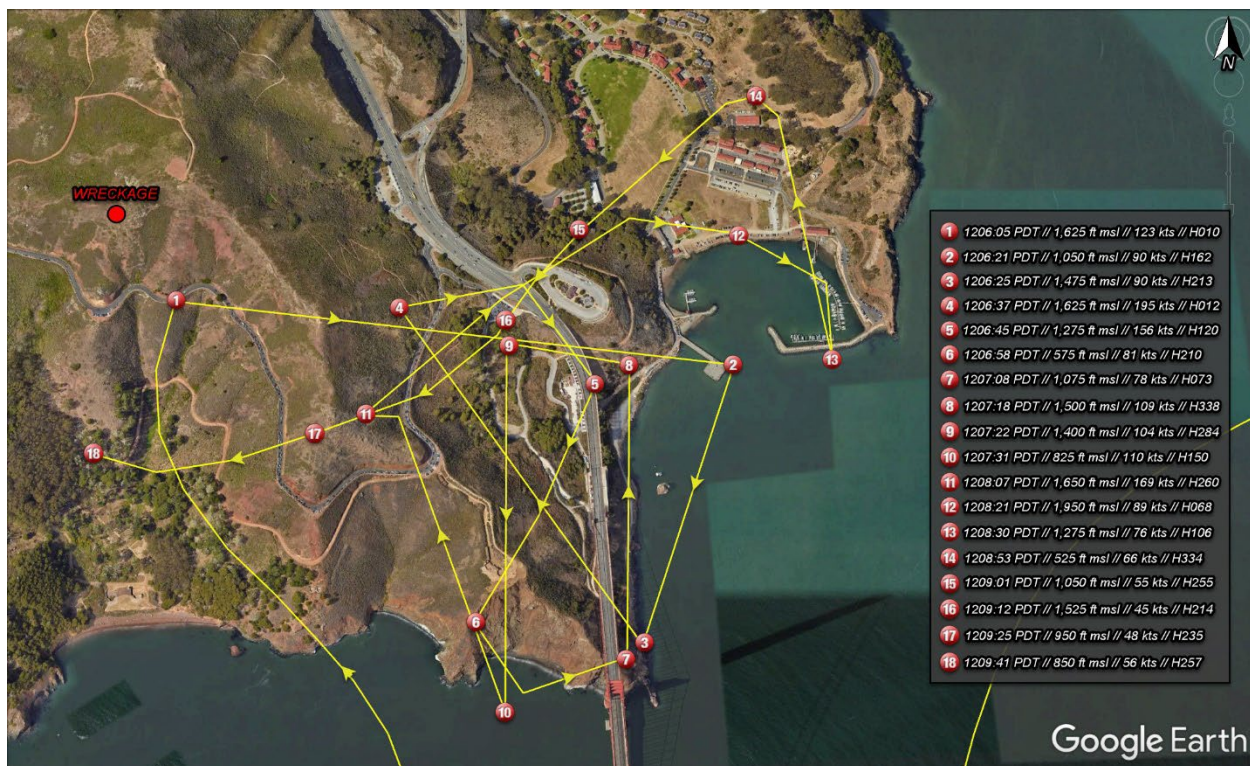
**Figure 4.** Overhead view of final segment of the accident flight overlaid onto satellite imagery with time, altitude, ground speed, and heading information.
