# R44 Cadet Weight and Balance

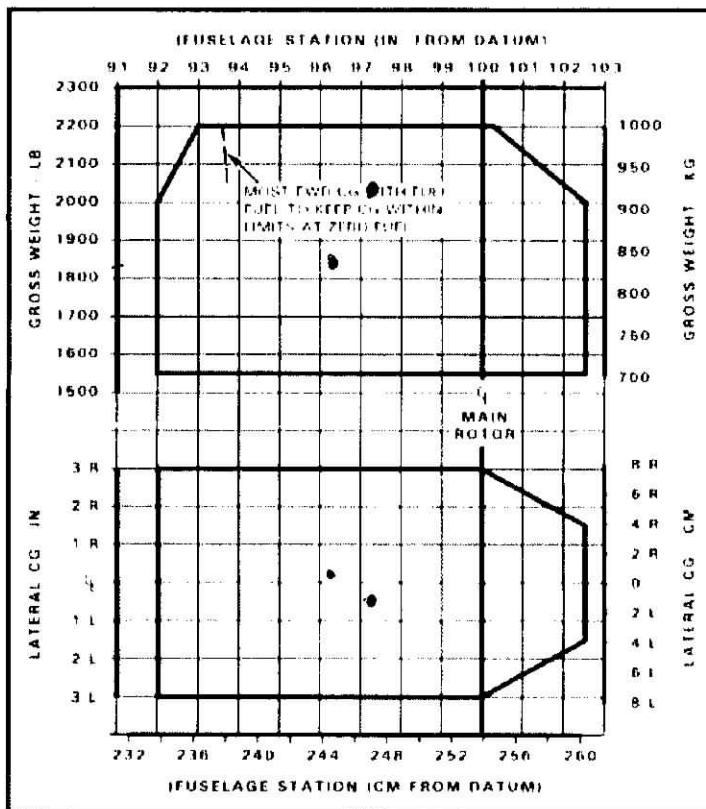
| Max Enroute Altitude (MEA) DA | 9610 |
| Highest Landing Elevation (HLE) DA | 8110 |
| Highest Landing Elevation (HLE) PA | 6310 |
| IGE | 9100 |
| OGE | 6200 |

During time of off airport

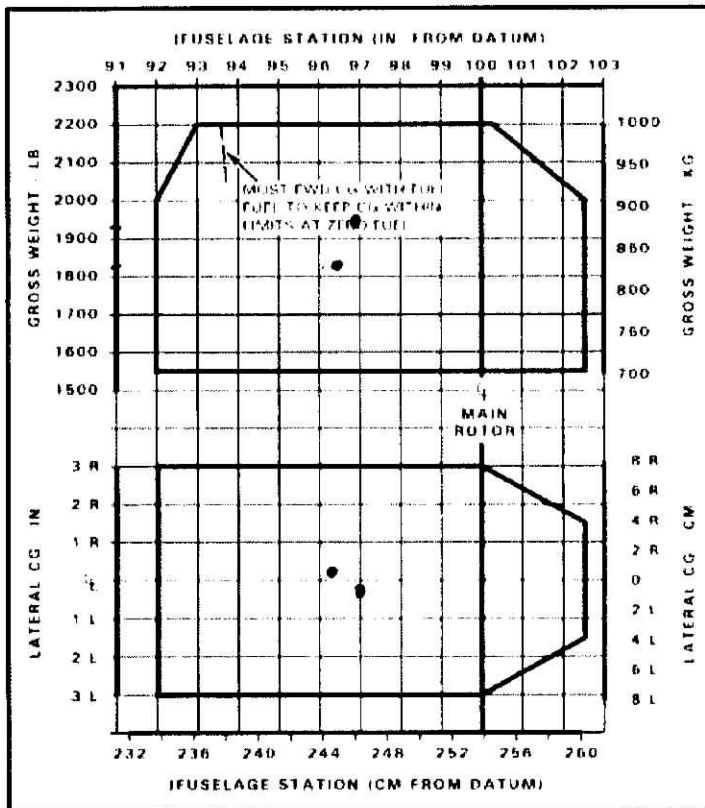
| Max Enroute Altitude (MEA) DA | 9390 |
| Highest Landing Elevation (HLE) DA | 7890 |
| Highest Landing Elevation (HLE) PA | 6330 |
| IGE | 9300 |
| OGE | 7,500 |

During time of off airport

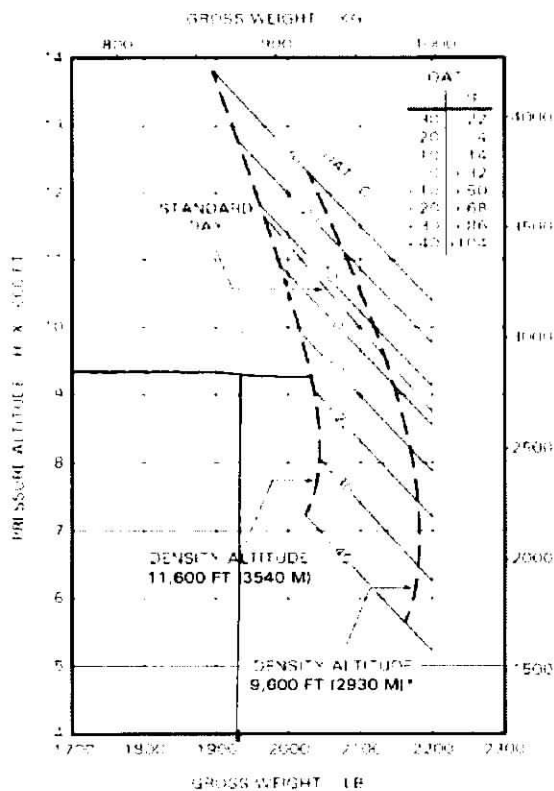
IN GROUND EFFECT AT 2 FEET SKID HEIGHT  
FULL THROTTLE  
ZERO WIND

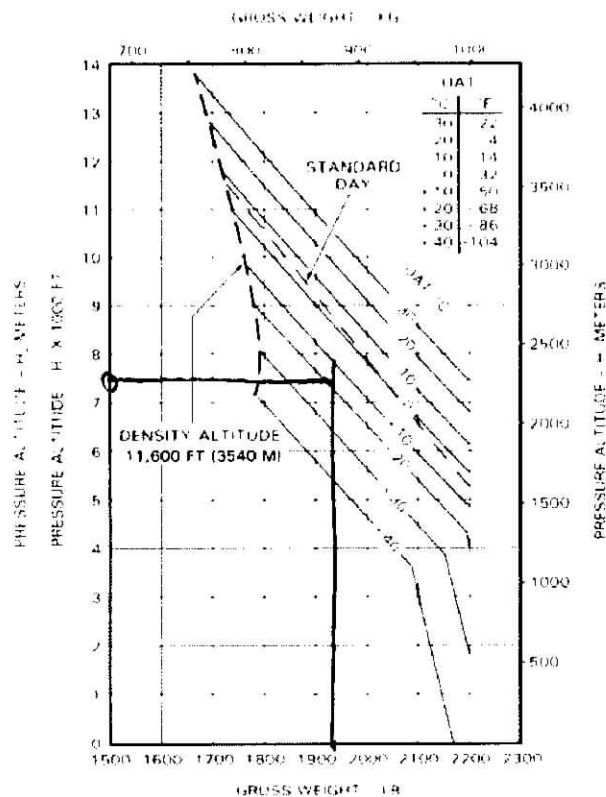
OUT OF GROUND EFFECT  
TAKEOFF POWER OR FULL THROTTLE  
ZERO WIND

OGE: 7,500

1/4 carb Heat: - 600 → 6900 OGE

School SOP: - 500 → 6400 OGE
