## ANC15FA071- Wreckage diagrams

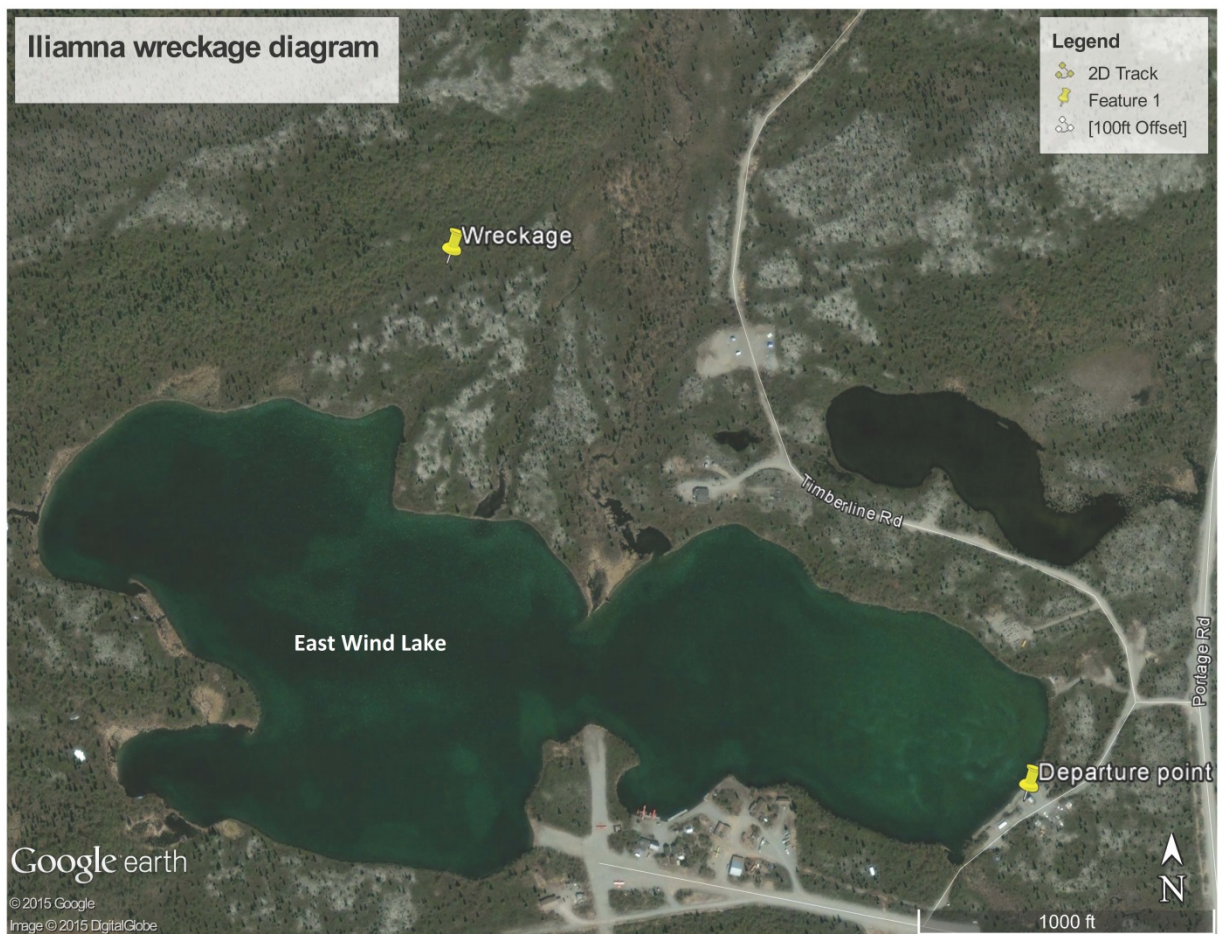
Figure 1: Google Earth image of departure point and wreckage.

The Safety Board investigator-in-charge performed an on scene wreckage documentation and initial examination on September 16, 2015. The main fuselage was located at 59.777778N -154.917778W, about 510 feet from the shore of East Wind Lake, on a magnetic heading of approximately 020 degrees.

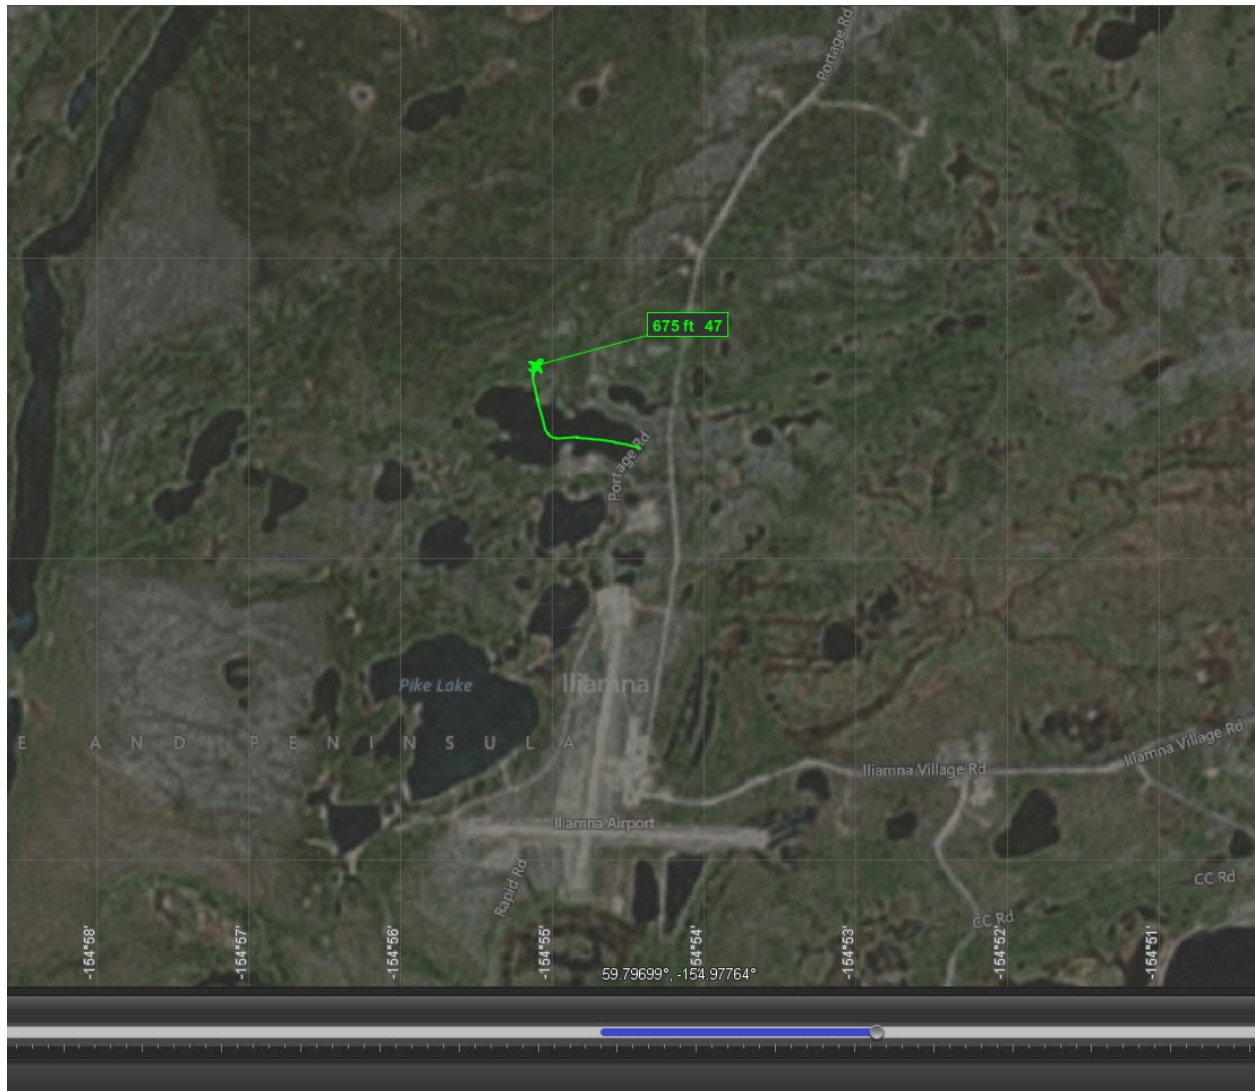
Figure 2: ADS-B flight track
