# NATIONAL TRANSPORTATION SAFETY BOARD

## Portable Electronic Device (PED)

### Specialist's Factual Report By Sean Payne

Location: Willow, Alaska  
Date: July 18, 2018  
Aircraft: De Havilland DHC-2  
Registration: N9878R  
Operator: Alaska Skyways, Inc.  
NTSB Number: ANC18FA055

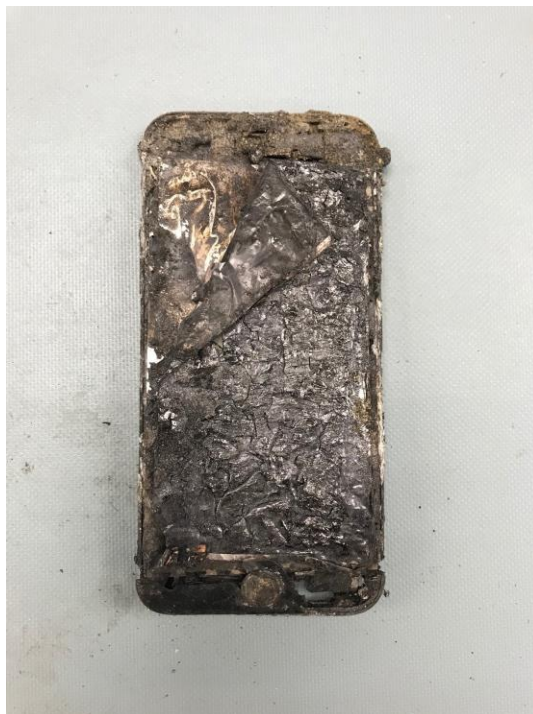
Upon arrival at the Vehicle Recorder Laboratory, an examination revealed the unit had sustained significant heat damage. The extent of the damage is shown in figure 1.

**Figure 1. Photo of damaged unit as received by the NTSB lab.**

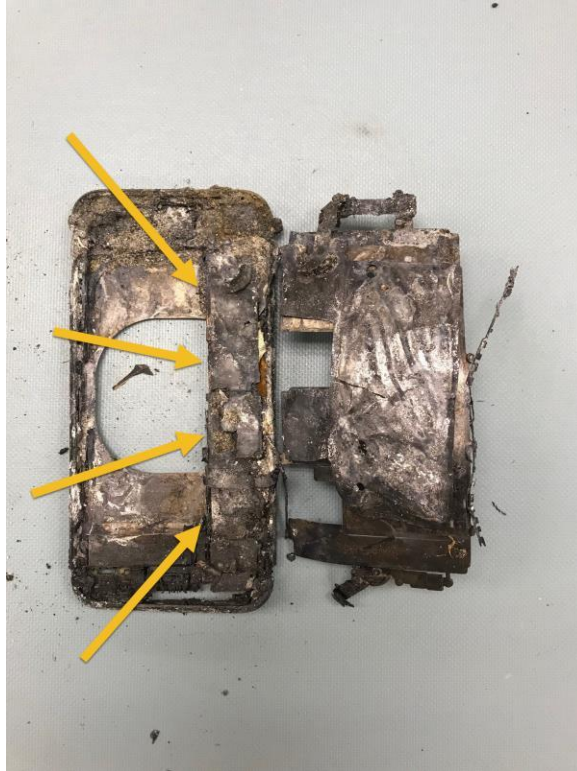
The device was opened (screen removed) and the internal components of the board were examined. The main board was destroyed by fire. For this device, there is no method to recover data from non-volatile memory<sup>1</sup> (NVM) components when removed from the main board. Furthermore, the extent of the heat damage to the NVM components would have precluded any possibility of data recover from an individual chip.

**Figure 2.** The device during internal examination. The region occupied by the main board is indicated by yellow arrows.

This device is capable of storing data in the non-volatile memory (NVM). The extent of the damage precluded normal recovery procedures and additional attempts were unsuccessful in yielding usable data. Therefore, no data pertinent to the event were recovered.
