# National Transportation Safety Board

ANC23FA074

## **GLOBAL POSITIONING SYSTEM DEVICE**

Location: St. Mary's, Alaska  
Date: September 12, 2023  
Time: 2047 Alaska daylight time (AKDT)  
Airplane: Piper PA-18-150, Neitz Aviation Inc., N109T

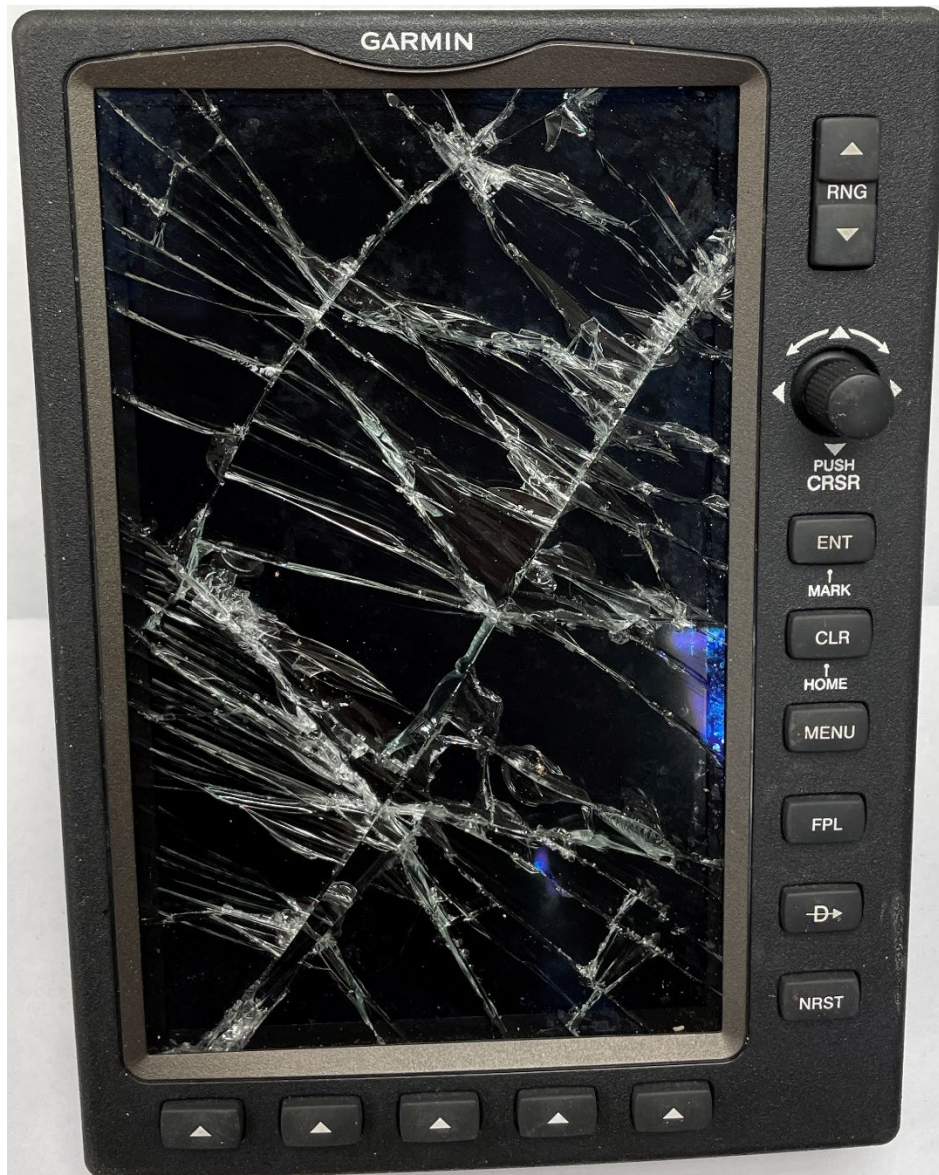
Upon arrival at the Vehicle Recorder Laboratory, an exterior examination revealed the unit had sustained impact damage, as shown in figure 1. The device was able to power on, and the data were downloaded normally using the manufacturer's procedure.

**Figure 1.** Garmin GPSMAP 696 as received by the Vehicle Recorder's Lab.

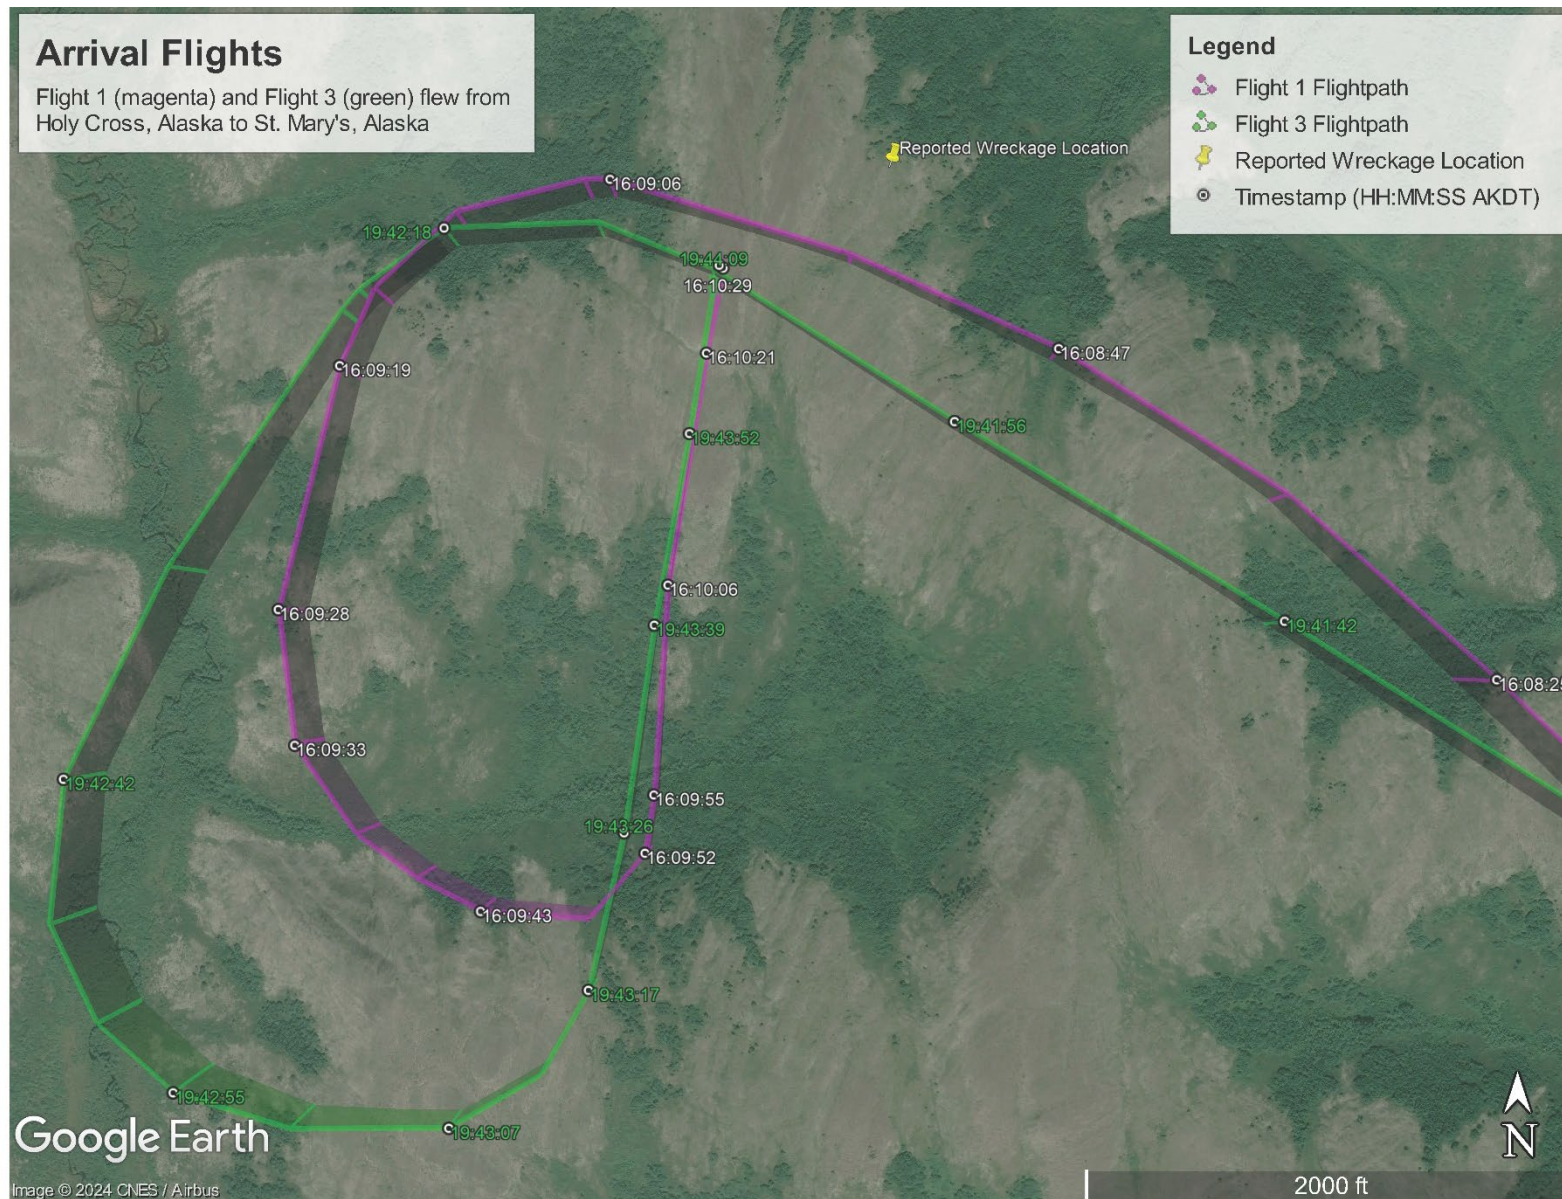
- Flight 1 was from Holy Cross to St. Mary's, and the Garmin GPSMAP 696 device recorded from 15:08:44 AKDT to 16:11:49 AKDT. The arrival of this flight is displayed in figure 2 as the magenta line.
- Flight 2 was from St. Mary's to Holy Cross, and the Garmin GPSMAP 696 device recorded from 16:58:02 AKDT to 17:57:46 AKDT. The departure of this flight is displayed in figure 3 as the blue line.

- Flight 3 was from Holy Cross to St. Mary's, and the Garmin GPSMAP 696 device recorded from 18:48:25 AKDT to 19:45:31 AKDT. The arrival of this flight is displayed in figure 2 as the green line.
- Flight 4 was the accident flight departing St. Mary's, and the Garmin GPSMAP 696 device recorded from 20:43:08 AKDT to 20:45:36 AKDT. The departure of this flight is displayed in figure 3 as the yellow line.

**Figure 2.** Google Earth overlay of the arrival flights (1 and 3) into St. Mary's.

Data obtained from the Garmin GPSMAP 696 was used to produce the following overlays and tabular data. Figures 2 and 3 are graphical overlays generated using Google Earth for the departing and arrival flights that day to and from Holy Cross and St. Mary's, respectively. The weather and lighting conditions in Google Earth are not necessarily the weather and lighting conditions present at the time of the recording.

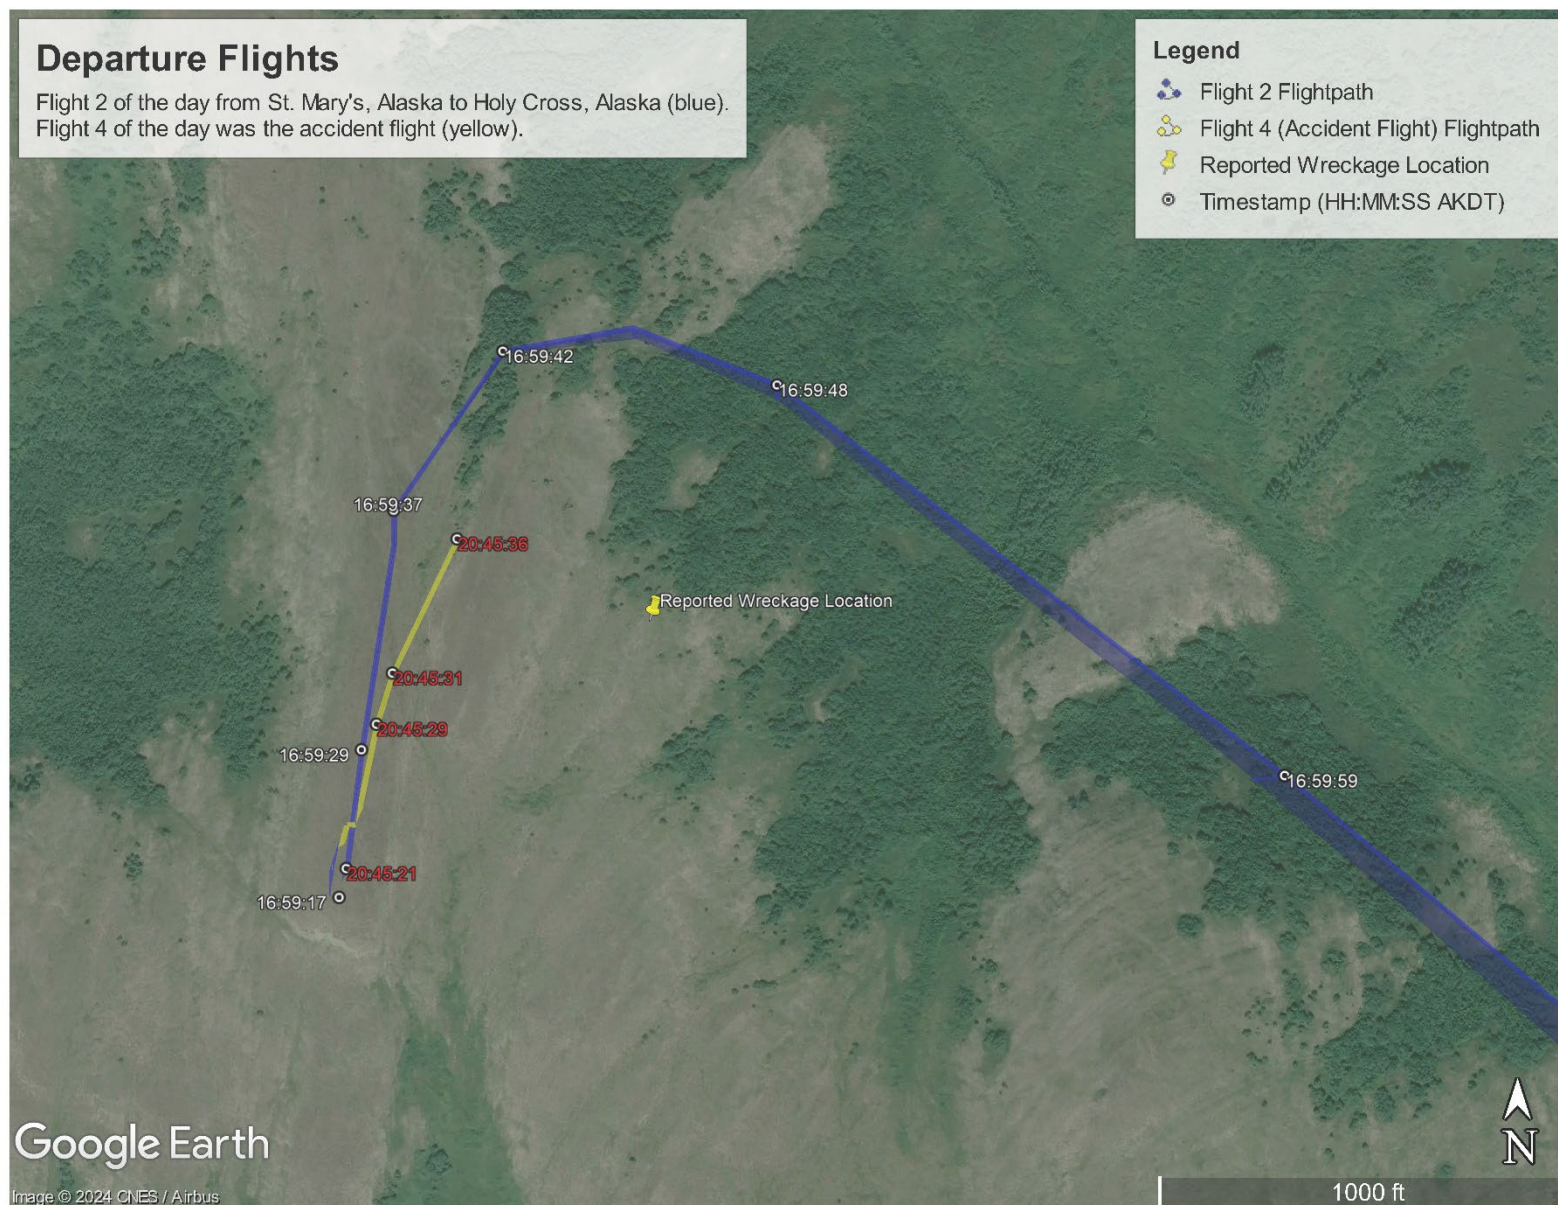
**Figure 3.** Google Earth overlay of the departure flights (2 and 4) from St. Mary's.
