# NATIONAL TRANSPORTATION SAFETY BOARD

## MATERIALS LABORATORY FACTUAL REPORT

Report No. 13-042

Place : Oak Grove, Louisiana  
Date : November 19, 2012  
Vehicle : Quicksilver GT400  
NTSB No. : CEN13LA063  
Investigator : Craig Hatch  
NTSB-CEN

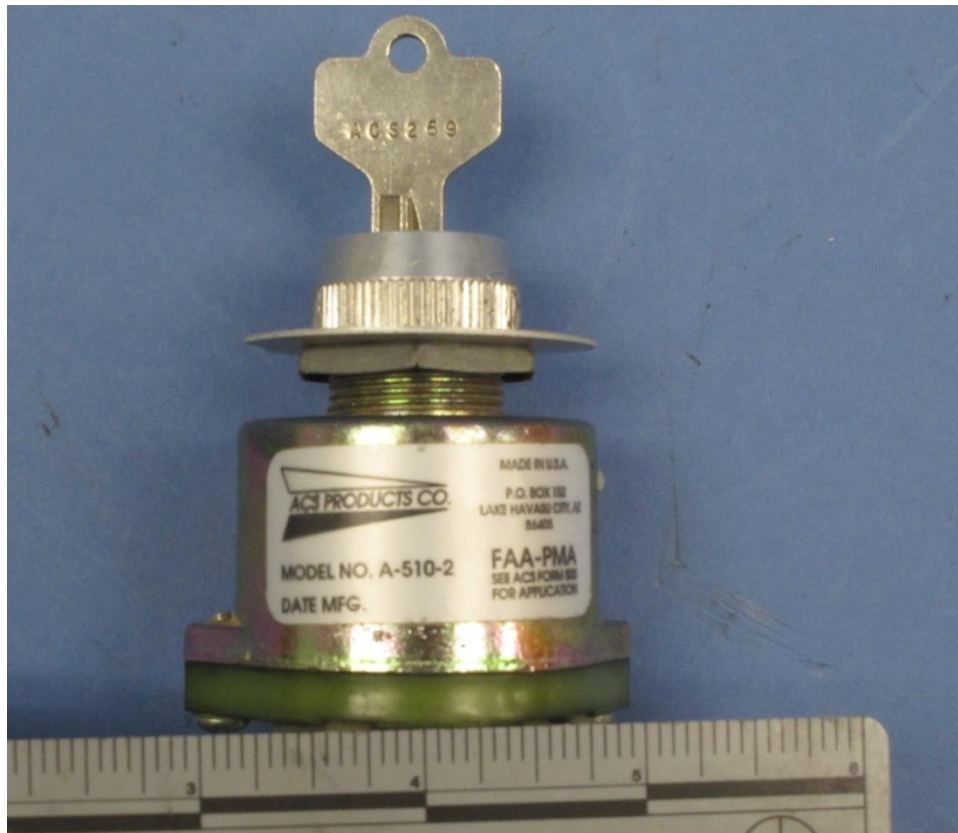
The ignition switch, as shown in Figure 1, was submitted to the Materials Laboratory for examination. The ignition switch was submitted to determine if an internal failure in the switch was allowing current to flow back into the key when the key was inserted. During the engine test for the accident aircraft, an inspector stated that he had received a shock from the key when the key was inserted and turned within the ignition switch.

**Figure 1. Overall photograph of ignition switch.**

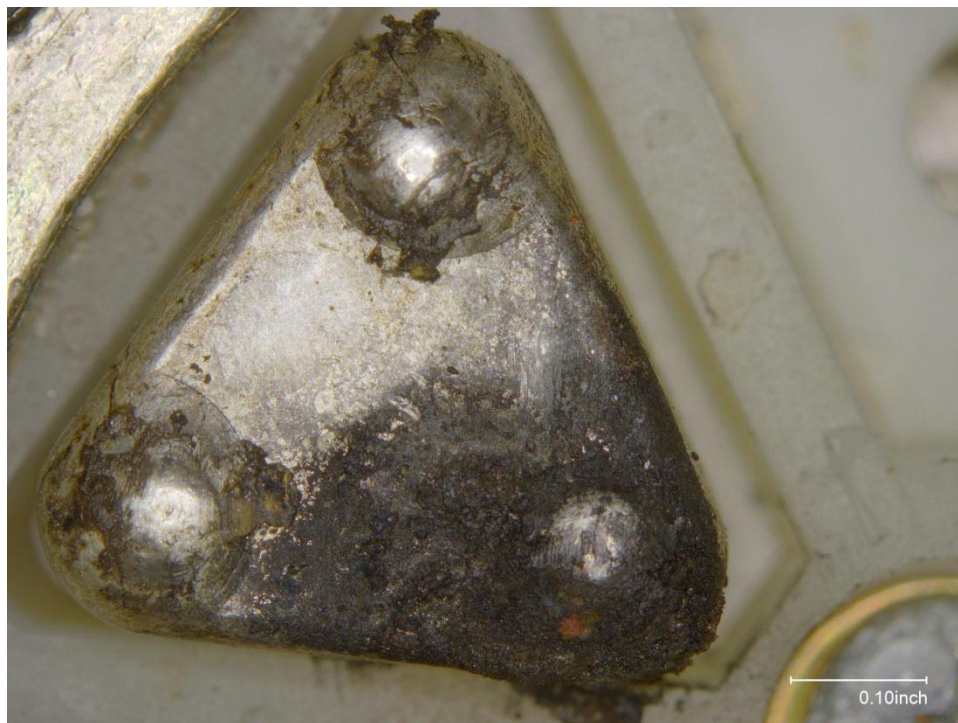
The ignition switch was disassembled. Photographs of the internal contacts are shown in Figure 2. The interior of the switch including large areas of the contact surfaces were coated with a black, slightly oily residue. A sample of this residue was removed from the contact for examination. The residue sample was examined using a Fourier Transform Infrared (FTIR) micro-spectrometer with a germanium attenuated

total reflectance (ATR) accessory<sup>1</sup> in accordance to ASTM E1252-98 and ASTM E334-01<sup>2</sup>. The spectrometer was used to collect and process infrared wavelength absorbance spectrum of the sample<sup>3</sup>. The resulting spectrum for the unknown residue had two significant peak patterns. A carbon-hydrogen bonding doublet peak was located between  $\sim 3000\text{-}2800\text{ cm}^{-1}$  indicating the presence of an aliphatic hydrocarbon and a broad negative peak located between  $\sim 2200\text{-}2000\text{ cm}^{-1}$  indicating of the presence of elemental carbon which absorbs infrared energy. The spectrum of the unknown residue was consistent with a lubricant containing a graphite thickener and a straight chained hydrocarbon base.

**Figure 2. Photograph of residue on contact surface.**
