# NATIONAL TRANSPORTATION SAFETY BOARD

## GPS Factual Report

Location: Delta, Colorado  
Date: November 29, 2013  
Aircraft: Cessna 182  
Registration: N3087Y  
Operator: Private  
NTSB Number: CEN14FA071

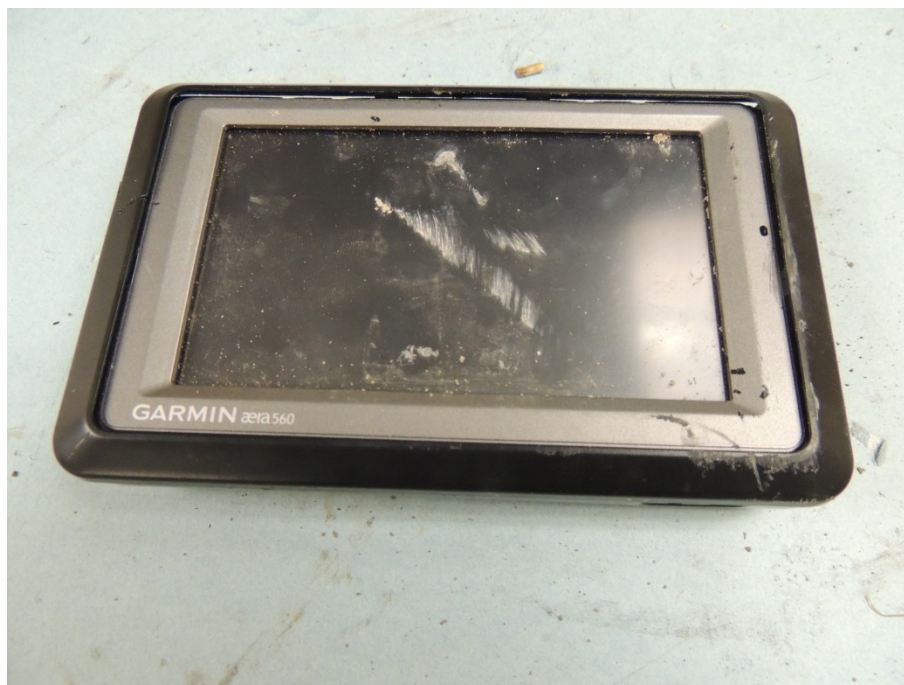
Upon arrival at the Vehicle Recorder Laboratory, an exterior examination revealed the unit sustained minor impact damage to the casing (figure 1). An internal inspection was performed and revealed the unit's integrated circuit board remained intact. The unit was powered on and the memory was downloaded using the manufacturer's recommended procedure.

**Figure 1. Photo of Garmin Aera 560 as received.**

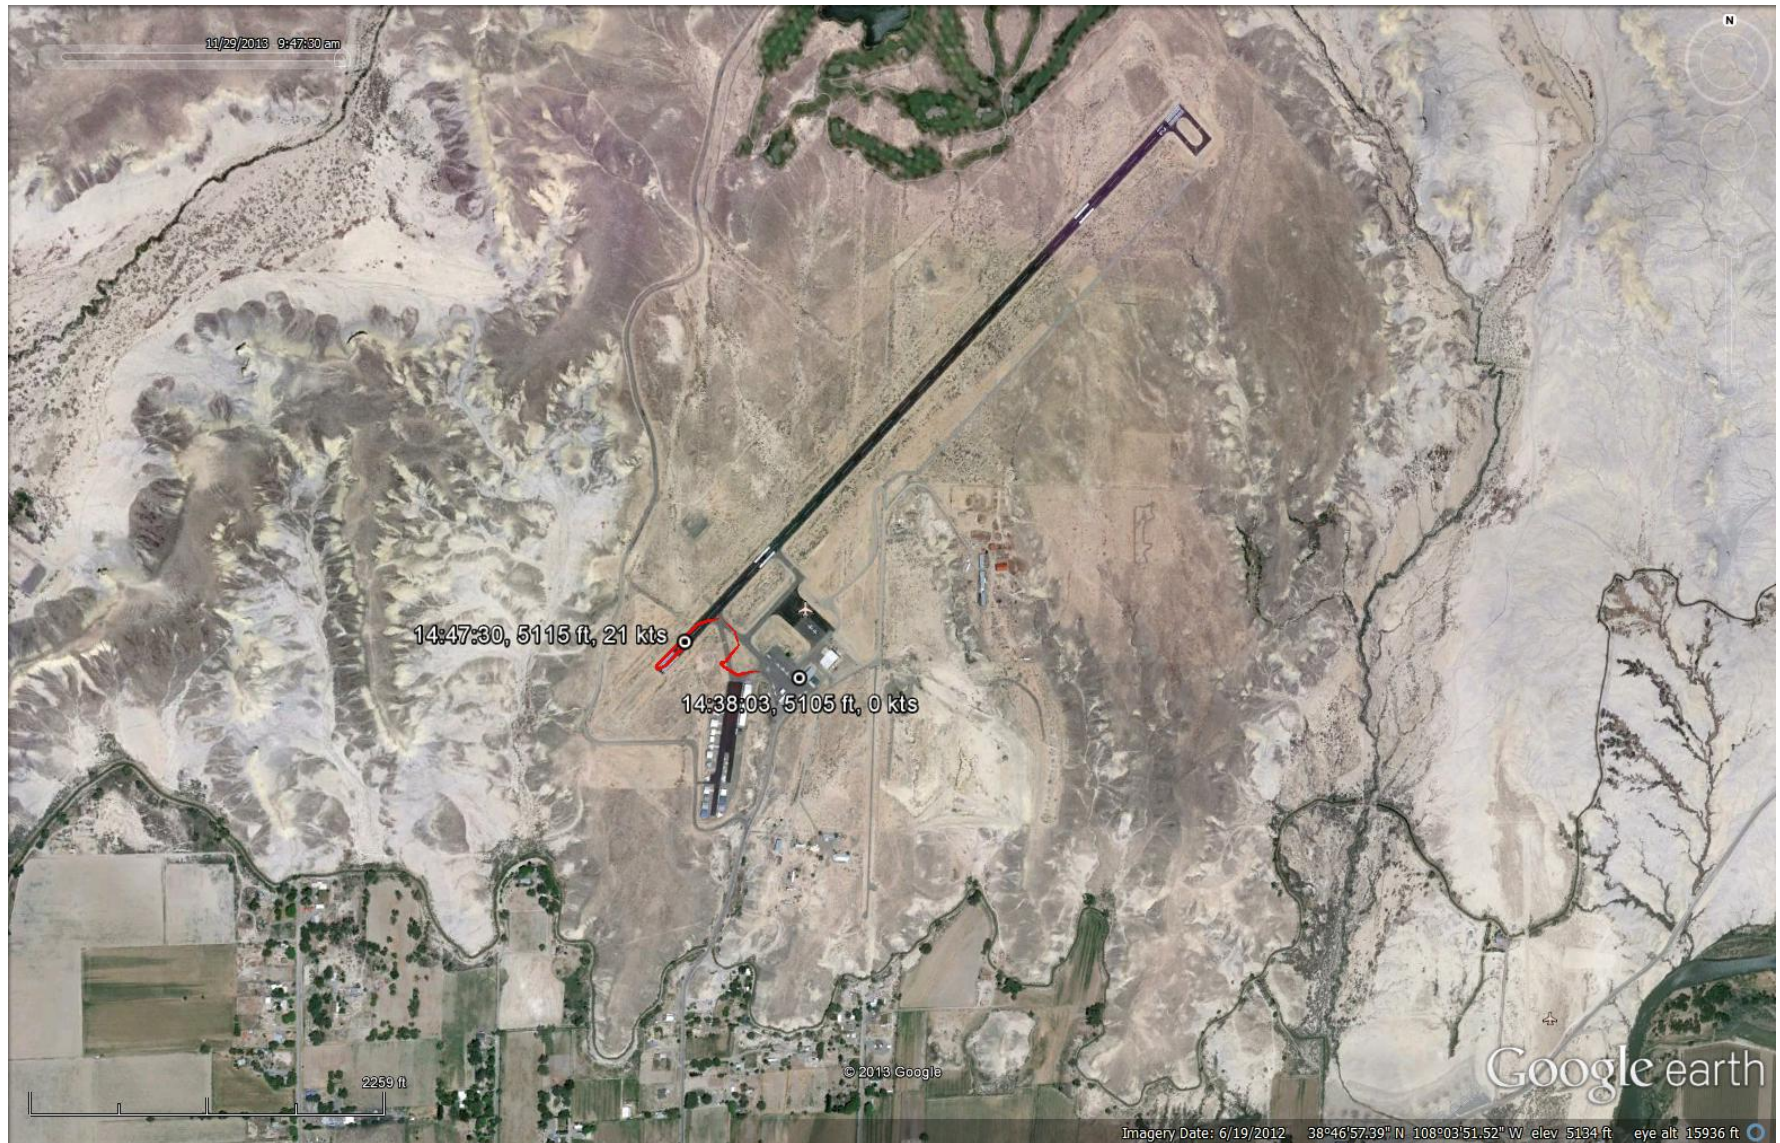
Figure 2 is a Google Earth top view overlay of the entire accident event. The first and last recorded data points are shown at 14:38:03 and 14:47:30 UTC respectively. The track shows the aircraft taxiing and taking off on runway 3 before the recording ends. The last recorded data point shows a groundspeed of 21 knots.

Figure 2. Overlay of accident event.

Tabular data used to generate figures 2 is included as Attachment 1. This attachment is provided in electronic comma-delimited (\*.CSV) format.
