**NATIONAL TRANSPORTATION SAFETY BOARD**  
Vehicle Recorder Division  
Washington, D.C. 20594

## **Electronic Devices Factual Report**

### **1. EVENT SUMMARY**

Location: Steamboat Springs, Colorado  
Date: August 9, 2014  
Aircraft: Piper PA 28R-201  
Registration: N3509M  
Operator: Journeys Aviation Flying Club  
NTSB Number: CEN14FA414

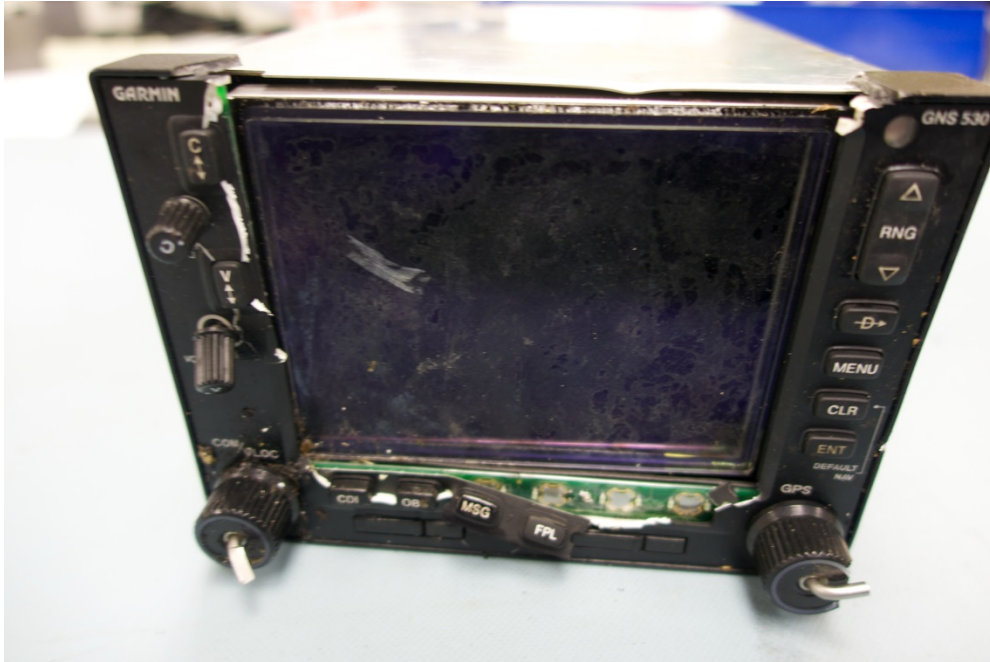
Upon arrival at the NTSB Vehicle Recorder Laboratory, an exterior examination revealed the unit received noticeable impact damage (figure 1). External power applied resulted in no response by the unit. No data was recovered from the device.

**Figure 1. Front face of Garmin GNS 530 as received.**

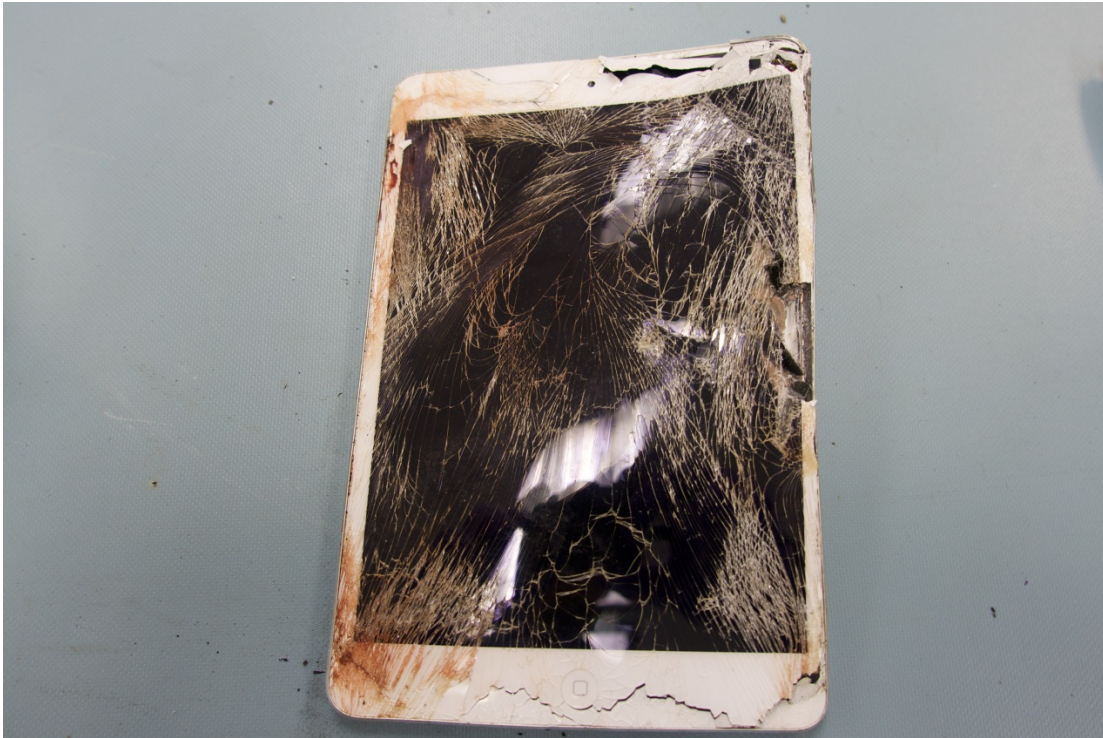
Upon arrival at the NTSB Vehicle Recorder Laboratory, an exterior examination revealed the device received heavy impact damage with a cracked and shattered screen (figure 2). An interior inspection revealed debris on the circuit board containing the non-volatile memory (NVM).

**Figure 2. Front face of iPad mini as received.**

The circuit board was removed and cleaned of biohazard by abrasively applying a mixture of filtrated water and ethanol. The circuit board was then placed in a vacuum oven to remove excess moisture at a temperature of 176 degrees Fahrenheit for 4 hours.

The cleaned circuit board was placed in a surrogate iPad mini. Several attempts to power the surrogate unit with the accident circuit board were unsuccessful. No data was recovered from the device.

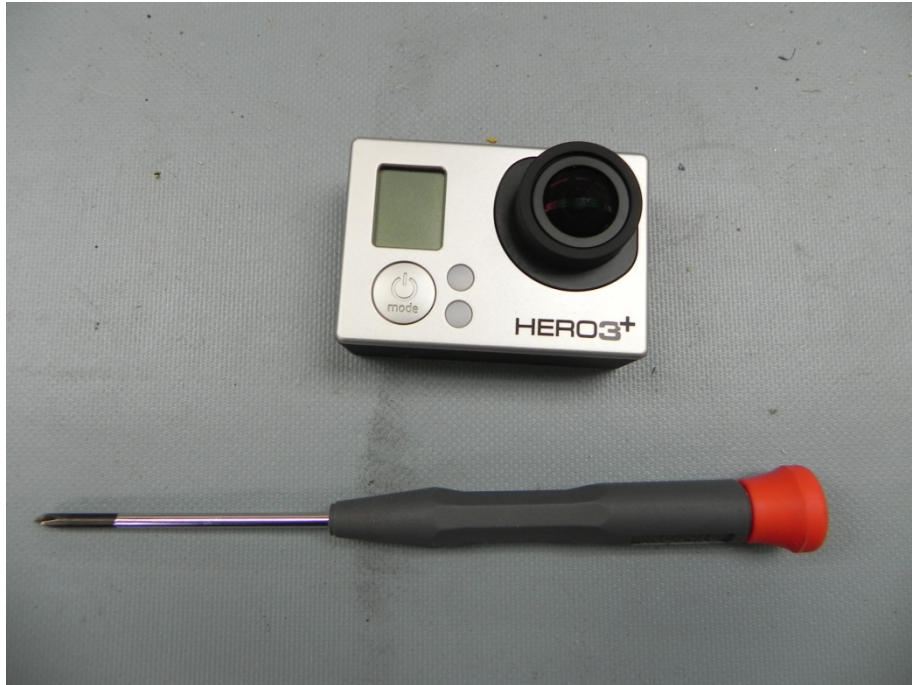
Upon arrival at the NTSB Vehicle Recorder Laboratory, an exterior examination (figure 3) revealed the device received minimal impact damage. The internal micro SD card containing the device's image data was located and removed.

**Figure 3. Front face of GoPro Hero 3+ as received.**

Files were downloaded from the micro SD card. Two picture files were located and dated past the accident day. The pictures were determined to be from first responders to the accident scene. No data pertinent to the investigation were found.
