# **EXEC 162F MAINTENANCE MANUAL**

The RotorWay EXEC 162F Maintenance Manual has been designed to provide the owner-operator the lowest operating cost possible while maintaining the flight characteristics and safety of their helicopter.

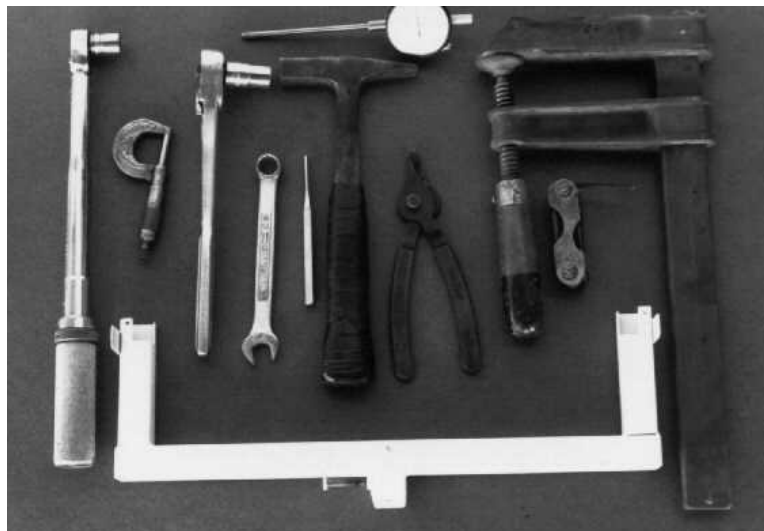
**Photo #1:** Tools required.

1. The following tools are required to preform the hub shimming procedures:
  - 3/8" torque wrench in ft. lbs. capable of 30-35 ft. lbs.
  - micrometer in thousandths of an inch
  - 3/8" drive ratchet with 9/16" socket
  - 9/16" box and open end wrench
  - 1/4" punch with a 3" shank
  - steel hammer and/or plastic hammer
  - snap-ring pliers that will fit the holes on the snap rings
  - spring scale
  - set of allen wrenches or at least one 1/4" and one 1/8" allen wrench
  - a clamp that spans the distance across the teeter blocks and has 4" jaws minimum
  - one rotor hub shimming fixture. See page 59 in this manual for a drawing of the fixture with dimensions and specifications. This fixture is also available from RotorWay, part number E08-6000.
  - one dial indicator with a 4" reach that reads in thousandths.

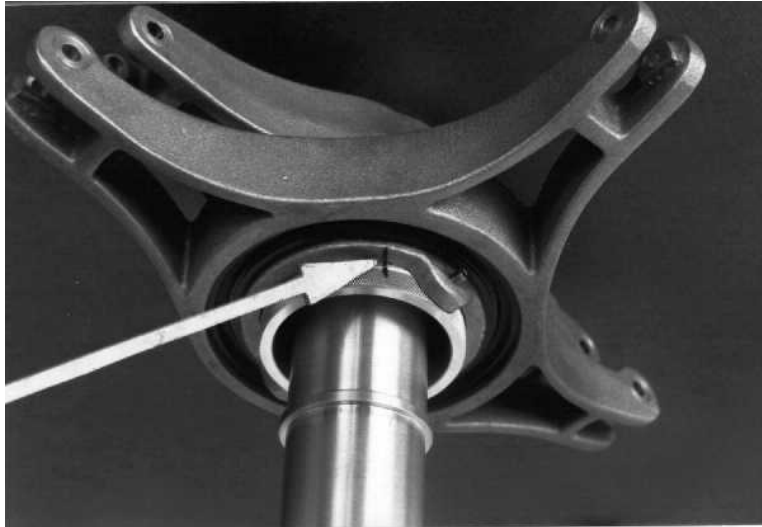
**Photo #14:** Placing an index mark.

1. Using a protractor level, set the swash plate perpendicular to the main shaft. Rotating the blades may help you in achieving the fore and aft angles. If a protractor level is not available, centering the cyclic stick should place the swash plate at a relative perpendicular angle to the shaft. Loosen the two set screws (part no. E00-9302, Ref. 16 on print E49-2002) three full turns. With your fingers, loosen the adjustment collar approximately 2 full turns in a counter clockwise direction, until it can be turned easily. Again using your fingers, turn the collar in a clockwise direction until it comes to a stop. Make an index mark on the adjustment collar and non-rotating swashplate with a pencil or marker. Back off the adjustment collar counter clockwise 1/2". Then tighten the two set screws. See photos #14-16. Note: Use silicone on the set screws to help lock them in position and prevent them from backing out. Do NOT use loctite.
