August 9, 2016

RE: N544SP

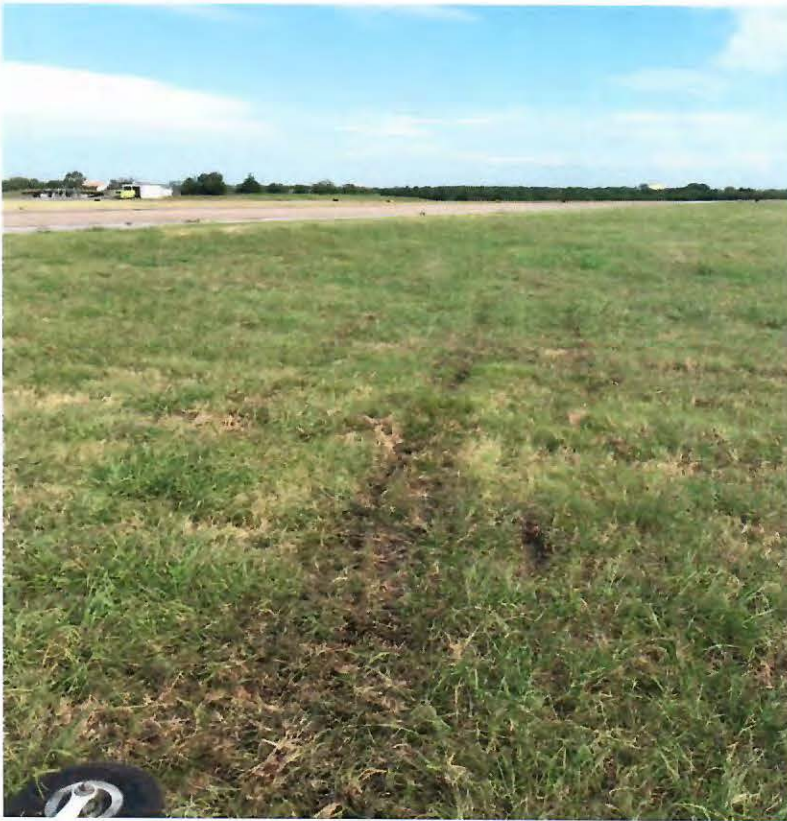
Final resting spot of aircraft

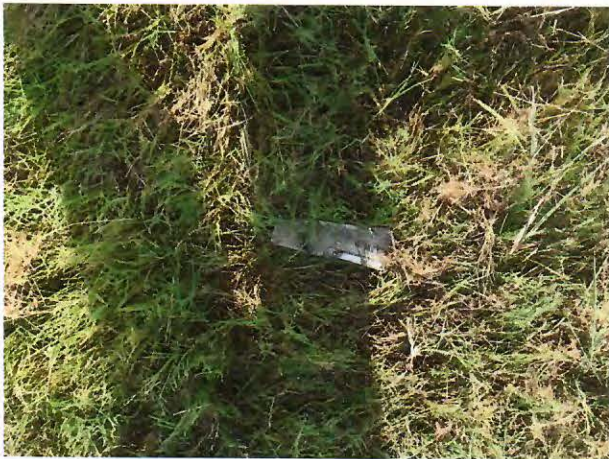
On taxiway echo looking NW

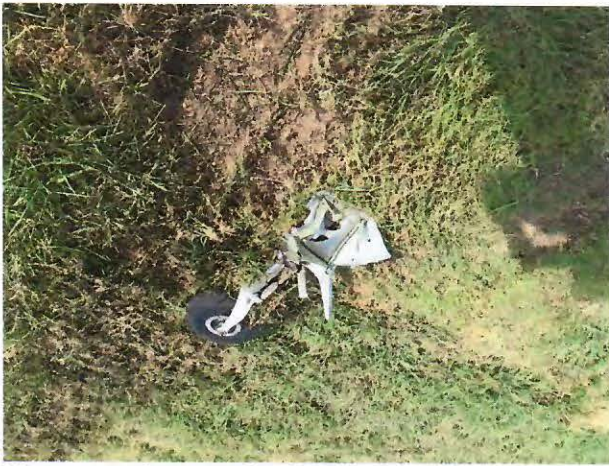
Left side of Nose gear fitting 30' NW of echo

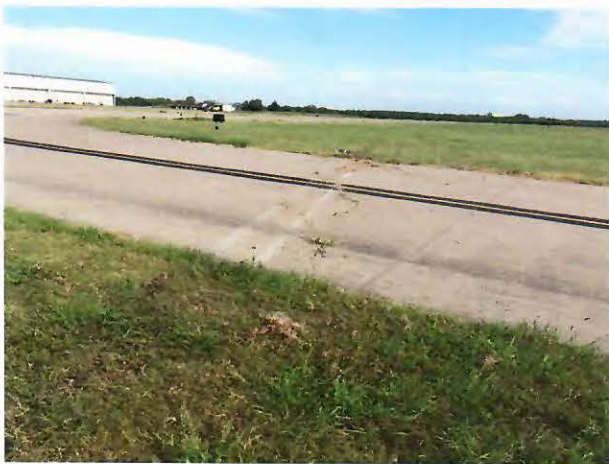
Nose gear just north of echo

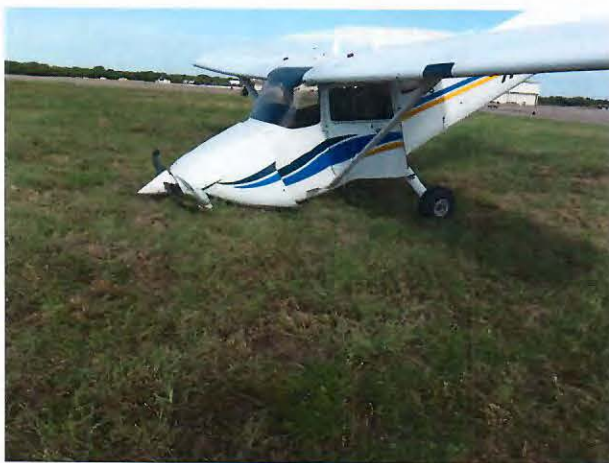
looking NW nose gear on northh side of runway
