# Pilots: Prevent Carbon Monoxide Poisoning

- The risk of carbon monoxide poisoning is overlooked and underestimated!

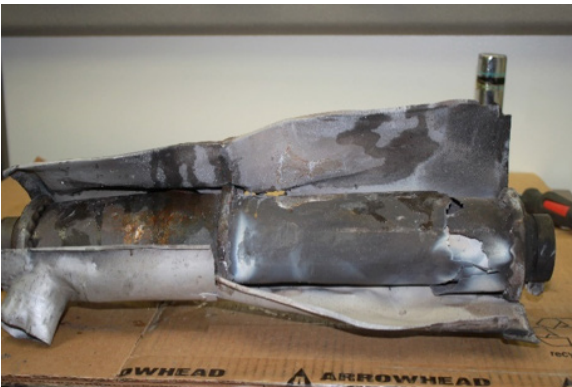
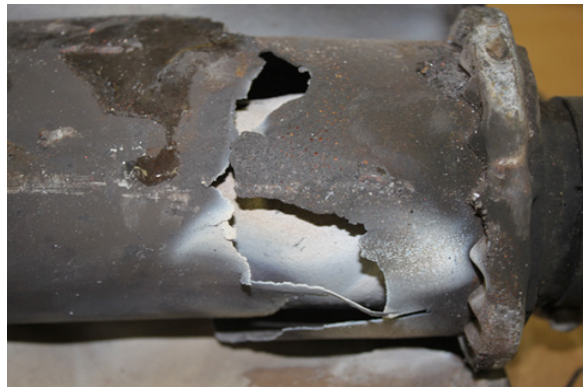
■ **Witnesses observed an experimental amateur-built, Hefty Polar Cub airplane flying erratically at a low altitude before impacting terrain.** A postcrash fire ensued, and the pilot was fatally injured. Toxicology testing revealed that the pilot's CO level was 48%; no soot was found in his airways, indicating the CO was not a result of the fire; thus, the NTSB determined that the pilot's severe CO impairment likely caused the pilot's loss of control. Examination of the airplane's exhaust system revealed that the exhaust/heater muffler was fractured, allowing CO to enter the cockpit (see figure 2). ([ANC16FA065](#))

**Figure 2.** Fractured exhaust muffler from a Hefty Polar Cub airplane (left) and a close-up photograph of the fracture in the exhaust muffler (right).

- **During preflight inspections, check the security and condition of the exhaust system. Look for cracking at the ends of the muffler; if you see signs of soot or exhaust flames, don't fly the airplane until it is examined by a mechanic. If you cannot see the muffler, inspect the shroud for any evidence of soot that might indicate cracking in the muffler.**
