# NATIONAL TRANSPORTATION SAFETY BOARD

## MATERIALS LABORATORY FACTUAL REPORT

Report No. 17-087

Place : Fargo, ND  
Date : 12/01/2016  
Vehicle : Cessna 340, N123KK  
NTSB No. : CEN17FA045  
Investigator : Arnold Scott

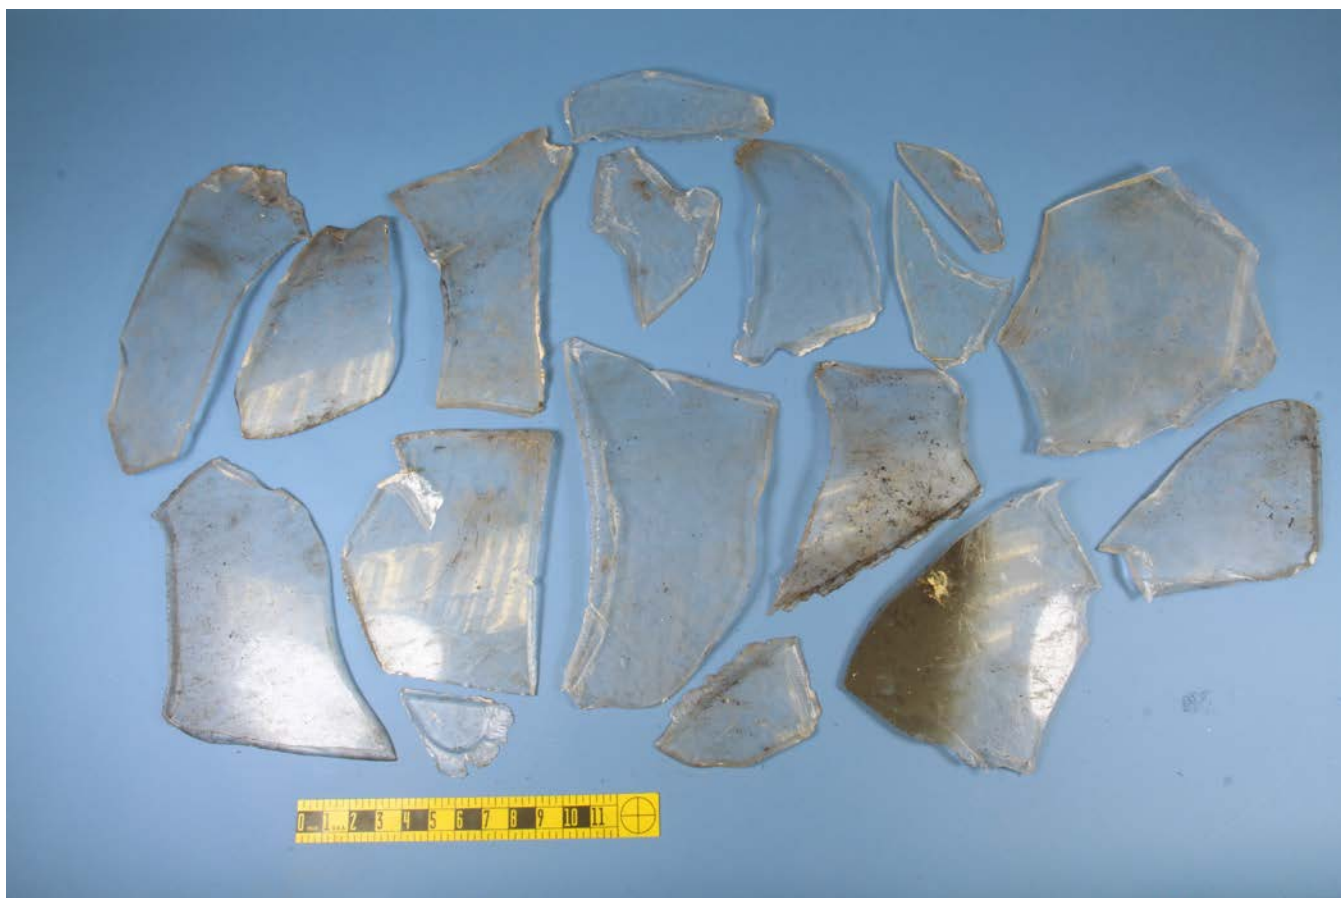
None of the portions of windshield exhibited any signs of thermal degradation. One portion of windshield (figure 3) exhibited staining on the exterior surface consistent with soot streaking. This staining on the exterior surface did not extend onto the fracture surface (figure 4). The remaining portions of the windshield did not exhibit evidence of soot deposition.

Figure 1: Portions of windshield.

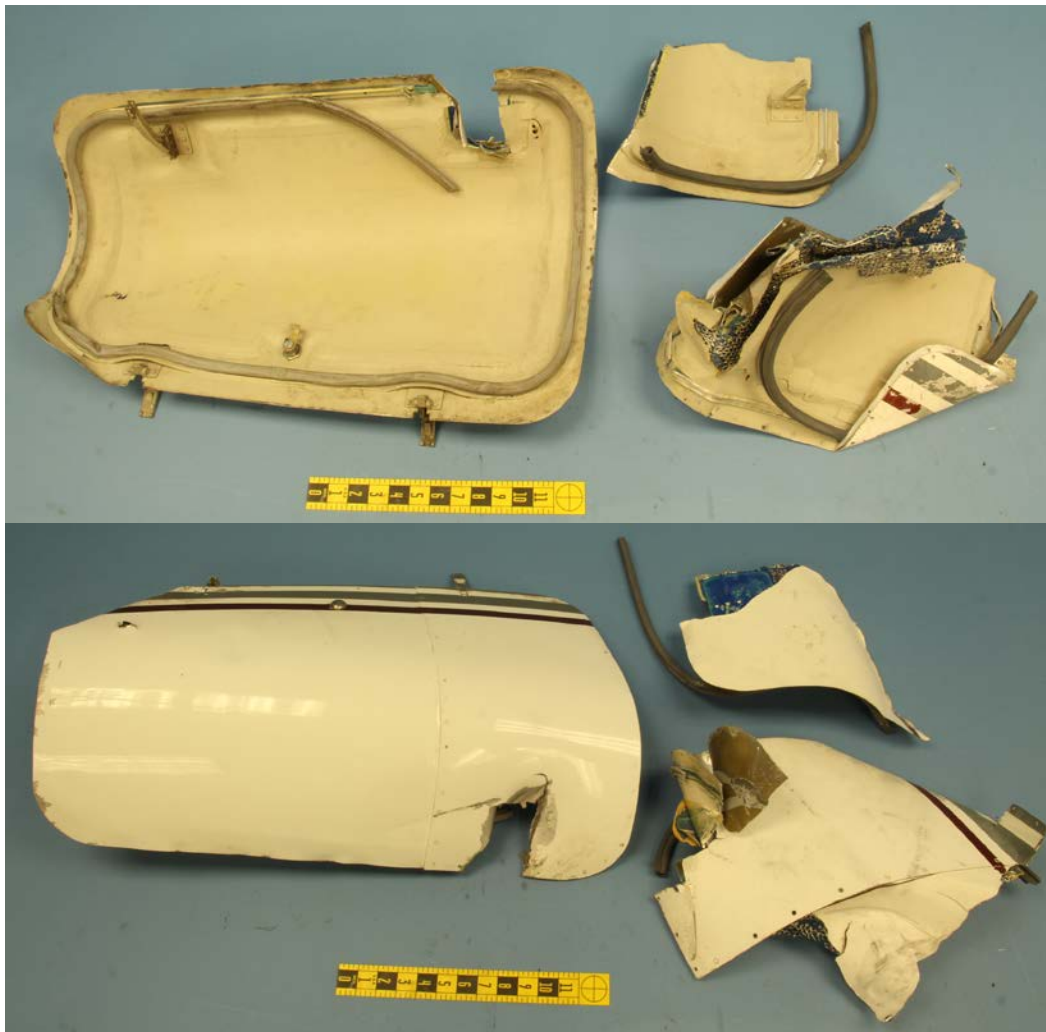
The portions of the two luggage compartment doors did not exhibit any soot deposits or thermal damage. These portions also did not exhibit evidence of deformation consistent with a high energy explosion. The latches present on one of the door portions were not deformed.

Figure 2: Portions of luggage compartment doors.

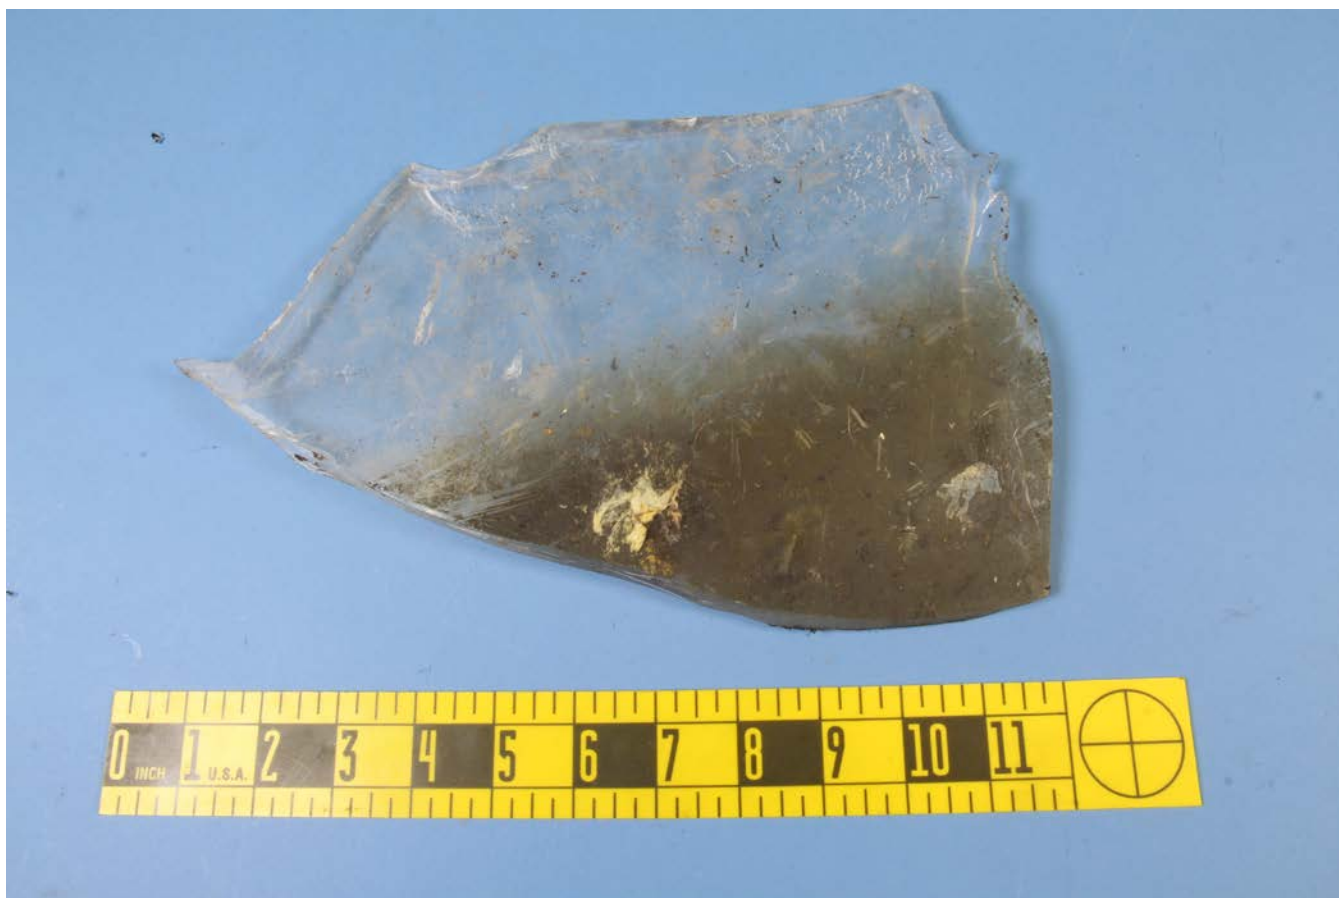
Figure 3: Portion of windshield with soot staining.

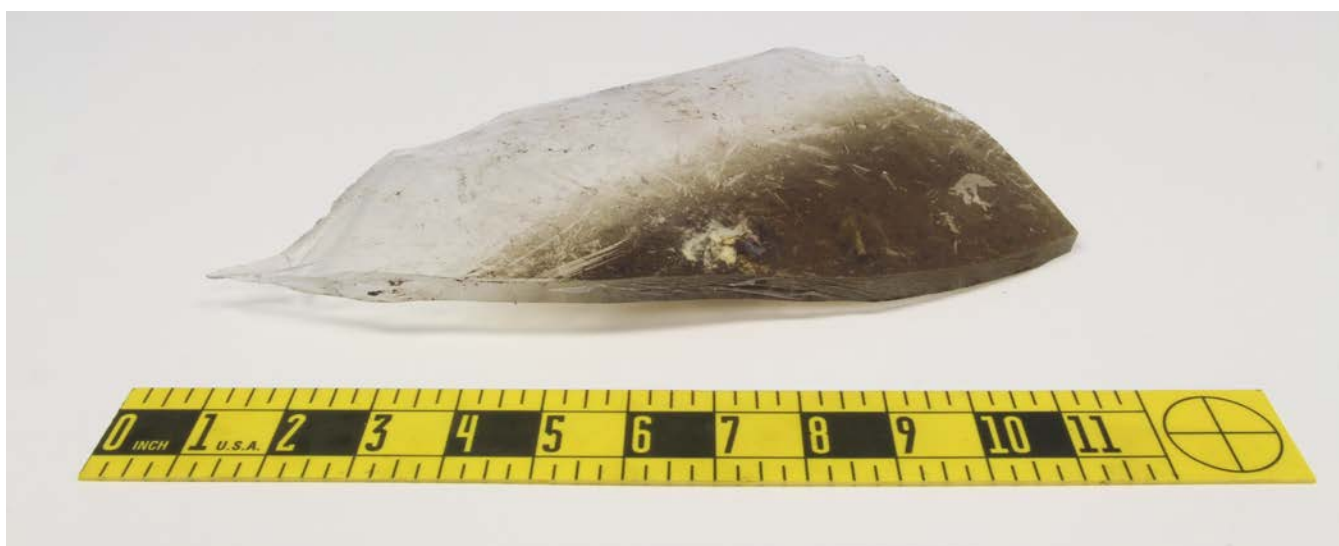
Figure 4: Clean fracture surface adjacent to soot stained exterior surface.
