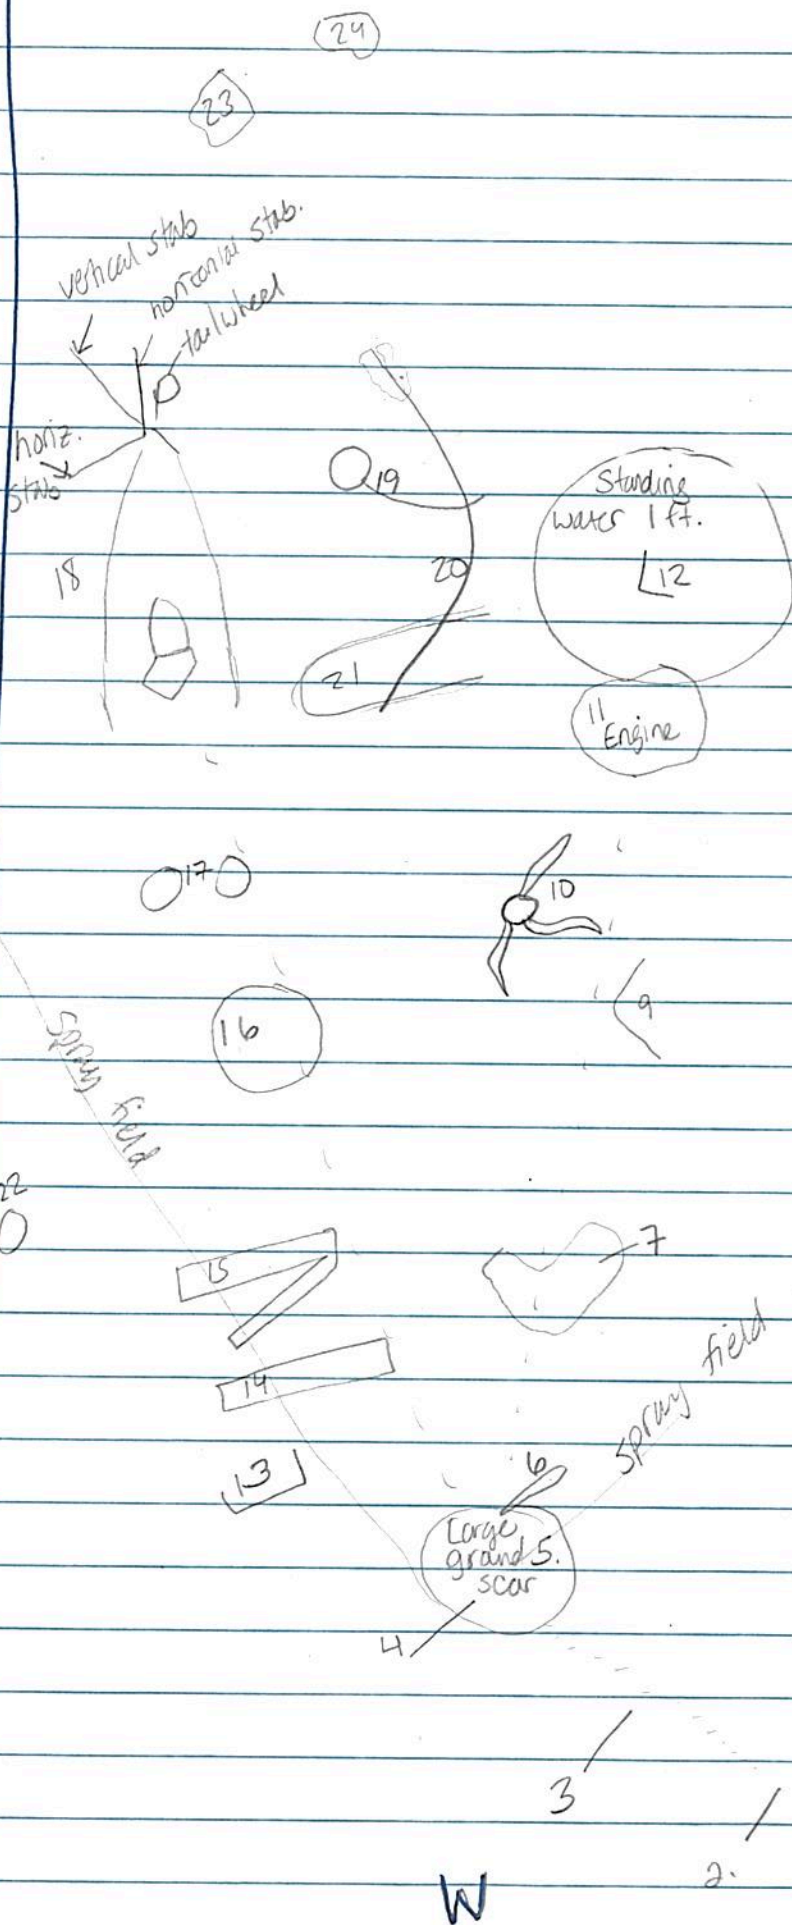
1. First point of impact
2. Prop strike
3. prop strike
4. prop strike
5. Large ground scar
6. prop blade
7. Right wing tip pieces
8. debris
9. debris
10. Prop assembly
- 11 Engine
12. Piece of left wing walk
- 13 Right leading edge
14. Spray boom
15. Right Aileron/Trim tab
16. Firewall
17. side panels
18. Fuselage/Emplane
19. left main gear
20. main spar
21. left wing
22. Right tire/gear assomb  
west of scene about 60yds
23. debris
24. Viewing panel (GPS)
