## The National Transportation Safety Board

Office of Aviation Safety  
Central Region  
Memorandum for the Record  
Vacuum Pump Gasket  
Examination  
CEN17LA286  
Walters Oklahoma  
July 8 2017

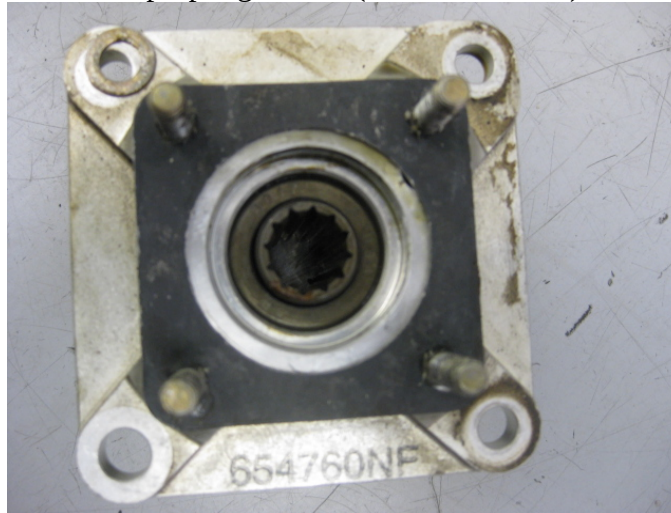
It was discovered that a gasket (P/N-21051) was installed on the vacuum pump. The gasket is normally used for the installation of a carburetor. The installed gasket did not completely cover the high-pressure oil orifice on the vacuum pump mounting fixture. The proper gasket is (PN-MS9134-01) for the vacuum pump.

Vacuum Pump Gasket Installed

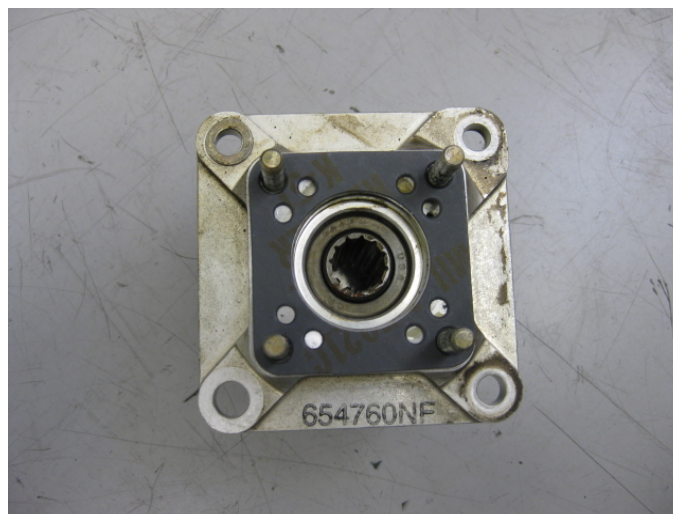
Exemplar Proper Vacuum Pump Gasket
