**NATIONAL TRANSPORTATION SAFETY BOARD**

## **Personal Electronic Device Factual Report**

Location: Detroit, Michigan  
Date: June 24, 2018  
Aircraft: Cessna P210N  
Registration: N3896P  
Operator : Private  
NTSB Number: CEN18FA236

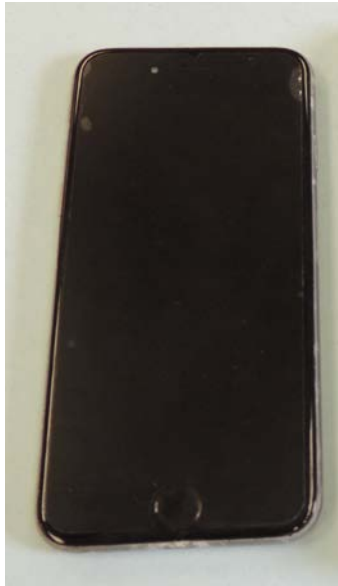
Upon arrival at the Vehicle Recorder Laboratory, an examination revealed the unit had sustained minor impact damage. The extent of the damage is shown in figure 1.

**Figure 1.** Photo of damaged iPhone 6S

The device was powered on normally, however, the display was malfunctioning. It was determined that the device would require substantial work to return functionality to the screen and in agreement with the Investigator-in-Charge, a full recovery of the device was not continued.

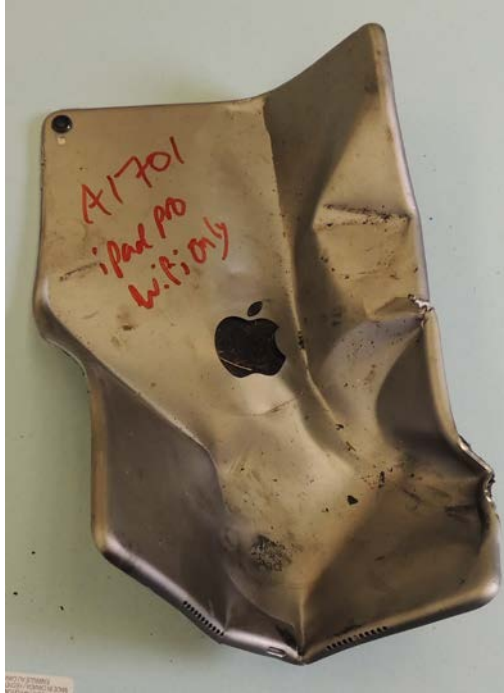
Upon arrival at the Vehicle Recorder Laboratory, an examination revealed the unit had sustained significant impact damage. Due to the damage noted and the substantial work required to recover the device, in agreement with the Investigator-in-Charge, a full recovery of the device was not continued.

**Figure 2.** Photo of damaged Apple iPad Pro

These devices are capable of storing data in the NVM. The extent of the damage to each device precluded normal recovery procedures. Therefore, no data pertinent to the event were recovered.
