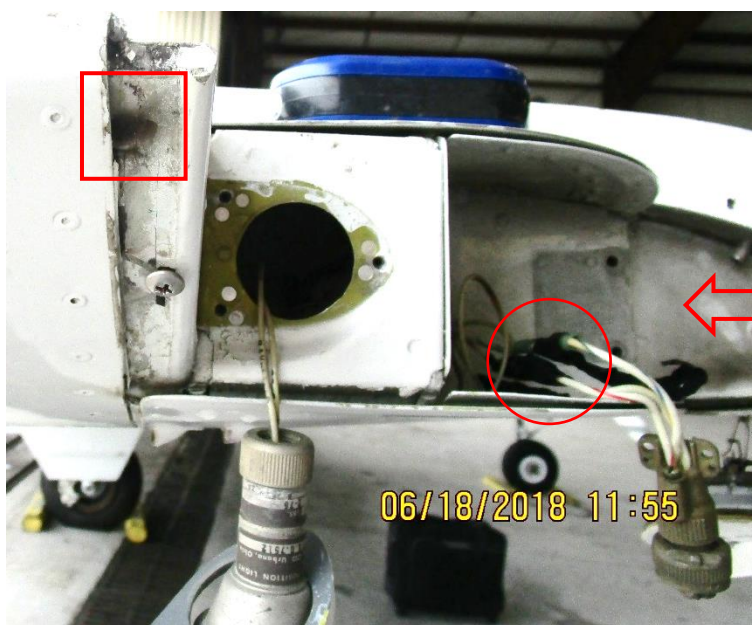
Figure 2 Photo 1625

Square shows soot.

Circle is the taped anti-collision  
light wiring.

Arrow is the soot on the bulkhead  
adjacent to

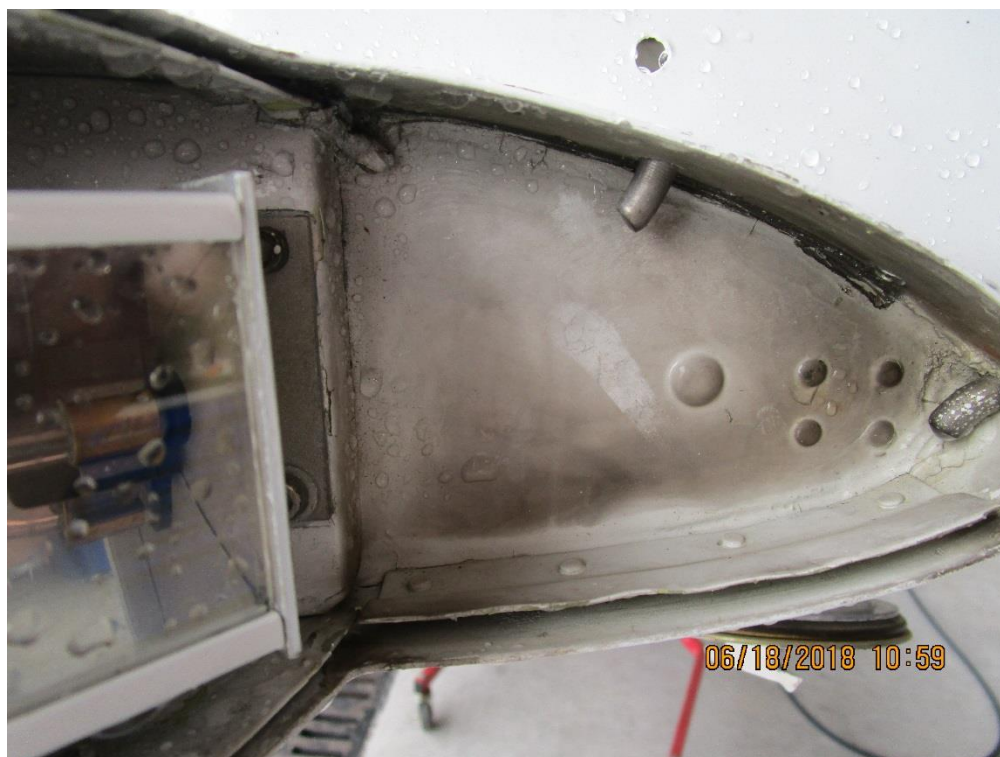
Figure 5 1603 Soot on bulkhead.

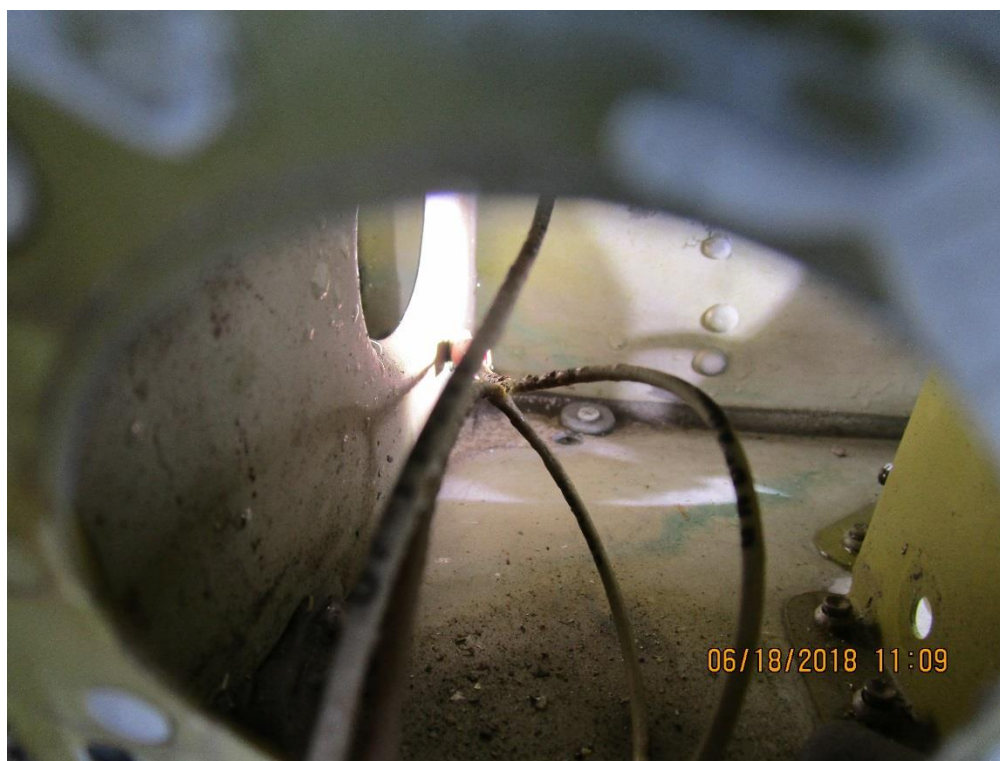
Figure 4 1608 Navigation light wiring slightly burned.

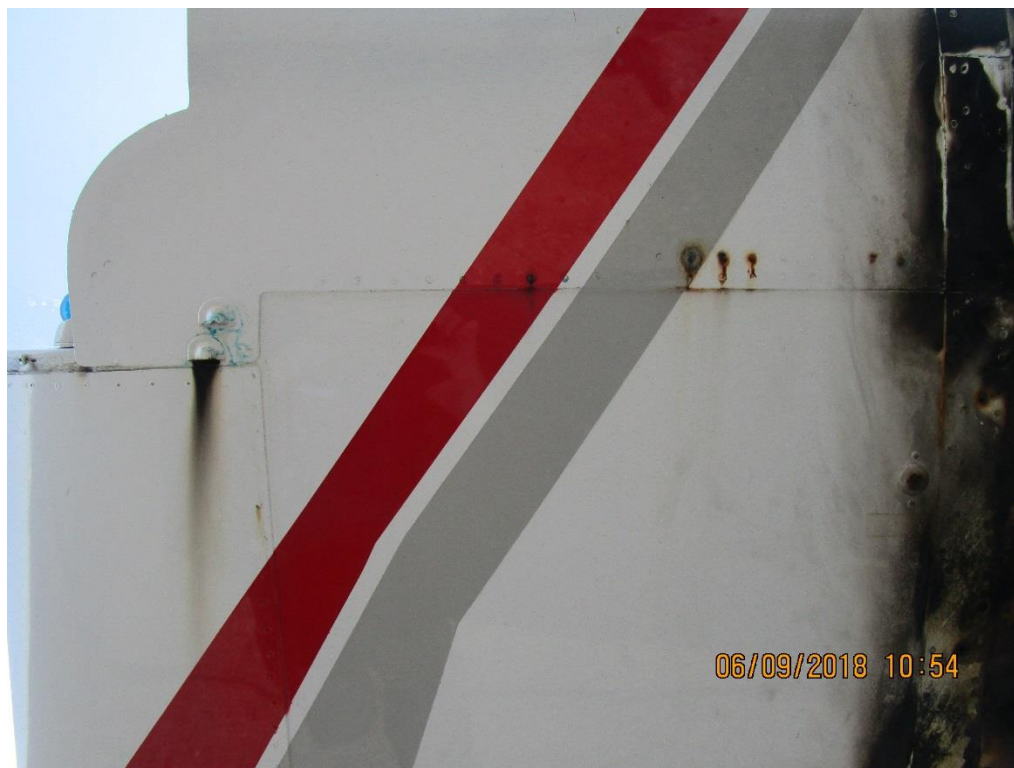
Figure 7 Underwing vent behind anti-collision light

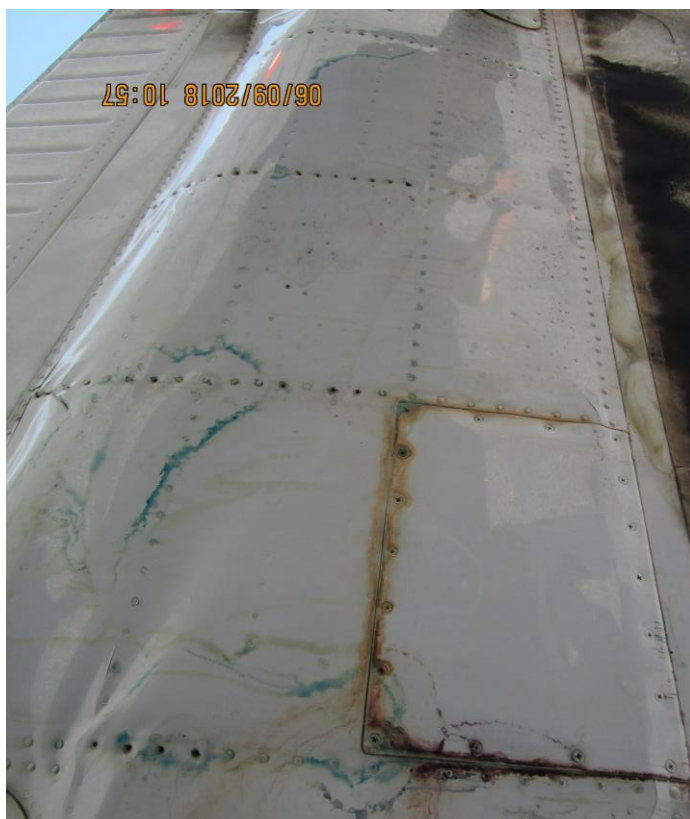
Figure 6 1567 View looking up & outboard bottom of RH wing.
