# The National Transportation Safety Board

Office of Aviation Safety  
Central Region  
Memorandum for the Record  
Witness Locations and  
Statements  
CEN19FA009  
Fulton Missouri  
October 17 2018

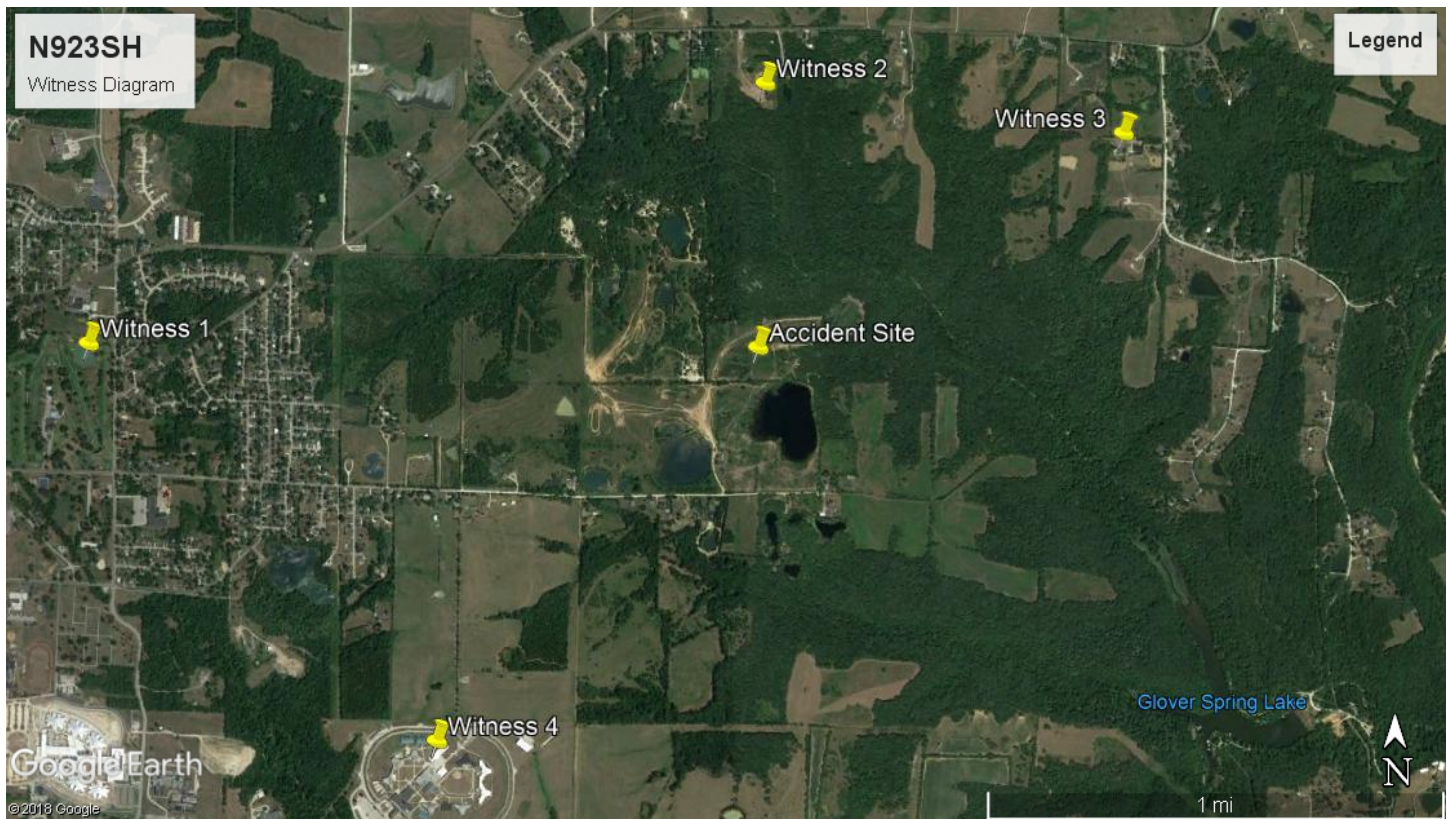
A diagram was created with the approximate locations of witnesses in proximity to the accident site. The witness locations are labeled 1-4 and their statements are summarized below the diagram.
