# The National Transportation Safety Board

Office of Aviation Safety  
Central Region  
Memorandum for the Record  
Summary of ATC  
Communications and Radar  
Track  
CEN19FA084  
Goshen Indiana  
February 21 2019

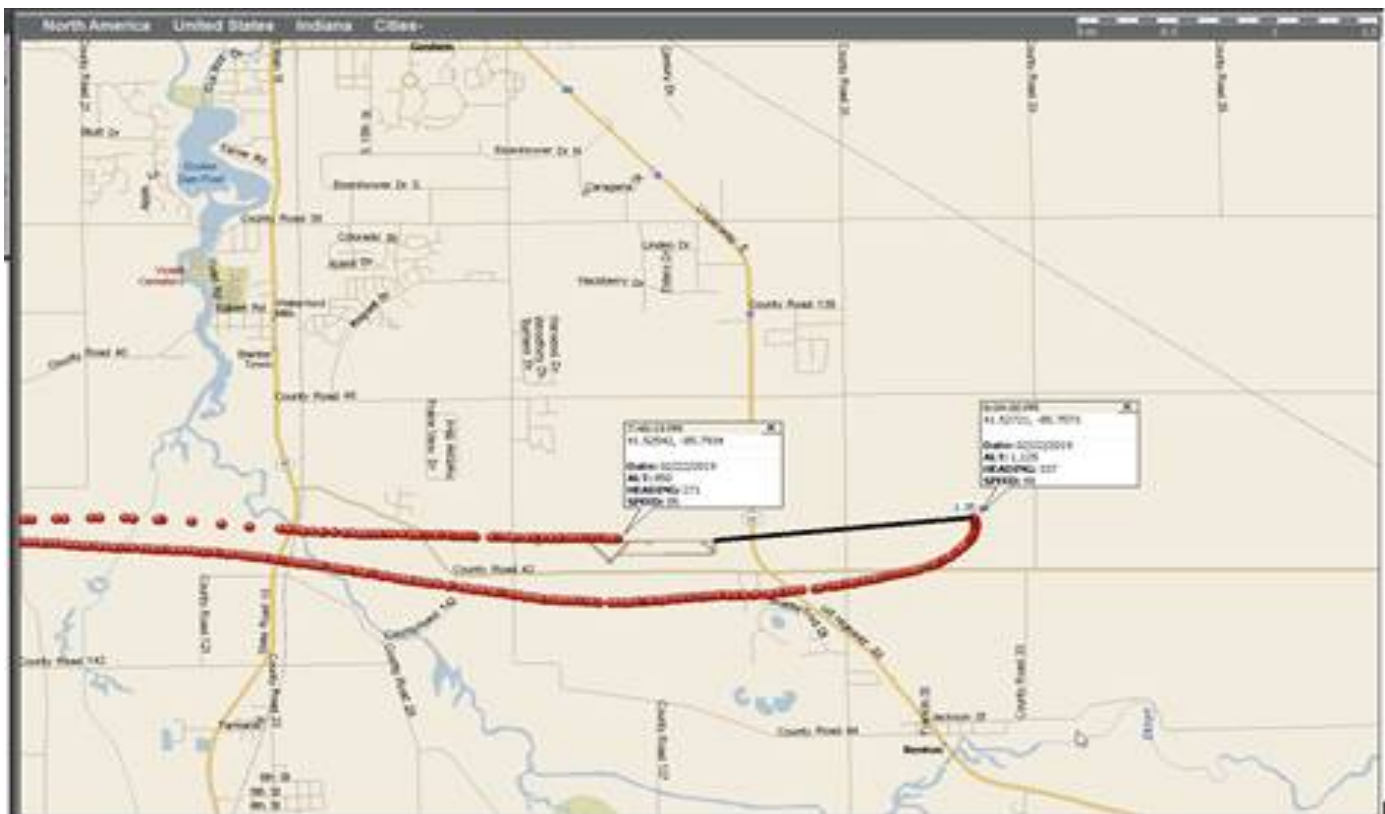
- The ATM stated that the S controller did not observe any anomalies with the flight and that N4922K's descent appeared normal. The ATM reported that the facility lost radar contact with N4922K after services were terminated at a point where they would normally expect to lose radar contact. The ATM stated that the facility received a call from the Central Regional Operations Center approximately eight minutes after services were terminated and were advised of the accident involving N4922K.
