**NATIONAL TRANSPORTATION SAFETY BOARD**  
Vehicle Recorder Division  
Washington, D.C. 20594

## **Electronic Devices**

### **Specialist's Factual Report By Deven Chen**

Location: Brainerd, Minnesota  
Date: June 28, 2019  
Aircraft: Agusta A09S  
Registration: N11NM  
Operator: Private  
NTSB Number: CEN19FA185

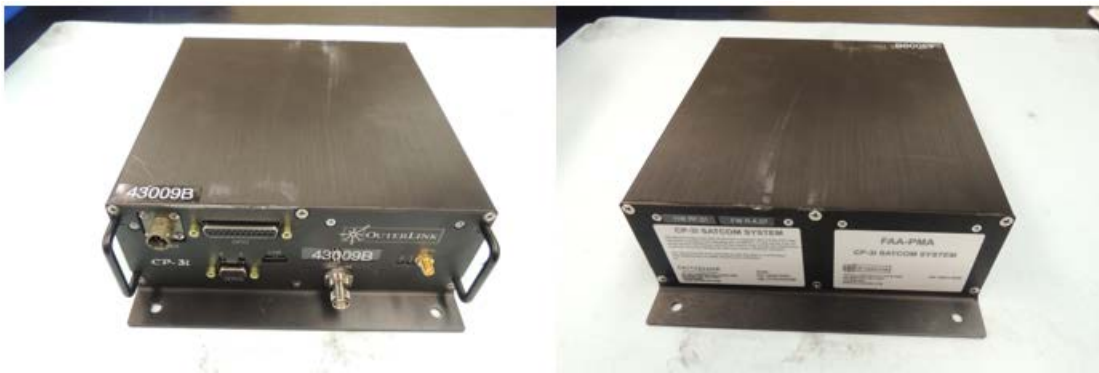
Upon arrival at the Vehicle Recorder Division, an exterior examination revealed the device was in good condition, as shown in Figure 1. The device powered up normally, and the stored data were downloaded using instructions provided by the manufacturer. Downloaded files were sent to the manufacturer. The manufacturer decoded the data and stated that those files were device system log files and did not contain any flight data. Thus, no data recovered from the device.

**Figure 1: Front and back of Outerlink CP-3i SATCOM Module as received.**

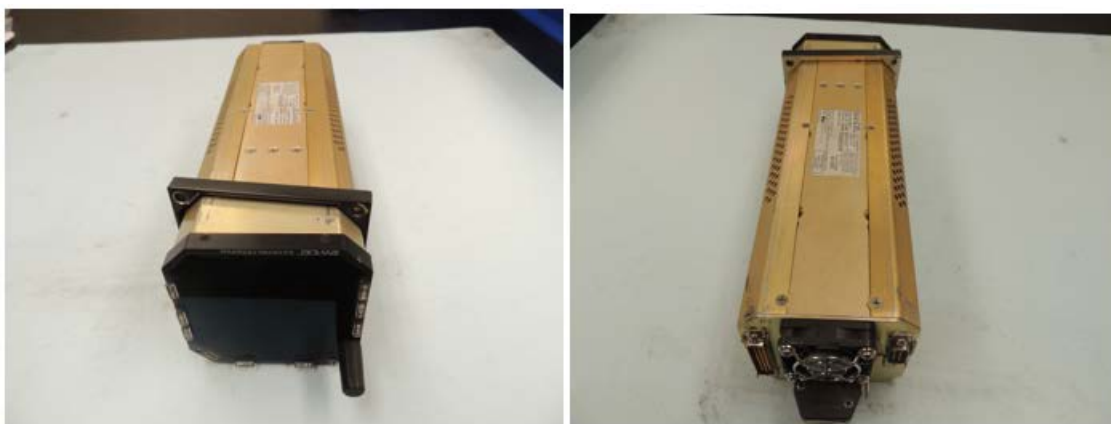
Upon arrival at the Vehicle Recorder Division, an exterior examination revealed the device was in good condition, as shown in Figure 2. The device powered up normally. The raw data were downloaded using manufacturer's software and sent to the manufacturer for decoding.

**Figure 2: Front and back of Sandel ST3400H as received.**
