# NATIONAL TRANSPORTATION SAFETY BOARD

### Specialist's Factual Report by Gerald Kawamoto

Location: Pleasant Plain, Ohio  
Date: March 18, 2020  
Aircraft: Piper PA-28  
Registration: N3943T  
Operator: Private  
NTSB Number: CEN20LA127

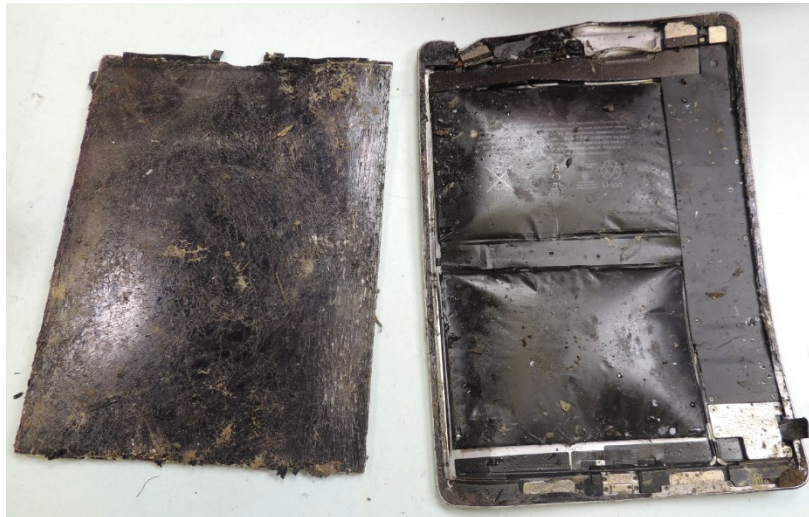
External examinations of the three PED devices revealed the devices has sustained impact damage resulting in inoperability, as shown in Figures 1 through 3. Further internal examinations revealed broken components and additional damage due to moisture. Due to the damage of the devices, no data were recovered.

**Figure 1. iPad Air as received.**

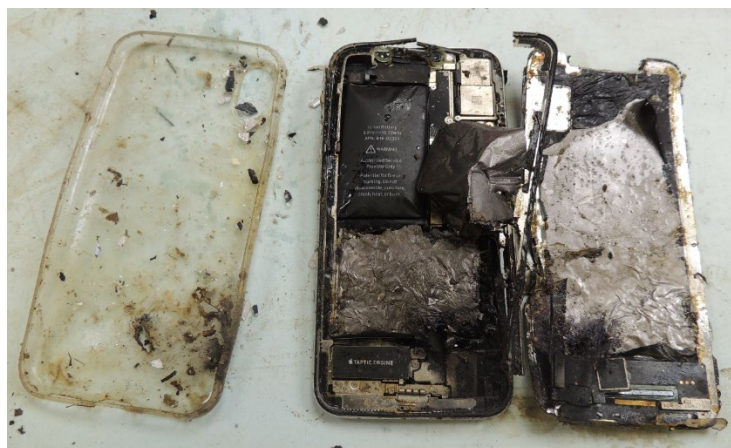
**Figure 2. iPhone X as received.**

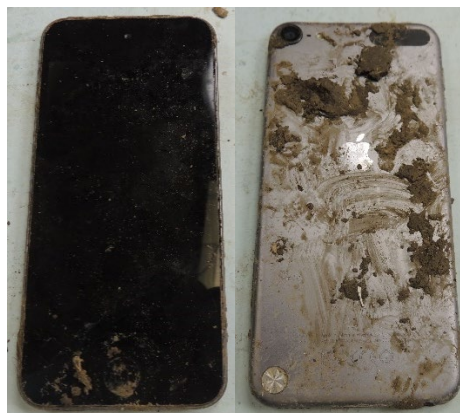
**Figure 3. iPod Touch as received.**

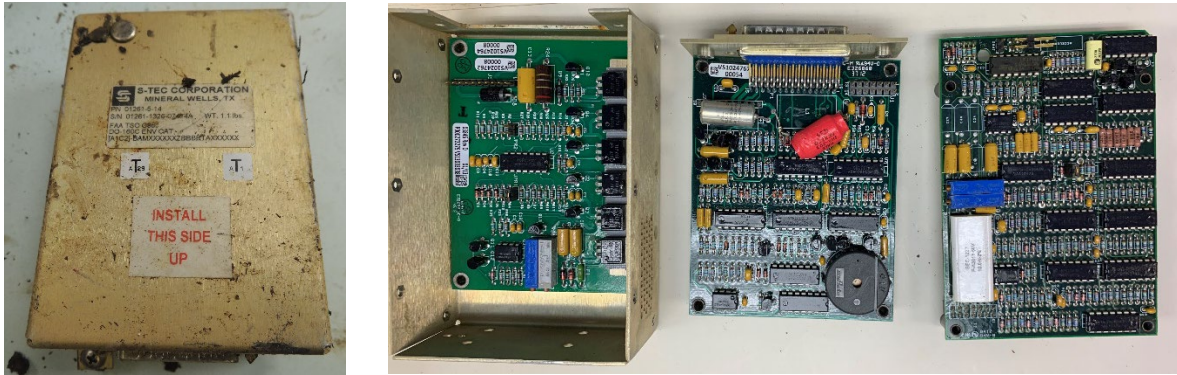
The S-Tec Pitch Computer is one part of a multi part S-Tec Autopilot system. The device was intact and no major external damage was visible, as shown in Figure 4. The internal components of the device were examined and there was no presence of NVM, thus no data were recovered.

Figure 4. S-Tec Pitch Computer as received (left). Internal components (right).

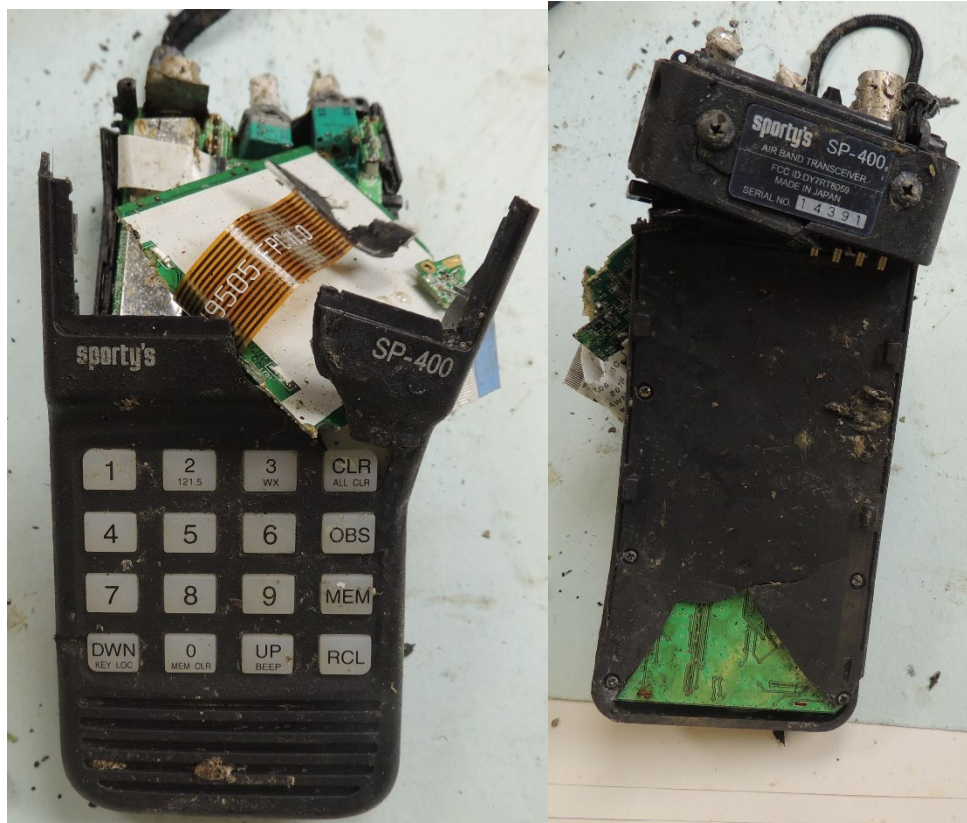
The Sporty's SP-400 is a handheld NAV/COM aviation radio. The device had sustained heavy impact damage, as shown in Figure 5, rendering it inoperable, thus no data were recovered.

Figure 5. Front and Back of the Sporty's SP-400 as received.

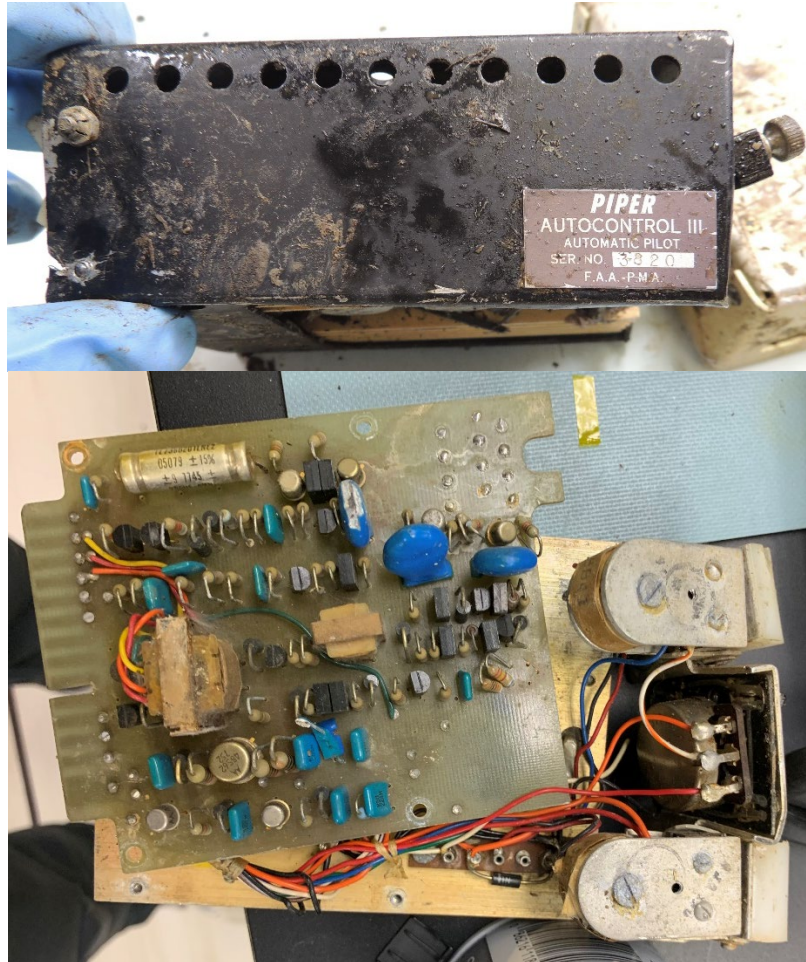
The Piper Autocontrol III is a lightweight automatic flight system. The device had sustained impact and moisture damage, as shown in Figure 6. The internal components of the device were examined and there was no presence of NVM, thus no data were recovered.

Figure 6. Piper Autocontrol III as received (top). Internal components (bottom).
