## CEN20LA339 CASE FINDINGS

**Jason Aguilera**  
**Air Safety Investigator**  
**Central Region**

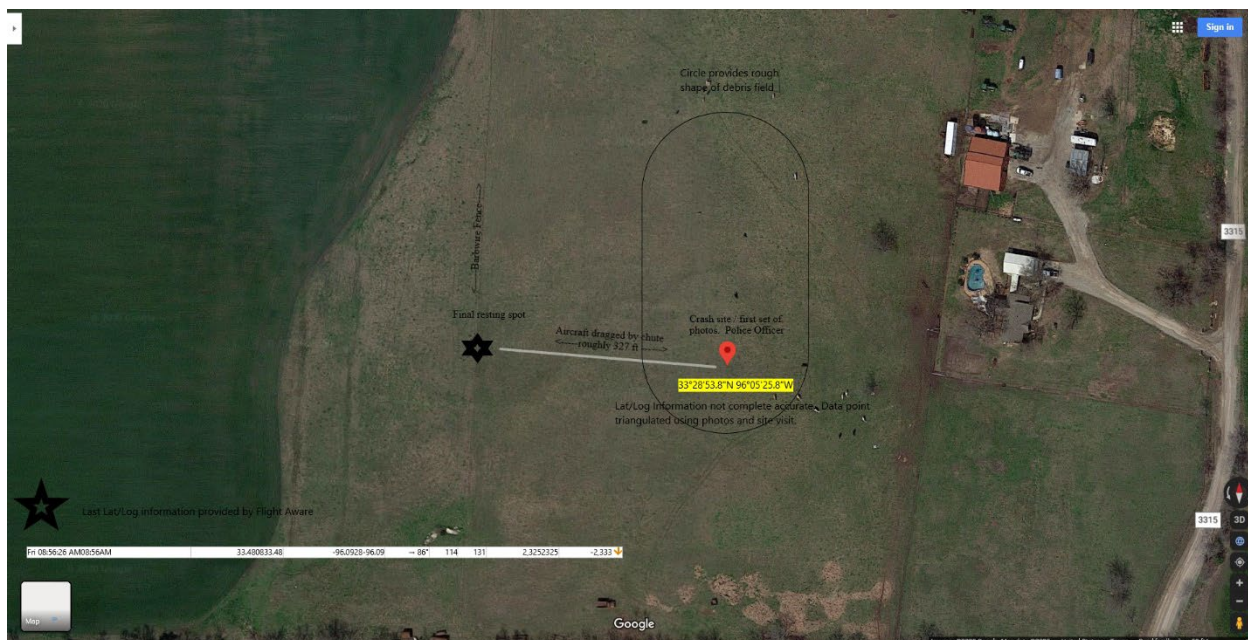
The airplane descended under the parachute canopy to an open field. After touchdown, the wind flipped the airplane and dragged the airplane over 300 ft before coming to rest.

The responding FAA inspector provided the following accident site diagram:
