**GROUP CHAIRMAN'S FACTUAL REPORT OF  
INVESTIGATION**

**CEN20LA419**

## Onboard Image Recorder

### Specialist's Factual Report

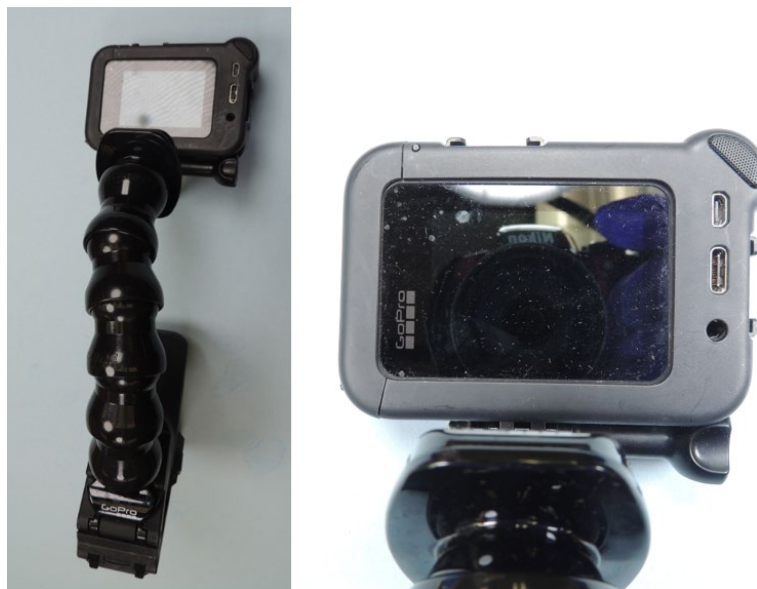
Upon arrival at the NTSB Vehicle Recorder Division, the device did not have any obvious damage. The device's memory card was removed, and the video and audio information were extracted from the memory card. Figure 1 shows on the left, the GoPro mounted on a holder upon arrival at the Vehicle Recorder Laboratory, and the screen of the GoPro on the right.

Figure 1. The condition of the GoPro upon arrival at the laboratory.

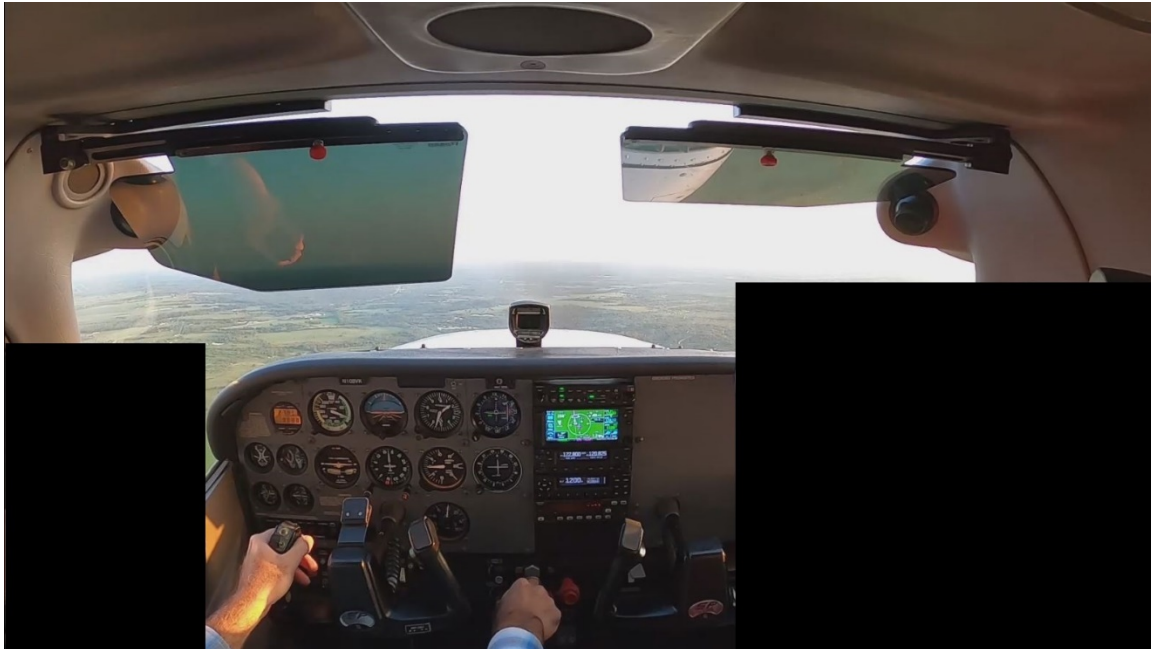
The video recording contained an over the shoulder view of the Cessna 172 occupants and the instrument panel. The camera was mounted on the headliner of the aircraft behind and between the instructor pilot and the student pilot. Figure 2 is a redacted screenshot of the camera's field of view on the accident aircraft. The instructor pilot is in the right seat and the student pilot is in the left seat. The video contained audio recordings of intra-cockpit communication between the instructor pilot and the student pilot, as well as over the air radio

**Figure 2. A redacted screenshot of the camera's field of view.**
