**NATIONAL TRANSPORTATION SAFETY BOARD**  
Vehicle Recorder Division  
Washington, D.C. 20594

## **Personal Electronic Devices**

**Specialist's Factual Report**  
**By W. Deven Chen**

Location: Janesville, Wisconsin  
Date: February 16, 2021  
Aircraft: Velocity Vtwin  
Registration: N13VT  
Operator: Private  
NTSB Number: CEN21FA130

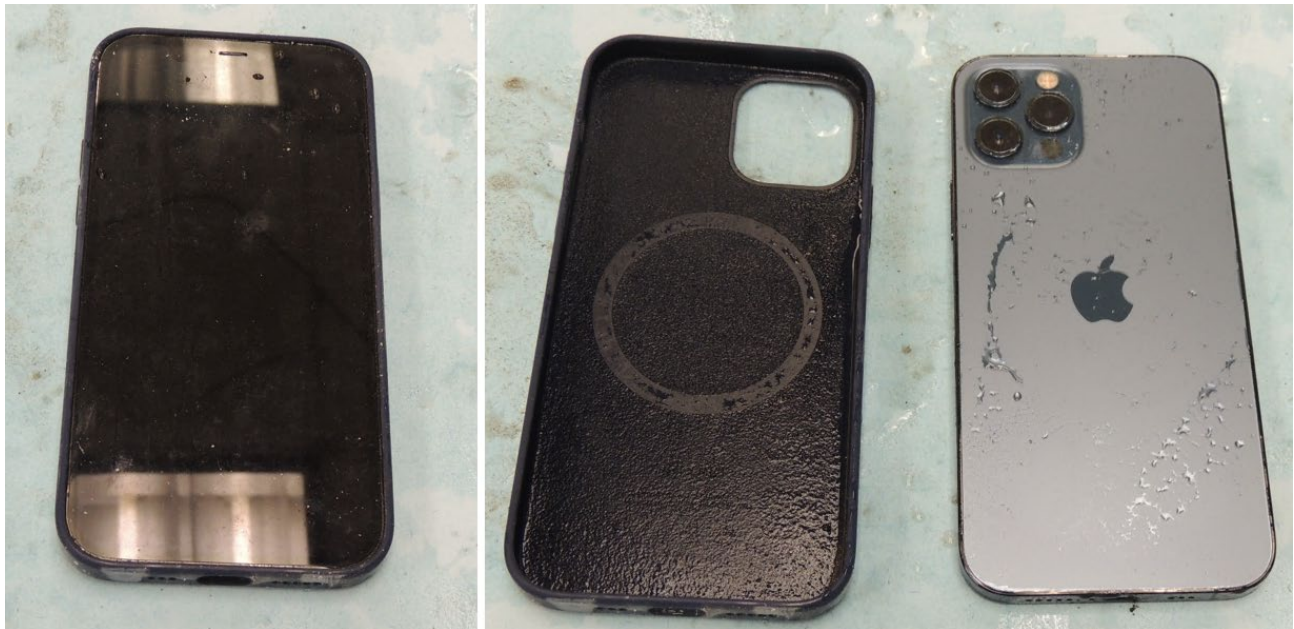
The device was submerged in water upon arrival at the Vehicle Recorder Division. An exterior examination revealed that the device had no impact damage, as shown in Figure 1. The device was carefully disassembled, ultrasonic cleaned and vacuum dried. The device powered on normally after being reassembled, and it was locked with a 4-digit passcode. There were three possible passcodes provided to the NTSB, however, none of them unlocked the device. Thus, there were no data recovered from the device.

**Figure 1: Front and Back of the Apple iPhone 12 Pro as received.**

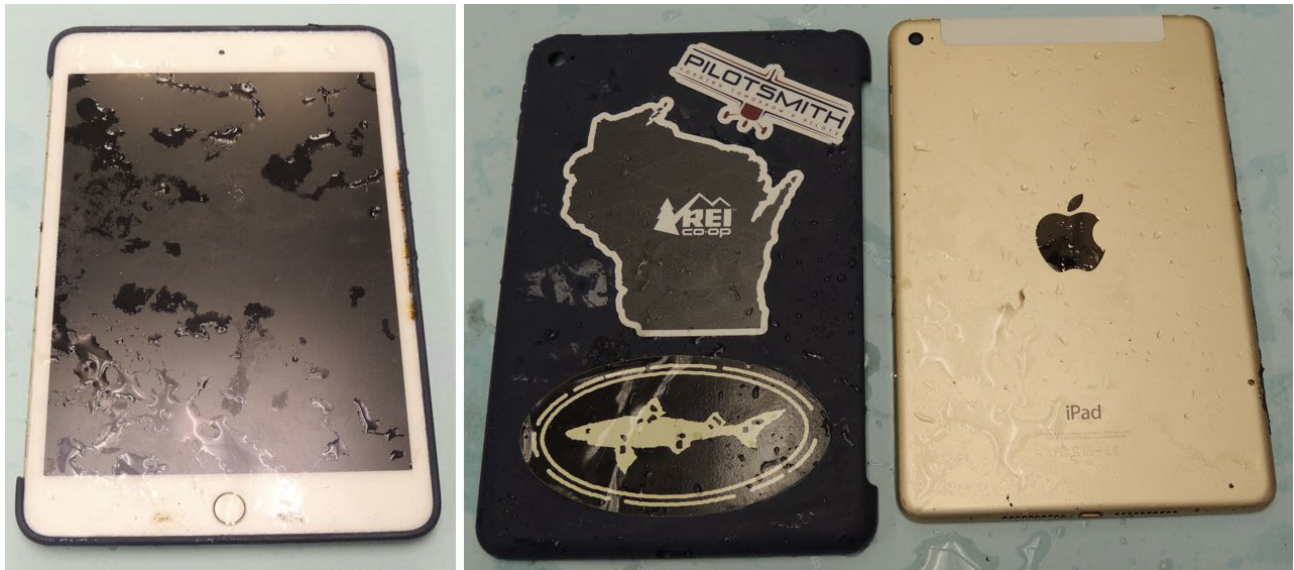
The device was submerged in water upon arrival at the Vehicle Recorder Division. An exterior examination revealed that the device had no impact damage, as shown in Figure 2. The motherboard was removed from the device and found to have corrosion from water intrusion. After being ultrasonic cleaned and vacuum dried, the motherboard was placed into a surrogate device, however, it went into a boot loop and did not power up. The extent of the damage precluded normal and advanced recovery procedures and additional attempts were unsuccessful in yielding usable data. Thus, there were no data recovered from this device.

**Figure 2: Front and Back of the Apple iPad mini 4 as received.**

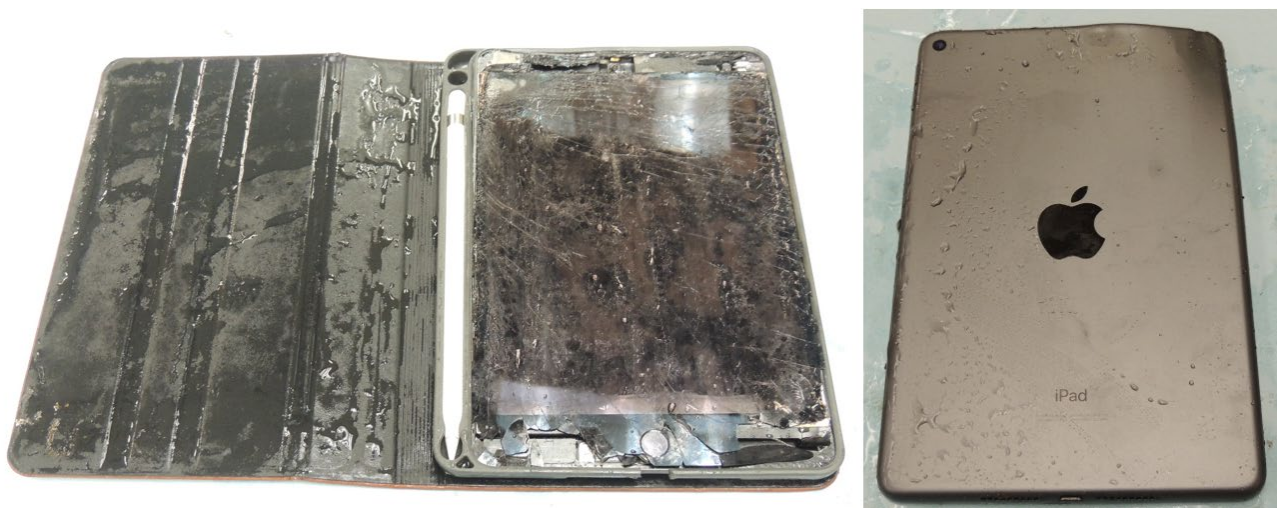
The device was submerged in water upon arrival at the Vehicle Recorder Division. An exterior examination revealed that the device had sustained severe impact damage, as shown in Figure 3. The motherboard was removed from the device and found to have severe corrosion from water intrusion. After being ultrasonic cleaned and vacuum dried, the motherboard was placed into a surrogate device, however, it did not power up. The extent of the damage precluded normal and advanced recovery procedures and additional attempts were unsuccessful in yielding usable data. Thus, there were no data recovered from this device.

**Figure 3: Front and Back of the Apple iPad mini 5 as received.**
