**From:** [Payne Sean](#)  
**To:** [Hodges Michael](#)  
**Cc:** [Babcock Christopher](#)  
**Subject:** CEN21LA351 - (Rushville, NE) - MGL Stratomaster Xtreme  
**Date:** Tuesday, January 25, 2022 7:43:26 AM  
**Attachments:** [stratomaster1.jpg](#)  
[FlightLogScreen.jpg](#)

#### **Email Report**

#### **MGL Stratomaster Xtreme**

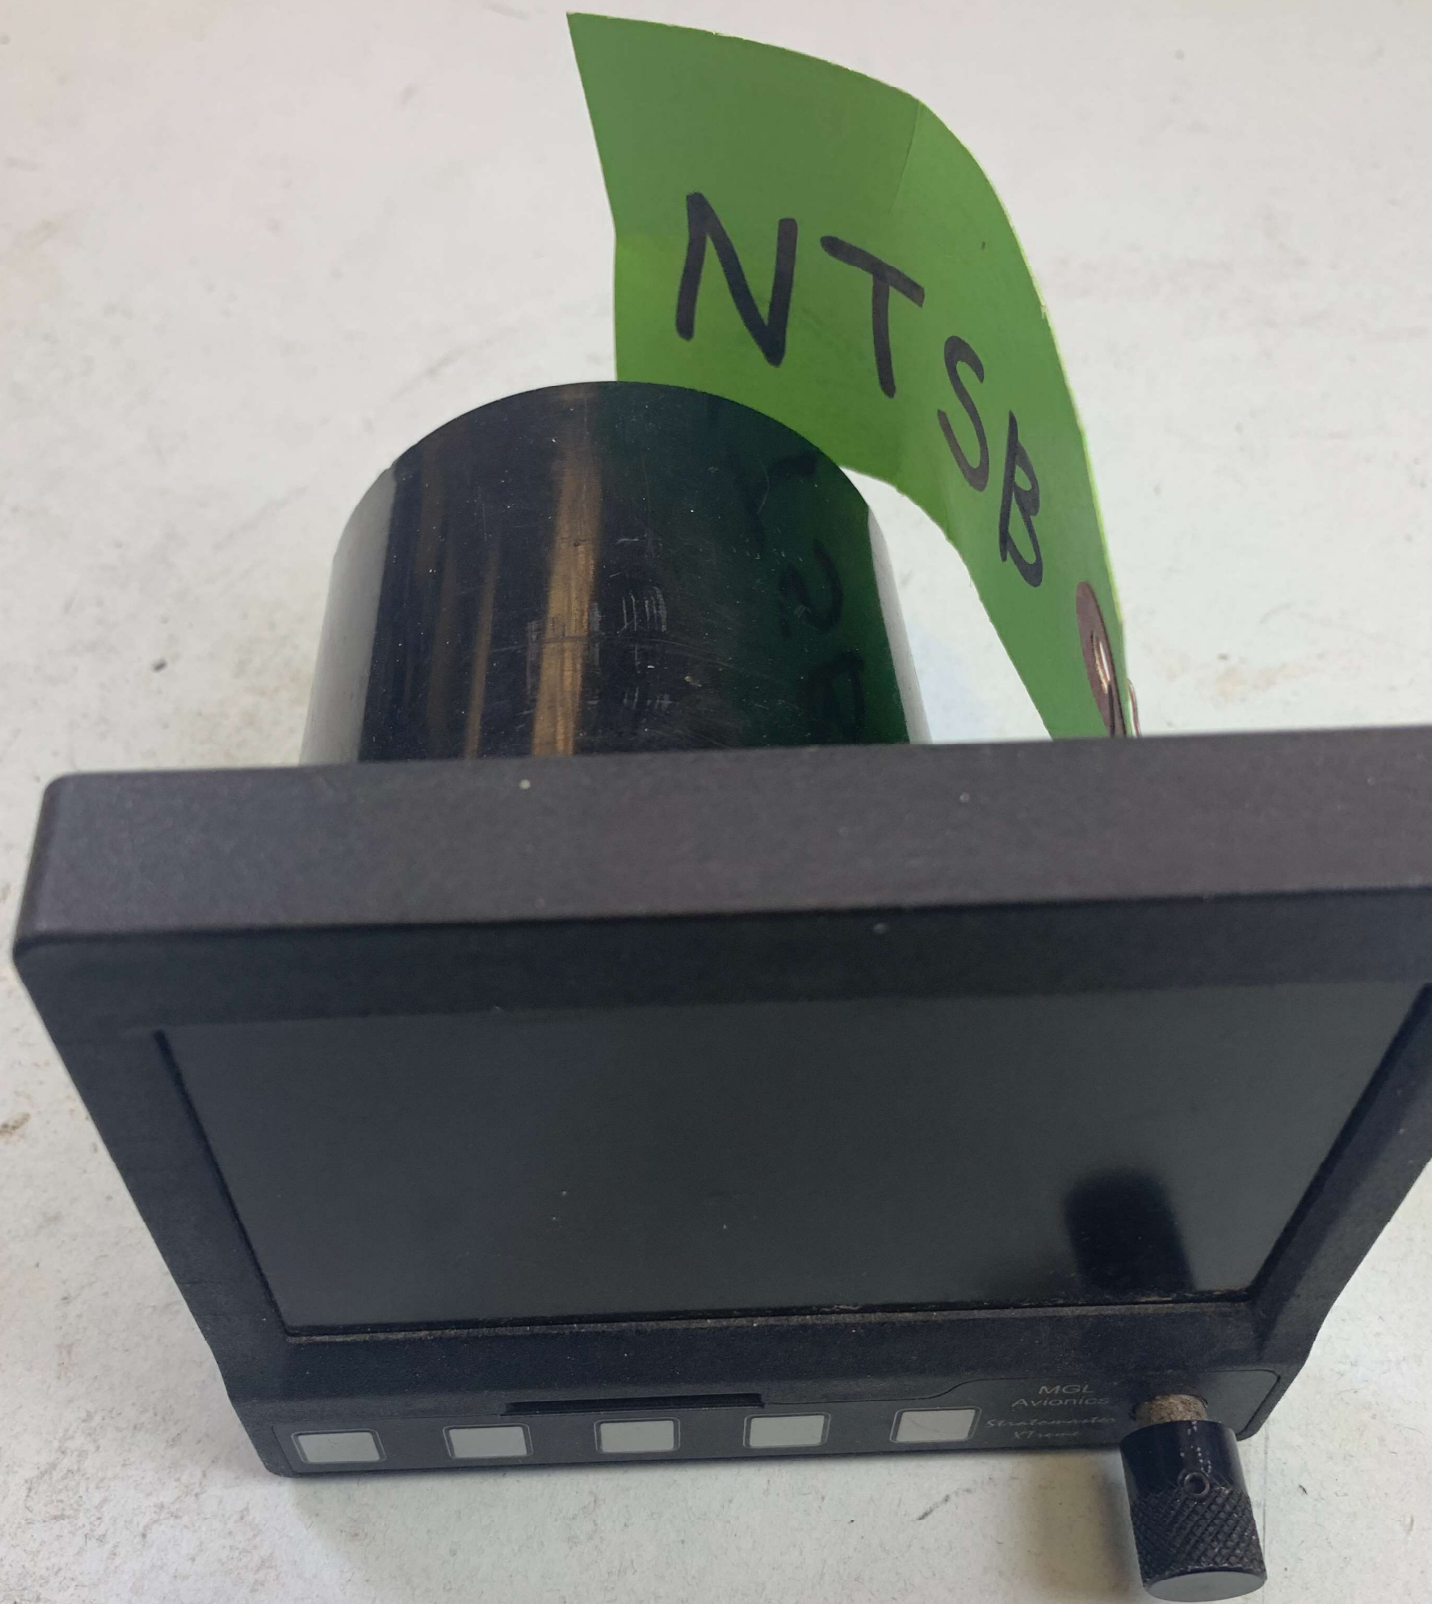
The Vehicle Recorder Division received one MGL Stratomaster Xtreme, serial number 1301174. A photo of the device is attached as stratomaster1.jpg.

The devices sustained no obvious impact damage. As shown in stratomaster1.jpg, the device's SD card slot was not occupied. The device was powered on a test bench using a DC power supply. The device's time was shown when booted, the device's time displayed January 6, 1980. The device's menus were explored and remnants of digital flight logs were found. These log files were exported to a surrogate SD memory card which was inserted on the lab bench. These flight logs contained only the following parameters: flight duration, pilot number, max altitude, max airspeed, minimum and maximum vertical speed, and Hobbs time. In general, these time stamps were stamped as being from 2014 to 2016. The last log file was dated as 00/00/2020 and contained the following values: flight duration – 00:12, maximum altitude 8030 feet, maximum airspeed 211 mph, maximum vertical speed per minute 990 feet per minute, minimum vertical speed per minute -2040 feet per minute, Hobbs time 707.5 hours (maximum Hobbs time recorded of all sessions displayed on the unit).
