# Carburetor Icing Probability Graph – CEN22FA208

Airplane: Piper PA32-260

Accident Date: 05/22/2022

Accident Location: Broomfield, CO

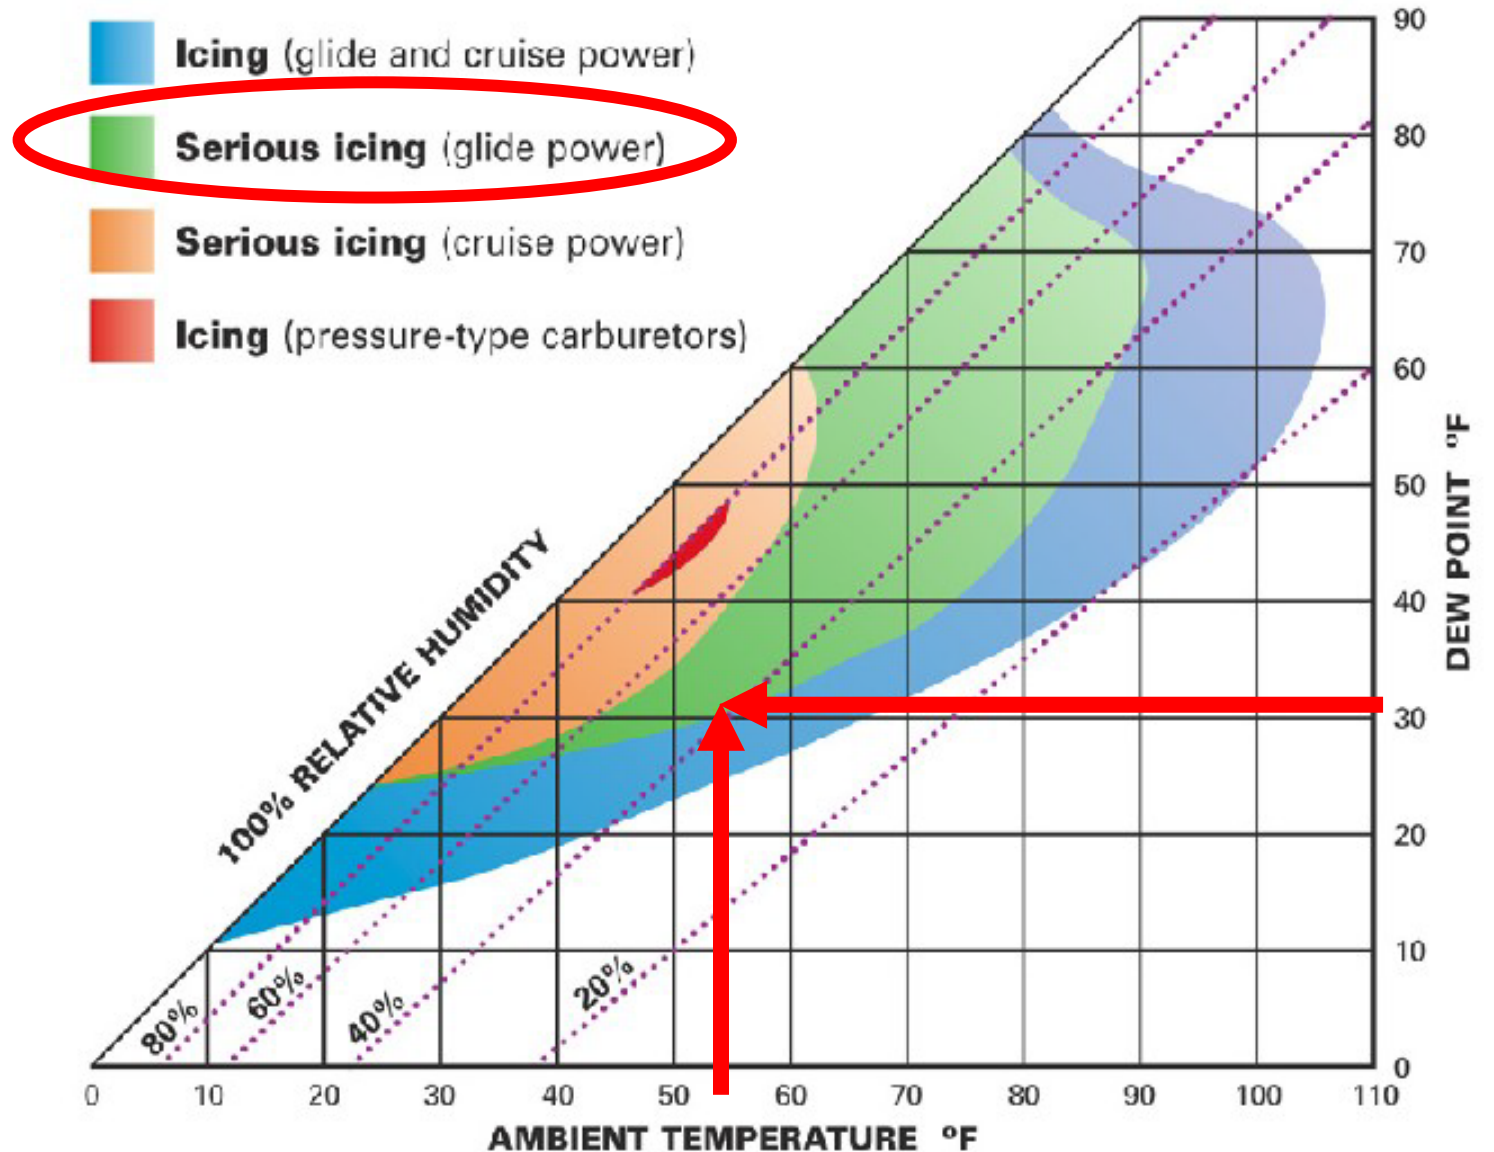
Weather: METAR KEIK 221755Z AUTO 19008KT 10SM  
BKN046 BKN075 12/M01 A3020

Temperature, 12° C = 53.6° F

Dew Point, -1° C = 30.2° F
