# SERVICE LETTER

Buckle/Connector Assembly Plug, P/N 502913  
Inspection and Removal

Cirrus Aircraft, SR2X, 7041-( ) Inflatable  
Restraint System Assembly

SL 7041, Issue: 1  
Page: 1 of 7  
Date: 24-Apr-2023

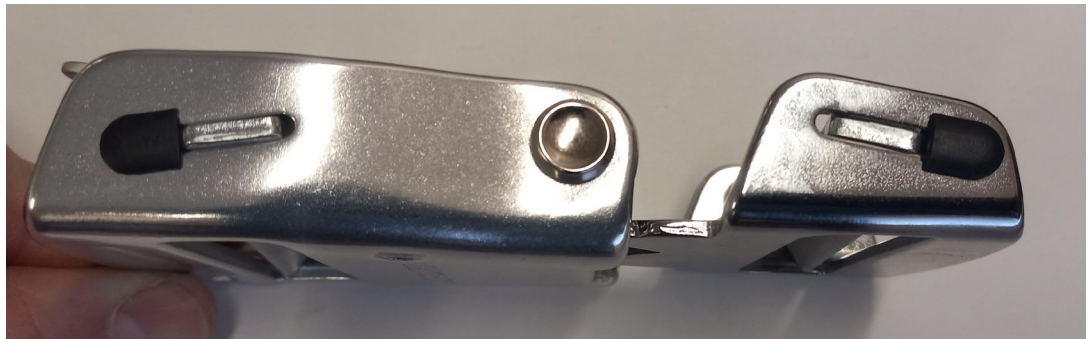
Figure 2. Buckle/Connector with Incorrect Plug Installation

2. Locate and inspect the buckle/connector assembly. If plug is installed incorrectly (as shown below), remove the plug using hand tools as needed.

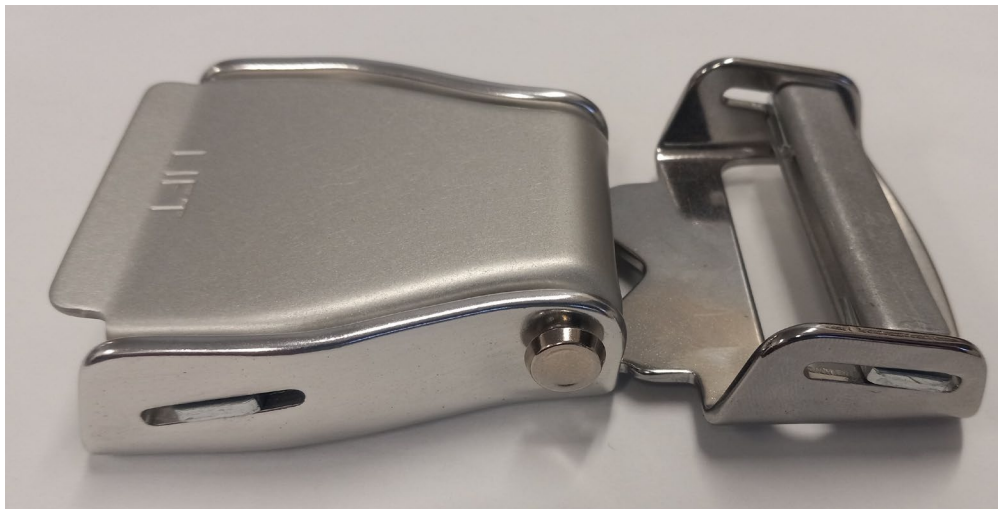
Figure 3. Buckle/Connector Before Plug Installation

3. Review Figure 3 for detail on where the plug is installed.
  - Slide the load bar (part which webbing wraps around) towards the webbing straps and hold it there while installing the plug.

- With the lot number on the plug facing inward lay the plug in the slot in the side of the buckle or connector lengthwise at an angle. The plug should be inserted into the end of the slot farthest from the webbing, and the curved end of the plug should face away from the webbing.

- With a small screwdriver, gently press in the center of the plug so that the lip of the plug comes through on the other side. (Note: use only enough pressure to make the lip of the plug pop through to the opposite side)

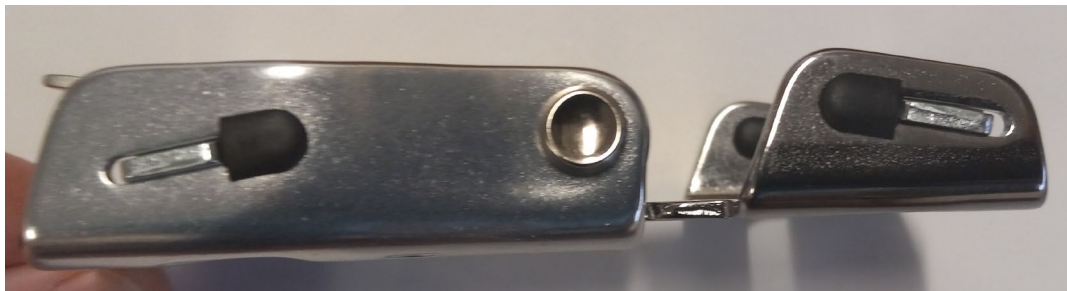
Figure 4. Buckle/Connector with Plug Installed

- Secure the plug with your finger to prevent the plug from disengaging out of the slot.
  - Ensure the plug is completely seated in the slot, and the lips on the plug are completely through the other side of the slot. See Figure 4.

- Repeat for the opposite side of the buckle/connector. Plugs must be installed in pairs, two per buckle.
- Inspect plugs for correct installation location per Figure 4 and Figure 5
