# Carburetor Icing Probability Graph – CEN22LA230

Airplane: Cessna 172P

Accident Date: 06/02/2022

Accident Location: Ennis, TX

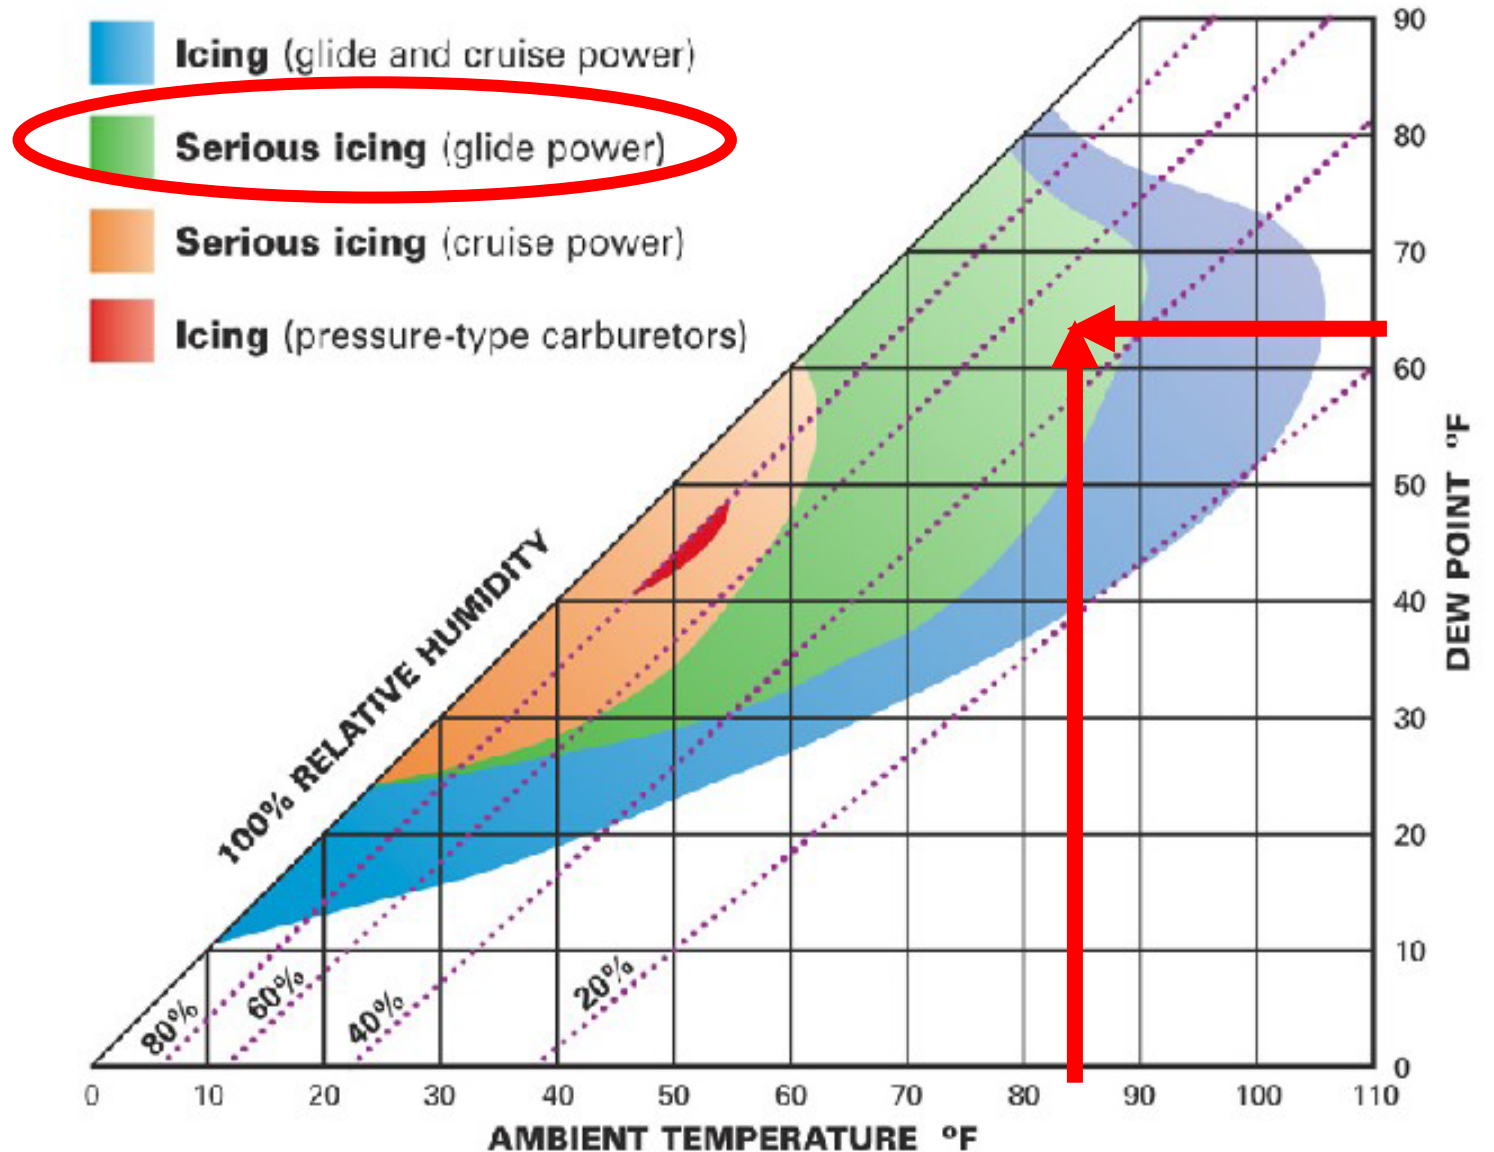
Weather: KJWY 022255Z AUTO 36006KT 10SM CLR 29/17  
A2995

Celsius to Fahrenheit Conversion:

Temperature, 29° C = 84.2° F

Dew Point, 17° C = 62.6° F

Source: Federal Aviation Administration

Special Airworthiness Information Bulletin CE-09-35

Carburetor Icing Prevention
