# National Transportation Safety Board

CEN23FA071

## PERSONAL ELECTRONIC DEVICES

Specialist's Factual Report

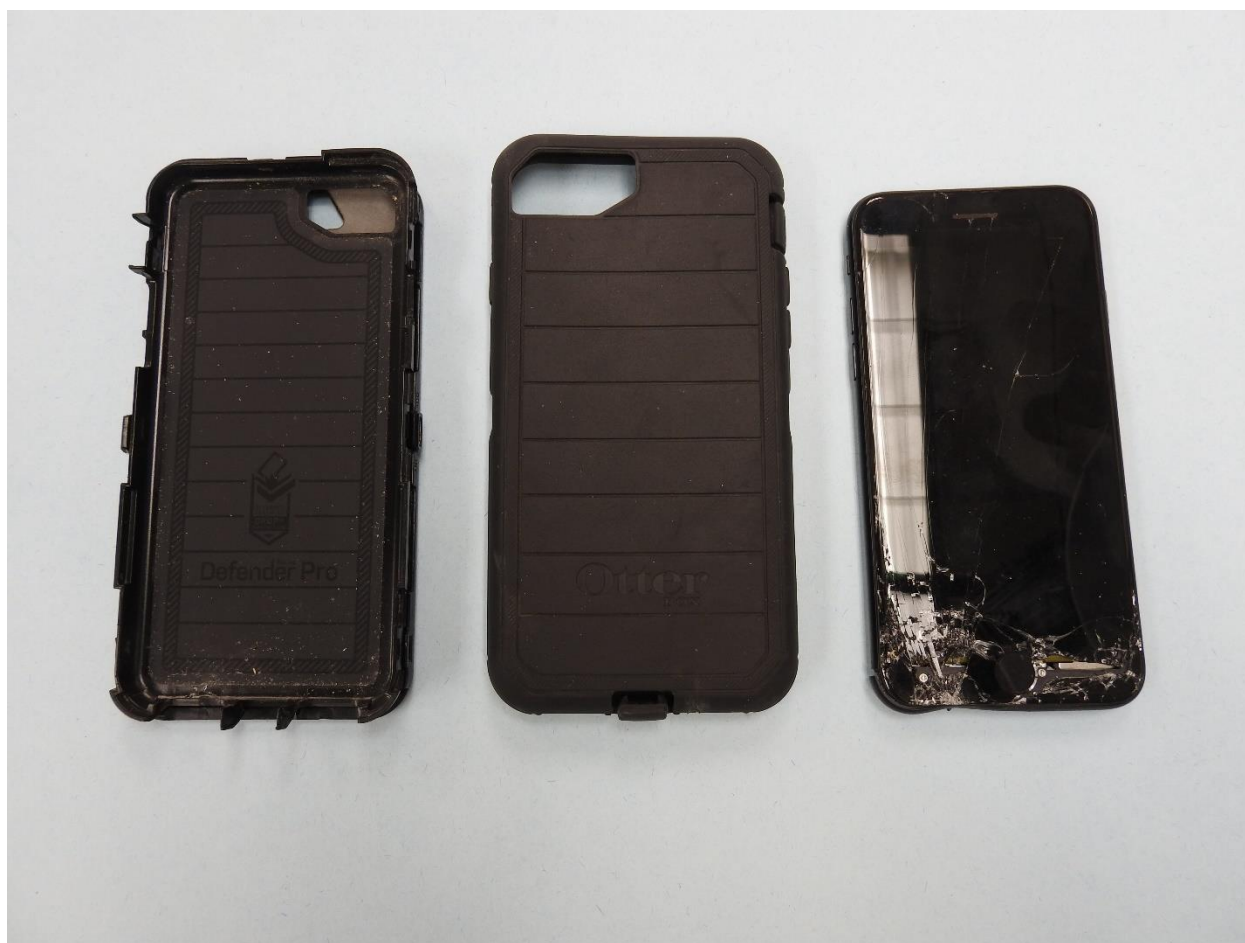
Upon arrival at the Vehicle Recorder Division, the Apple iPhone SE 2020 had sustained impact damage, as shown in figure 1. Despite significant damage to the bottom part of the device, the device powered up normally and was unlocked with a provided passcode. A video, which was recorded during the accident flight, was downloaded from the device. The documentation of this video can be found in the *Video File and Onboard Image, Audio, and Data Recorder - Group Chairman's Factual Report* in this investigative docket. There were no other data pertinent to the accident on the device.

**Figure 1.** Apple iPhone SE 2020 as received.

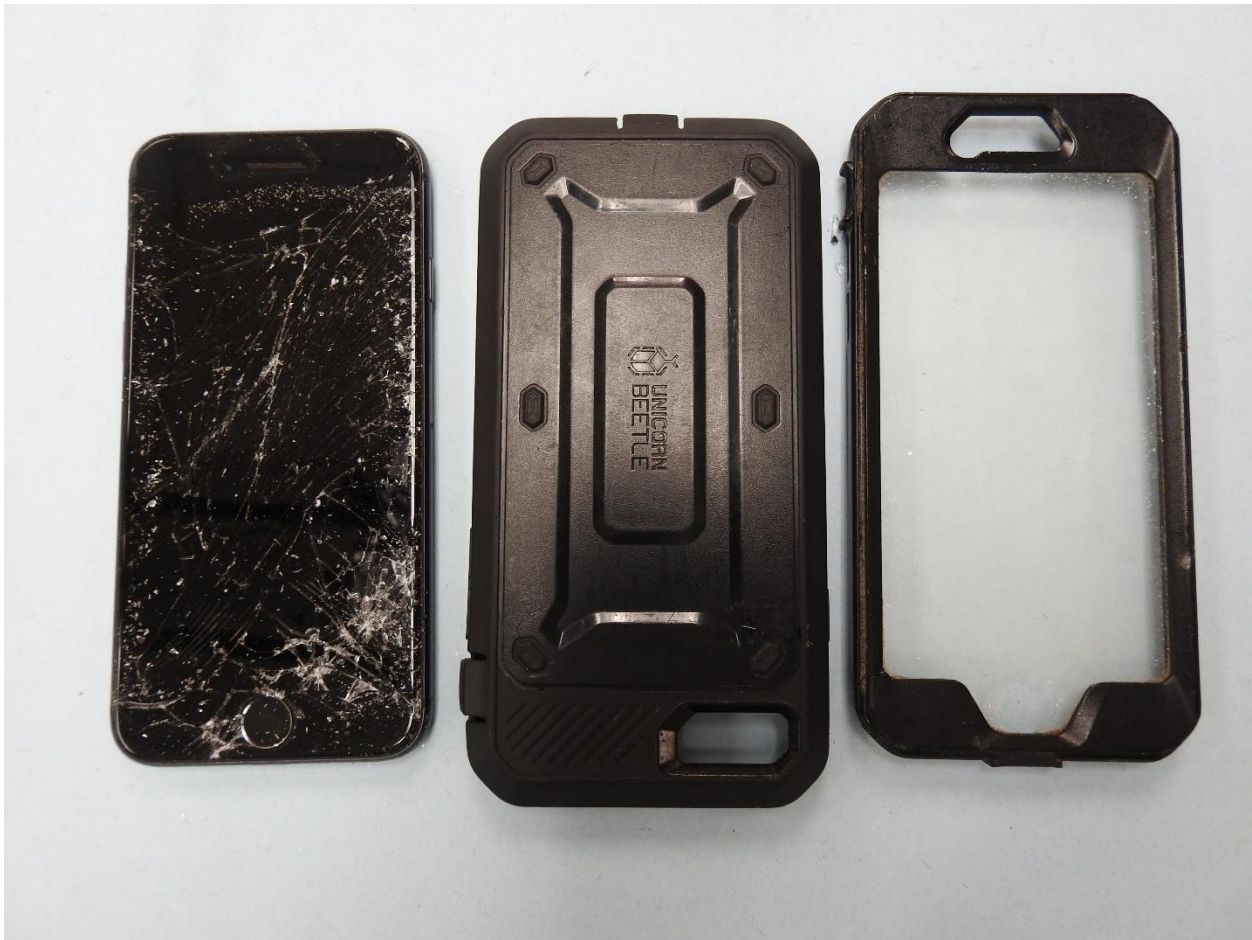
The Apple iPhone 8 had sustained impact damage in the event. The extent of the damage is shown in figure 2. The device was inoperable. After the screen and digitizer were replaced, the device powered on normally and was unlocked with a provided passcode. The recorded data were examined, and no data pertinent to the accident were found.

**Figure 2.** Apple iPhone 8 as received.
