# National Transportation Safety Board

CEN24FA049

## **ELECTRONIC DEVICES**

Location: Sterling City, Texas  
Date: November 29, 2023  
Time: 1430 central standard time (CST)  
Airplane: MD Helicopters Inc. MD600N, N745MB

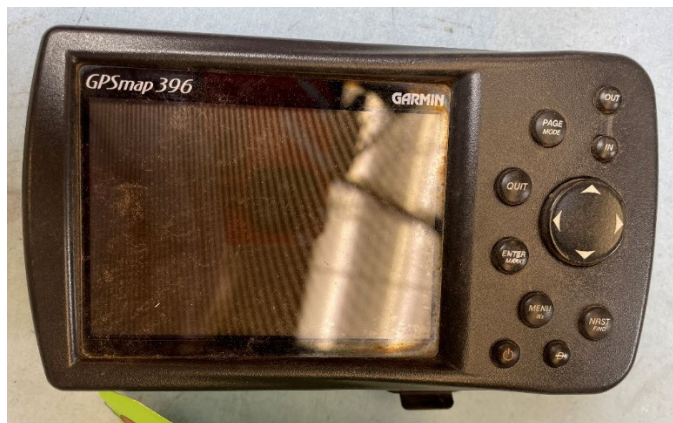
The device was in good condition upon arrival at the Vehicle Recorder Laboratory, as shown in Figure 1. The device powered on normally and a review of its contents revealed that the recording function was set to "off" and no track logs were present, thus, no accident-related data were recovered.

**Figure 1.** Garmin GPSMAP 396 as received.

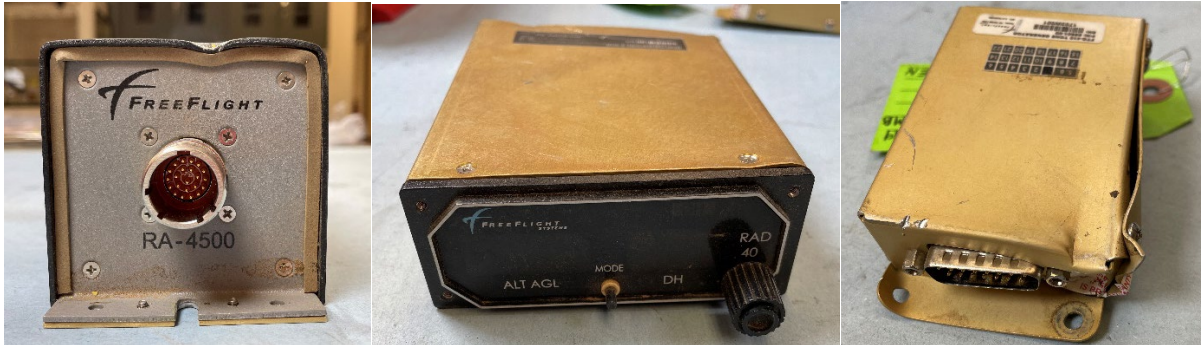
The Vehicle Recorder Laboratory received three FreeFlight Systems devices. The devices sustained impact damage, as shown in Figure 2. Correspondence with the manufacturer indicated that no historical data is stored internally on the devices, thus, no accident-related data were recovered.

**Figure 2.** FreeFlight Systems avionics. RA4500 (left), RAD-40 (center), and FTG-410 (right).

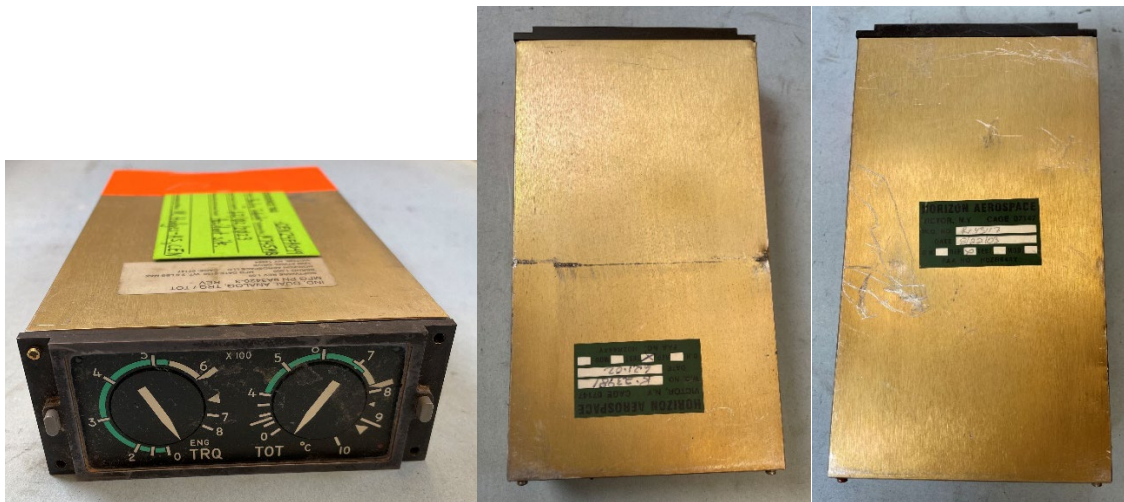
The Vehicle Recorder Laboratory received three Horizon Aerospace devices. The devices sustained minor impact damage, as shown in Figure 3. No data were recovered from the devices.

**Figure 3.** Horizon Aerospace avionics. Dual Analog Indicator (left), Quad Digital Indicators (center and right).
