# National Transportation Safety Board

CEN24FA167

## **MATERIALS LABORATORY**

Factual Report 24-036

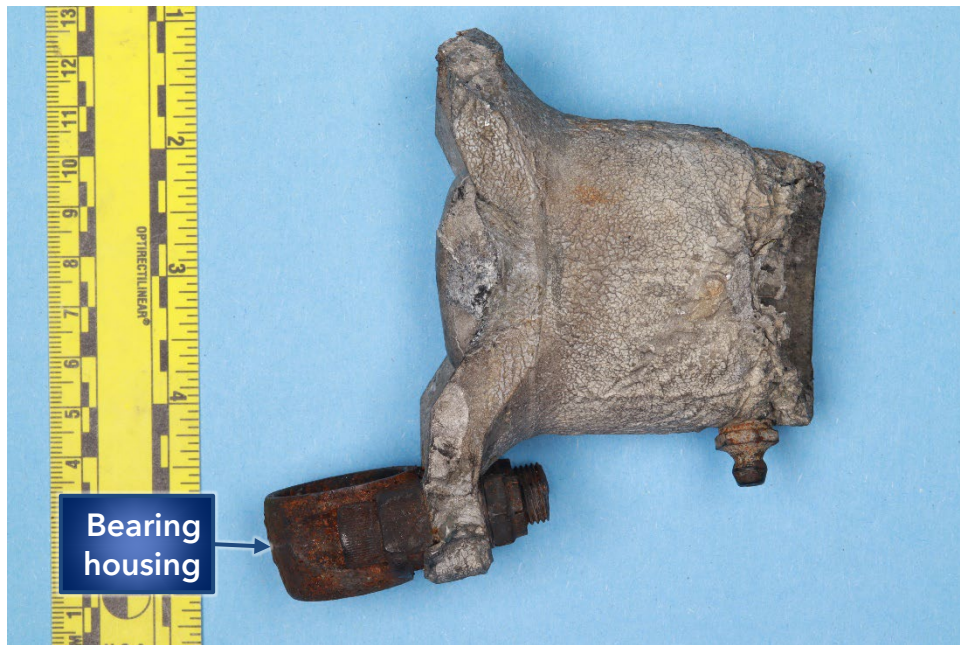
An overall view of the submitted portion of a driveshaft universal joint assembly is shown in figure 1. Overall, the steel bearing housing was darkened and oxidized consistent with high heat exposure. The aluminum alloy shaft piece was oxidized and wrinkled with missing material consistent with exposure to heat sufficient to cause partial melting. The driveshaft joint arm with the attached bearing housing was bent, displacing the attached bearing housing radially outward.

**Figure 1.** Overall view of the submitted driveshaft universal joint piece.

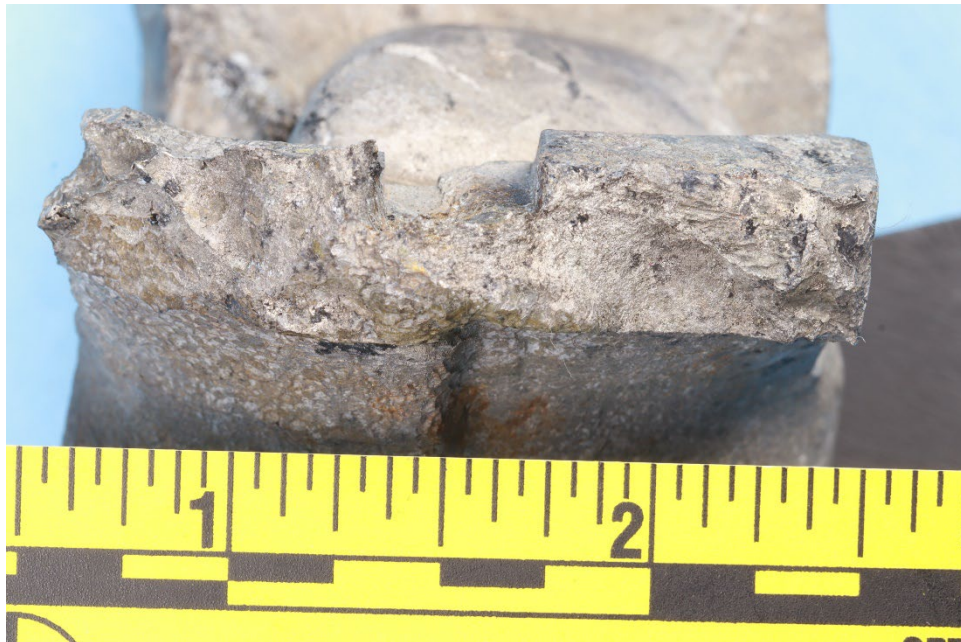
The driveshaft joint arm at the upper side of the photograph in figure 1 was fractured, and the fracture surface is shown in figure 2. The fracture surfaces were heavily oxidized. On the left side of the fracture as shown in figure 2, the fracture surface was thinned to a ridge near the middle of the fracture with external surface oxidation extending toward the ridge consistent with extensive deformation and necking prior to separation at high temperatures. Less deformation was observed at the right side of the fracture surface, but the overall fracture pattern had a rough, irregular fracture consistent with ductile overstress fracture. No evidence of a preexisting separation prior to exposure to high heat approaching the melting temperature was observed.

**Figure 2.** Fracture surface of the arm at the upper side of the photograph in figure 1.
